Aviation Investigation Final Report

Location:	Sheridan Lake, Colorado	Accident Number:	CEN16FA188
Date & Time:	May 18, 2016, 09:01 Local	Registration:	N6609P
Aircraft:	Cessna P210N	Aircraft Damage:	Substantial
Defining Event:	Loss of control in flight	Injuries:	1 Fatal
Flight Conducted Under:	Part 91: General aviation - Personal

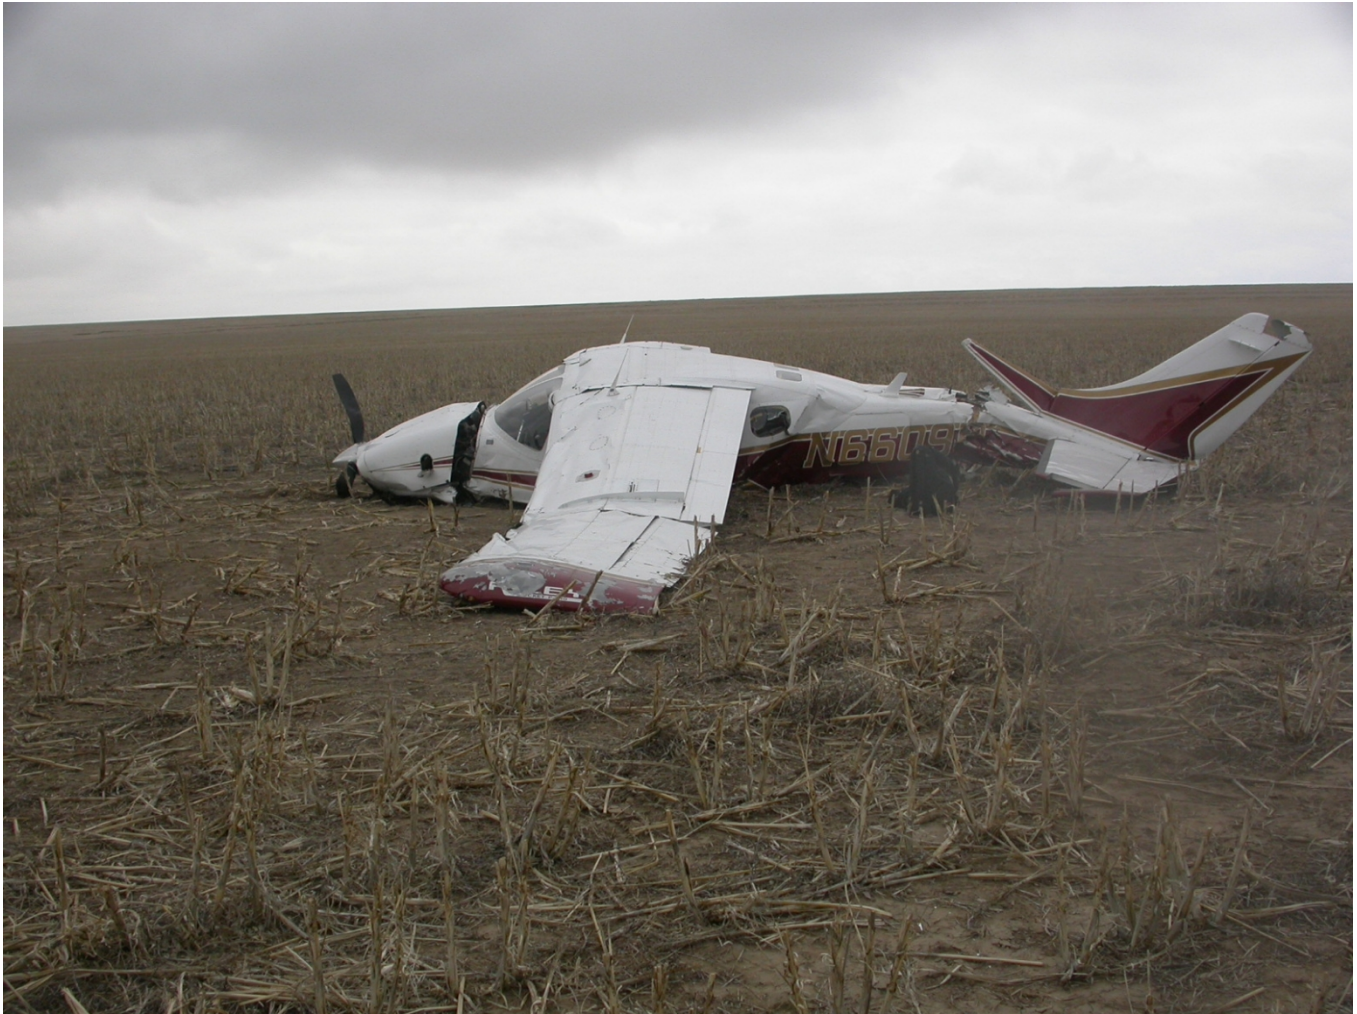
Fig. 1 View of the airplane at the accident site

The airplane impacted an open, harvested agricultural field in a wings-level, flat pitch attitude. The left wing was canted aft and the right wing was canted forward, consistent with the airplane being in a left spin at impact. The tail was bent slightly to the left of the fuselage and the engine was displaced slightly to the right. The fuselage was leaning slightly to the left. The landing gear was found in the retracted position.
