# Aviation Investigation Final Report

<b>Location:</b>	Brunswick, North Carolina	<b>Accident Number:</b>	ERA16LA209
<b>Date &amp; Time:</b>	June 10, 2016, 09:00 Local	<b>Registration:</b>	N2283M
<b>Aircraft:</b>	WSK PZL MIELEC M 18A	<b>Aircraft Damage:</b>	Destroyed
<b>Defining Event:</b>	Aircraft structural failure	<b>Injuries:</b>	1 Fatal
<b>Flight Conducted Under:</b>	Part 137: Agricultural

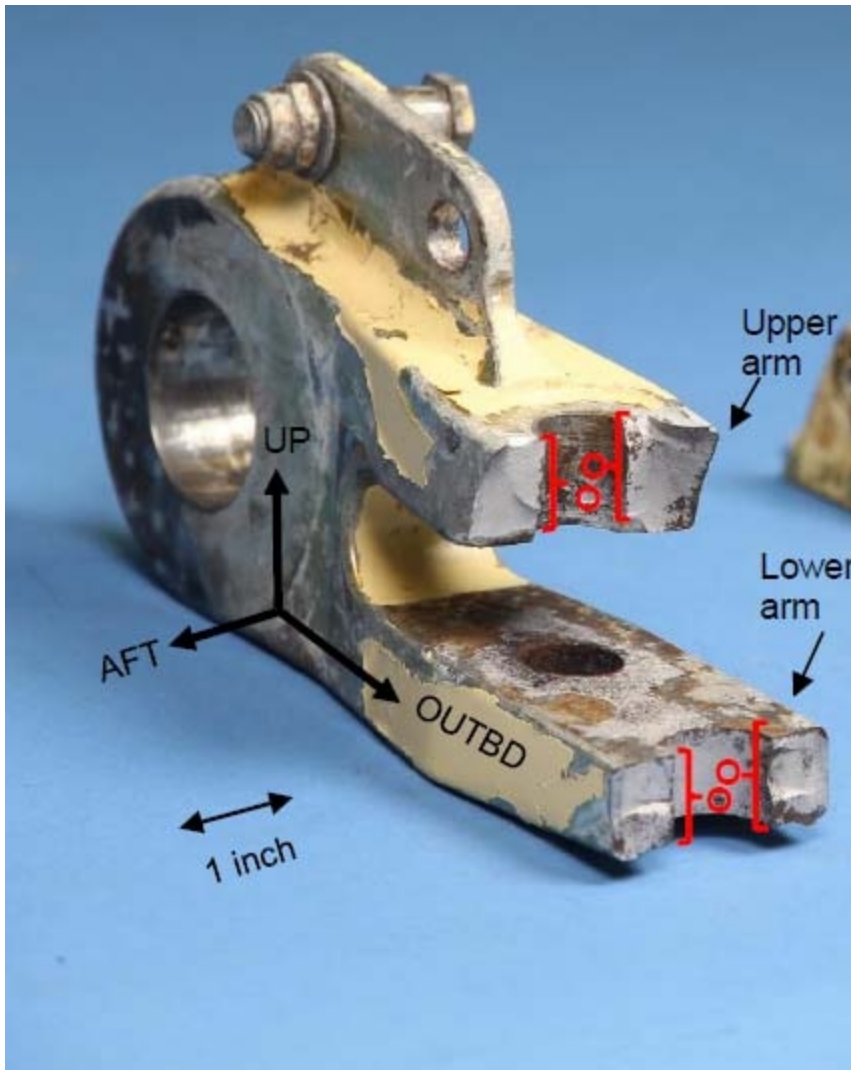
Figure 1. Right outboard wing forward spar, lower fitting.

The right outboard wing forward spar lower fitting fractured through the upper and lower arms in the areas indicated by arrows in figure 1. Each arm contained six vertical bolt holes used to attach the fitting to the outboard wing forward spar. The fracture in the upper arm intersected the inboard vertical bolt hole, and the fracture in the lower arm intersected the second vertical bolt hole from the inboard end. Bench binocular microscope of the fractured arms revealed all the fracture faces contained fatigue cracks that emanated from the bore of the holes on diametrically opposite sides of each hole, in the areas indicated by brackets "O" in figure 1.

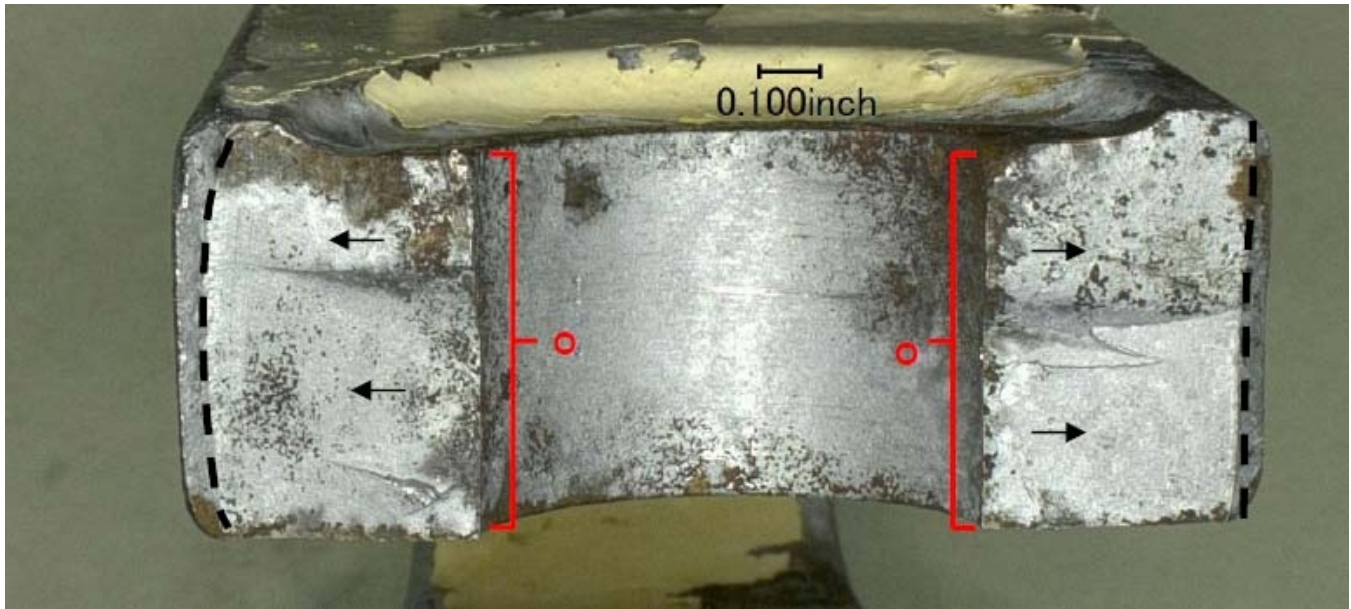
Figure 2. Right outboard wing forward spar, Lower fitting, Lower arm.

Figure 2 shows a photograph of the lower arm fracture faces. The fatigue cracks in the lower arms initiated from multiple origins along the entire length of the bolt hole, in the areas indicated by brackets "O" in figure 2. Most of the fatigue crack origins were associated with corrosion pitting in the bore. Fatigue propagation on each side of the hole was through a 90% of the thickness and terminated in the areas indicated by dashed lines in figure 2.

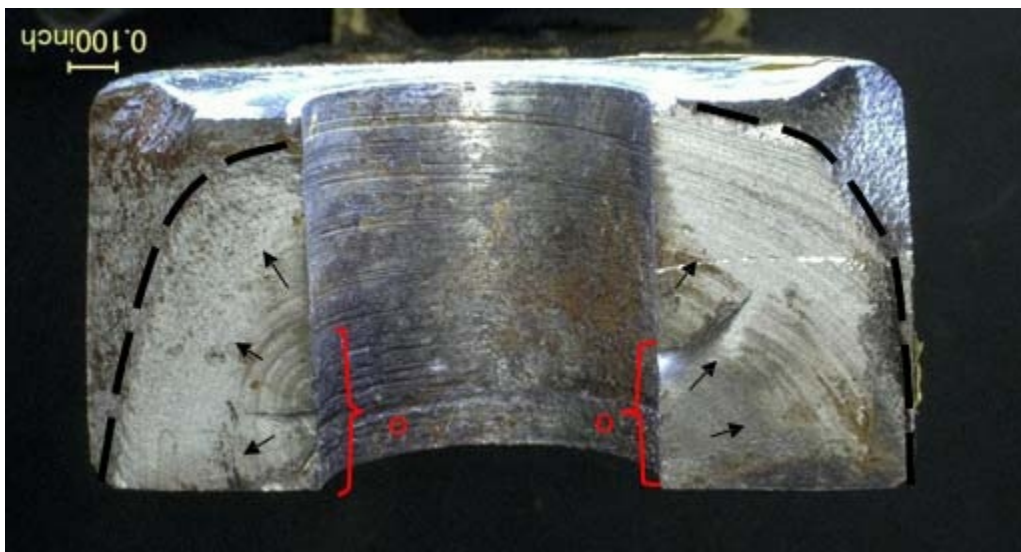
Figure 3. Right outboard wing forward spar, lower fitting, upper arm.

Figure 3 shows a photograph of the upper arm fracture faces. The upper arm fractures contained similar fatigue cracks with the exception that the fatigue cracks initiated from multiple origins near the lower portion of the bolt hole. Most of the fatigue crack origins were associated with corrosion pitting in the bore. The fatigue cracks in the upper arms exhibited better defined fatigue fracture features than those on the lower arms.

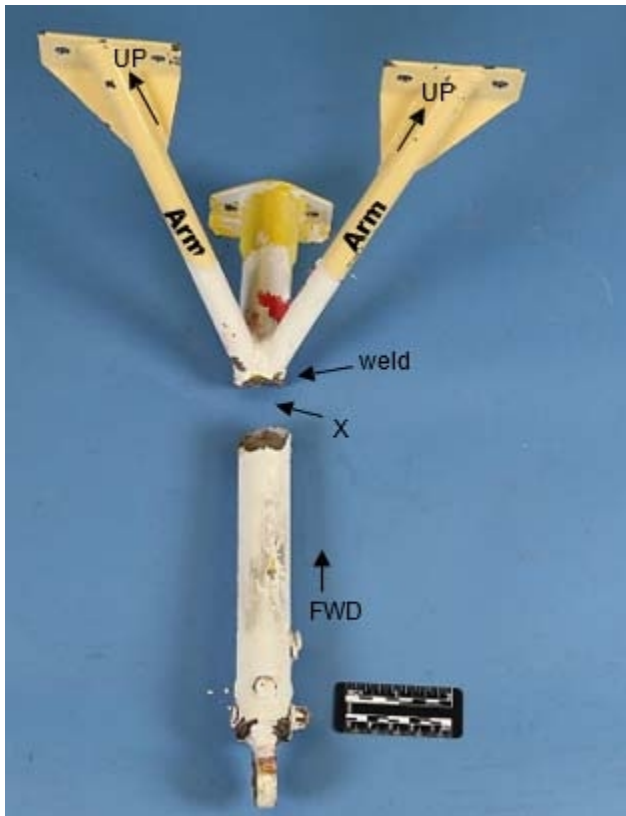
Figure 4. Right outboard aileron attach bracket.

Figure 4 shows a photograph of the right outboard aileron attach bracket, which contained a circumferential fracture in the main tube portion, near the location where the two upper arms were welded to the main tube. The fracture intersected the aft edges of the welds at the base of the two arms, indicated by arrows "X" in figures 4. Bench binocular microscope examination of the forward face of the main tube fracture revealed multiple fatigue cracks that emanated from the outer surface of the main tube at the aft edges of the welds. Fatigue propagation was through about 50% of the thickness and extended around about 30% of the tube circumference. Corrosion was noted on the outboard tube surface.
