# Aviation Investigation Final Report

<b>Location:</b>	Hayward, California	<b>Accident Number:</b>	WPR16FA126
<b>Date &amp; Time:</b>	June 19, 2016, 11:49 Local	<b>Registration:</b>	N1270P
<b>Aircraft:</b>	Piper PA 23-150	<b>Aircraft Damage:</b>	Destroyed
<b>Defining Event:</b>	Loss of control in flight	<b>Injuries:</b>	1 Fatal
<b>Flight Conducted Under:</b>	Part 91: General aviation - Personal

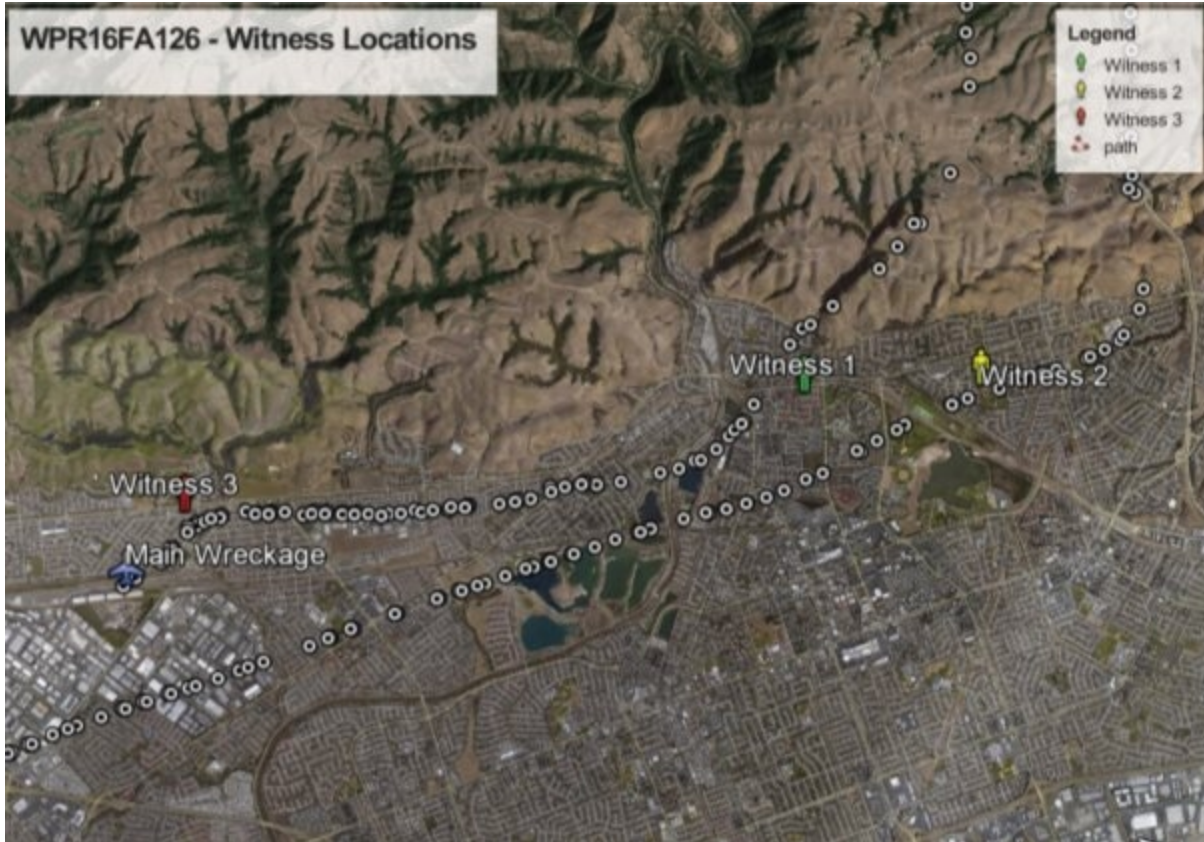
Figure 1 – Witness Locations

Three witnesses were interviewed: two who saw the airplane flying inbound to land (witnesses 1 and 2) and one who saw the airplane moments before it impacted the building in the rail yard (witness 3). As shown in Figure 1, Witness 1 was located near the airplane's inbound leg, about 9 nm southeast of HWD. Witness 1 reported that she heard an abnormal sound from inside her home. She went outside and saw an airplane approaching her house from a group of hills located to the east. The airplane appeared to be losing altitude, and the engine made a "sputtering sound," which she also described as "cutting out." The sound repeated when the airplane flew above her property and again seconds later after it passed her home.

Witness 2 was located about 10 miles southeast of HWD near the airplane's outbound leg and about 1 mile south of the airplane's inbound leg. Witness 2 stated that he was working in his yard all morning and initially saw a red and white airplane on a southeast heading about 1,750 ft. He never saw any smoke but heard a sound that resembled an engine "backfiring." The airplane subsequently made a left turn, proceeded eastbound, and disappeared behind a group of hills. About 30 minutes later, he saw the same airplane northeast of his house flying toward the airport. The witness reported hearing sounds like an engine "popping" and "backfiring." He added that he did not see any smoke, foreign object debris, or fluids coming from the airplane, and he further said that the engine "backfiring" sounds were much louder than those he heard during the airplane's outbound leg.
