# Aviation Investigation Final Report

| <b>Location:</b> | Alamogordo, New Mexico | <b>Accident Number:</b> | CEN16LA234 |
| <b>Aircraft:</b> | North American Navion | <b>Aircraft Damage:</b> | Substantial |
| <b>Defining Event:</b> | Loss of engine power (total) | <b>Injuries:</b> | 2 None |

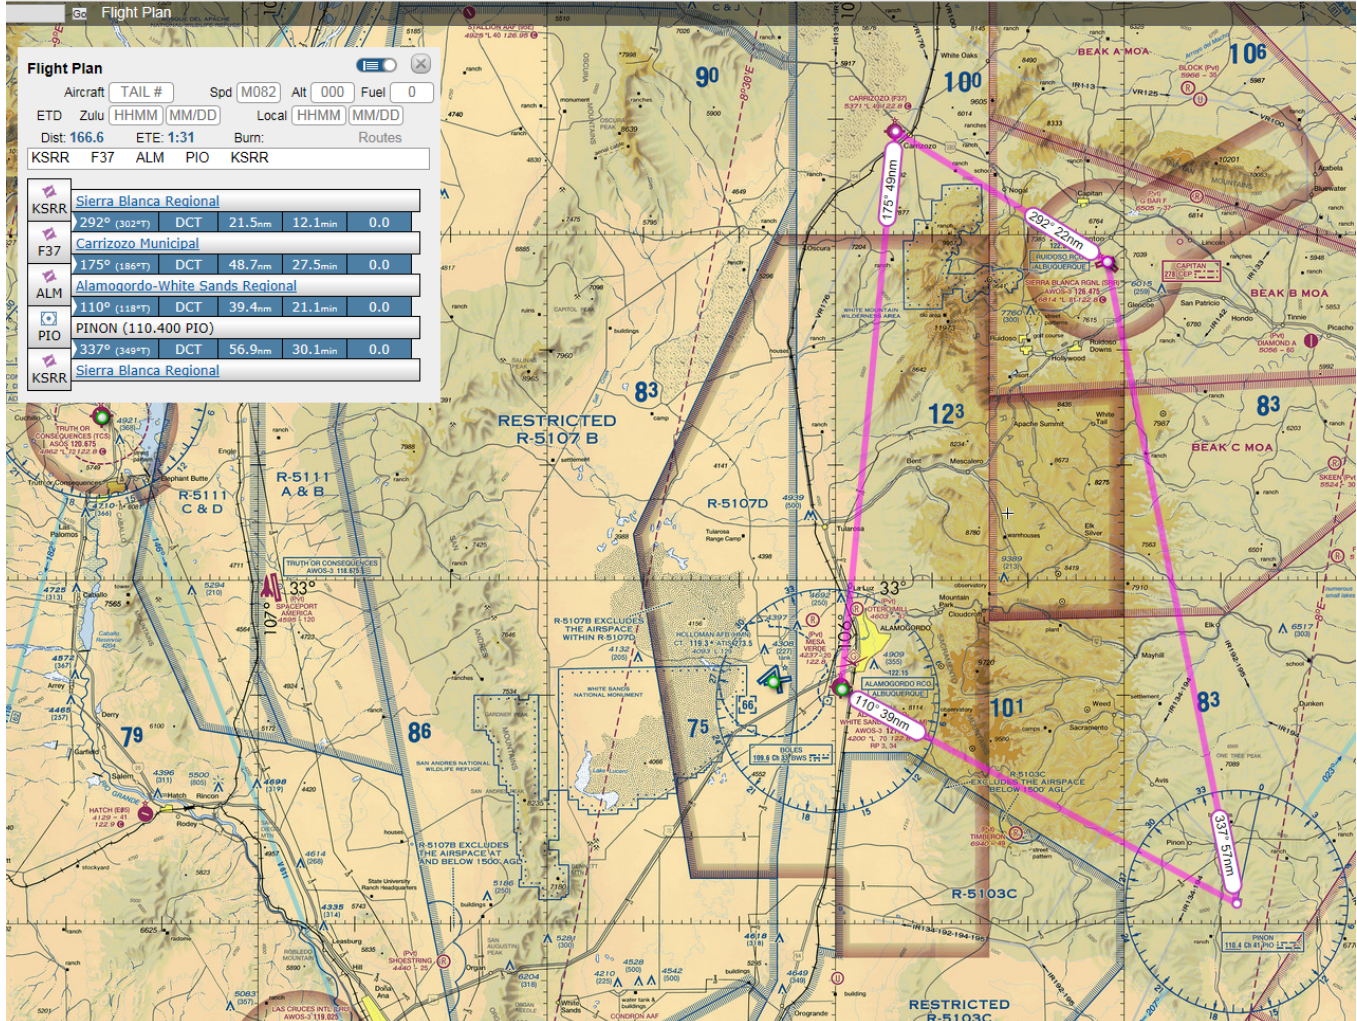
Figure 1 – Aeronautical Chart with Flight Route

The pilot stated that he and his passenger were flying in a planned proficiency competition with several other airplanes. The objective of the competition was to predict a time en route and total fuel consumption for a predetermined four-leg route, then fly the route as close as possible to the predicted time and fuel consumption (Figure 1).

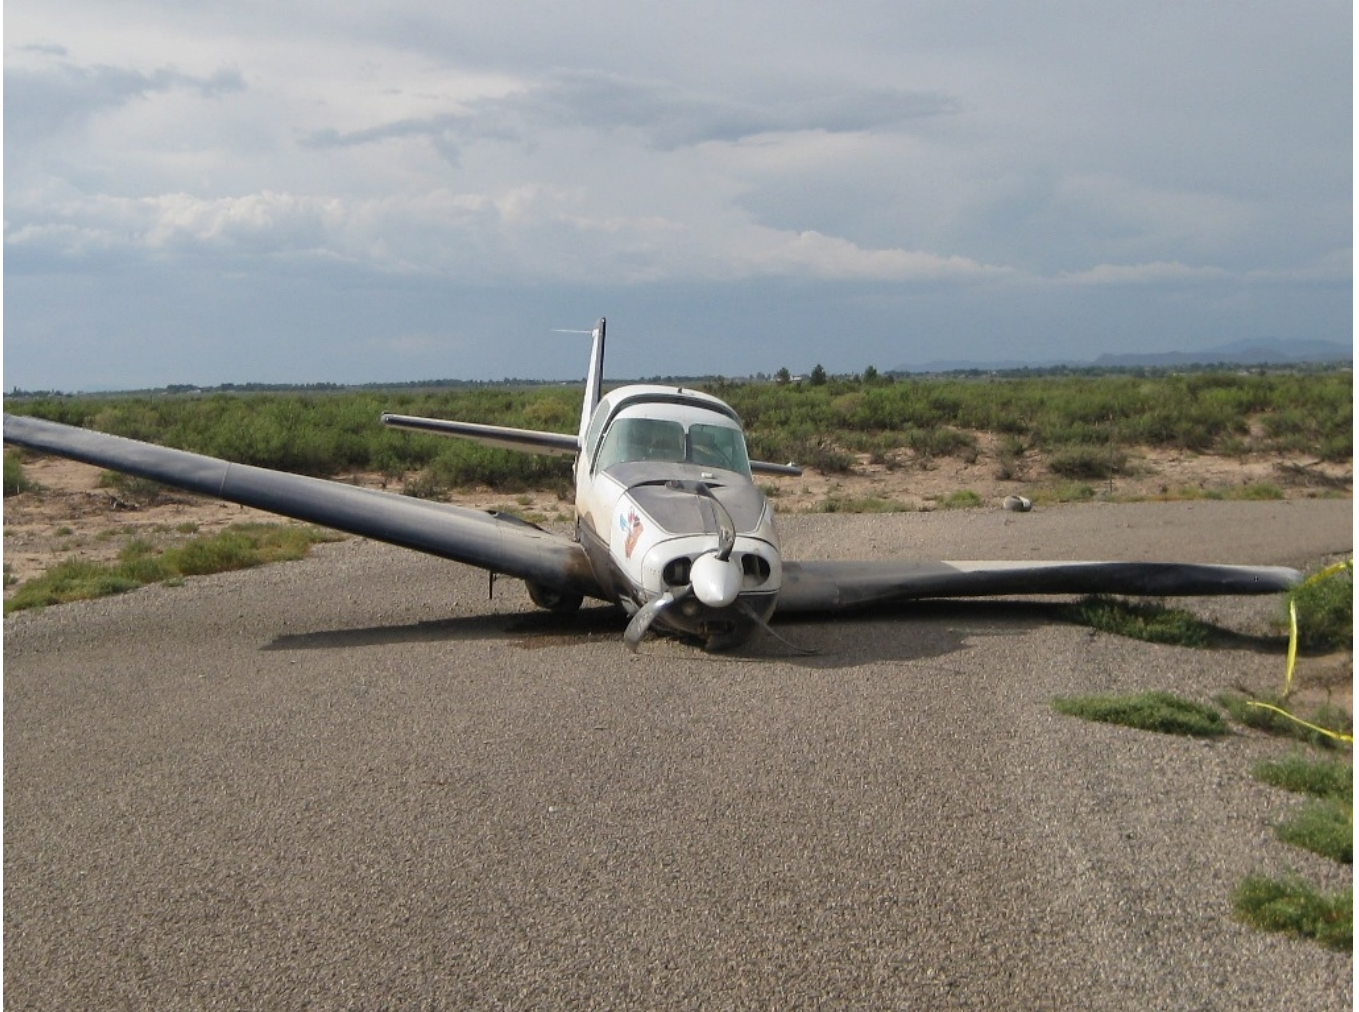
Figure 2 – Airplane on Road

The airplane was in cruise flight and level at 7,500 ft mean sea level (msl) when the pilot noticed the engine was "running rough." At 0958, the Nos. 1 and 5 cylinders were significantly cooler than the other 4 cylinders; No. 1 cylinder head temperature (CHT) was 350° and the exhaust gas temperature (EGT) was 990° while No. 5 CHT was 305° and EGT was 1320°. In contrast, the No. 6 CHT was 398°. At 1010, the airplane reached 8,000 ft msl over mountainous terrain when they noticed an "acrid metallic smell" in the cabin. The pilot made a distress call on the radio, then a right turn towards an airport. About 13 nautical miles (nm) southeast of Alamo-White Sands Regional Airport (ALM), the engine was "running very rough" and the pilot heard a "metallic clanking" sound. He reduced the engine power and descended. About 5 to 6 nm from ALM, the engine continued to operate with reduced power and the airplane continued to descend. The pilot setup for an emergency landing on a residential road, but with no engine power available the airplane landed in a field about 100 yards short of the road. The airplane continued into a drainage culvert and then came to rest on the road. The airplane sustained substantial damage to the engine mounts, firewall, wing spar, fuselage, and empennage (Figure 2).

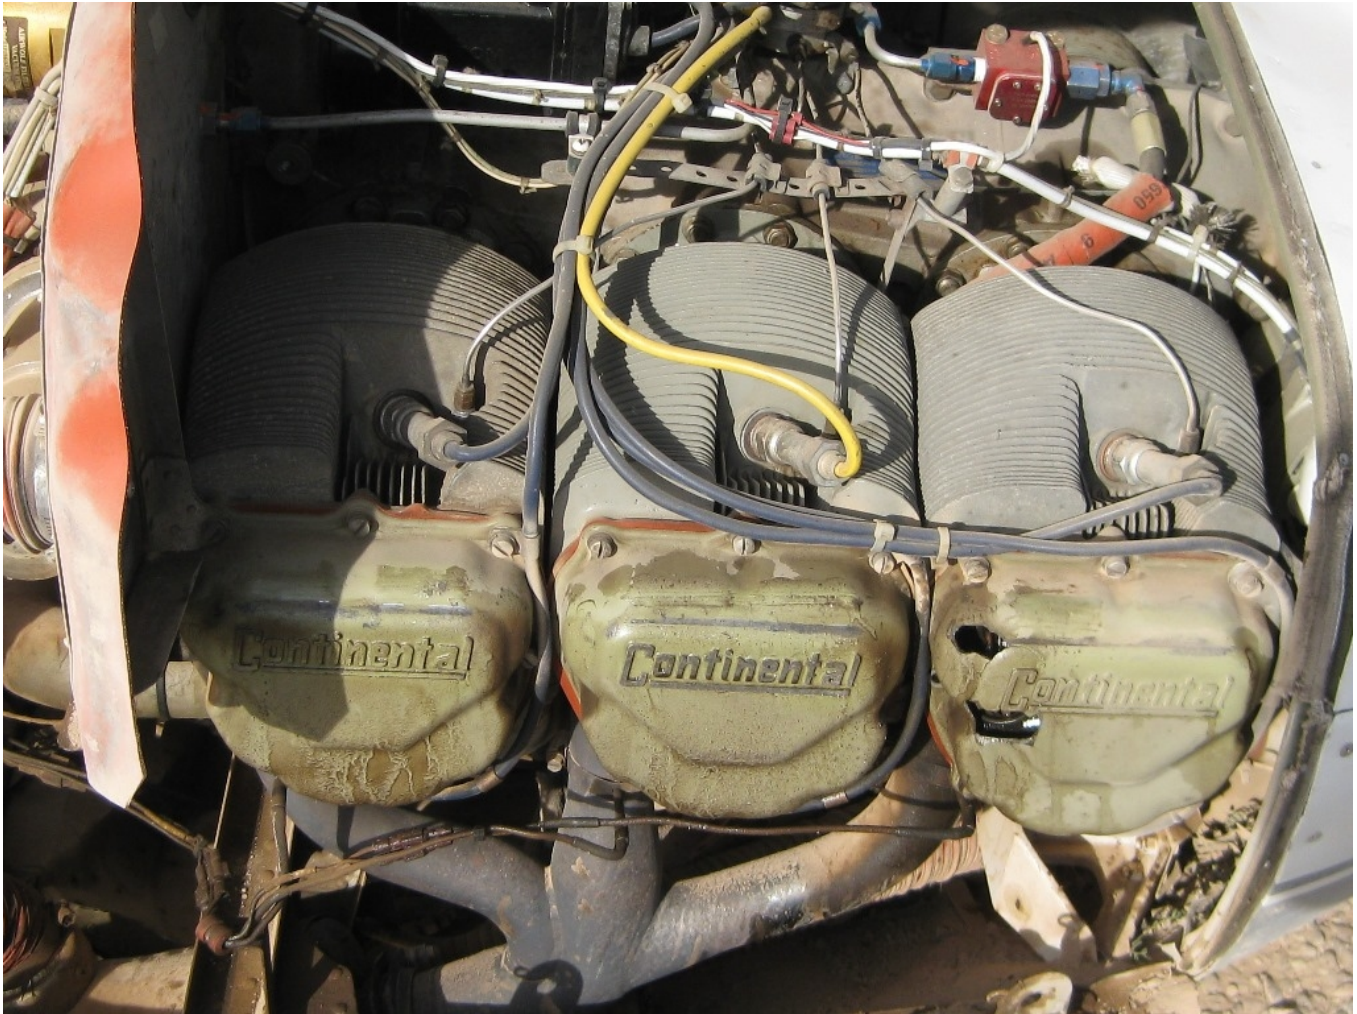
Figure 3 – Engine Cylinder No. 5 Damage

A postaccident examination of the engine revealed that the engine crankcase was cracked at the base of the No. 5 cylinder and the cylinder's rocker box cover exhibited multiple holes. The oil sump contained a large amount of metal debris and damaged components from the No. 5 cylinder. The No. 5 cylinder exhaust valve spring key was worn and damaged. The exhaust valve guide was fragmented and the valve guide bore was worn beyond the specified size, which indicated the valve guide was moving inside the guide bore. The No. 5 piston and cylinder damage were a result of the valve being released into the cylinder during engine operation. It is likely that the valve spring key failed and allowed the valve to release into the cylinder.

The failure of the No. 5 exhaust valve key spring, which resulted in a total loss of engine power.

The responding Federal Aviation Administration (FAA) inspector conducted a postaccident examination at the accident site with the pilot. They removed the engine cowling to examine the Continental Motors IO-520-B engine. The No. 5 cylinder appeared damaged and the engine crankcase was cracked in the same area (Figure 3).

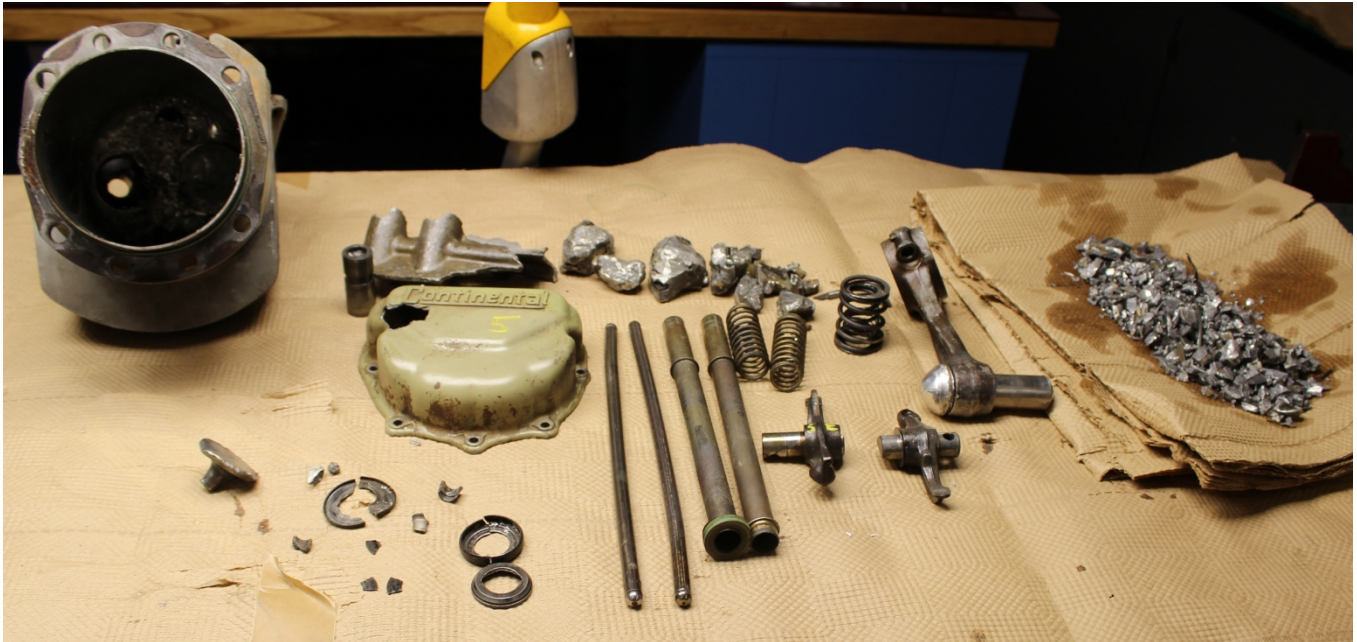
Figure 4 – No. 5 Cylinder Parts Disassembled

The No. 5 cylinder was disassembled (Figure 4) and examined at the Continental Motors Analytical Department under the auspices of the NTSB. The examination revealed that the exhaust valve guide was fragmented; some of the valve guide fragments were not recovered for examination. The valve guide was marked with "FAA-PMA" on one of the fragments, which indicated that it was not a Continental Motors part. FAA Parts Manufacturer Approval (PMA) are third-party manufactured replacement or modification parts sold for installation on a type-certificate product. The valve guide bore (Figure 5) was worn beyond the specified size and showed signs of the valve guide moving in the guide bore. The exhaust valve head hardness was checked and met the appropriate specification. Only one valve key spring was found with the parts and it was worn.
