Aviation Investigation Final Report

Location:	Italy, Texas	Accident Number:	DCA16FA199
Date & Time:	July 6, 2016, 11:48 Local	Registration:	N525TA
Aircraft:	Bell 525	Aircraft Damage:	Destroyed
Defining Event:	Aircraft structural failure	Injuries:	2 Fatal
Flight Conducted Under:	Part 91: General aviation - Flight test

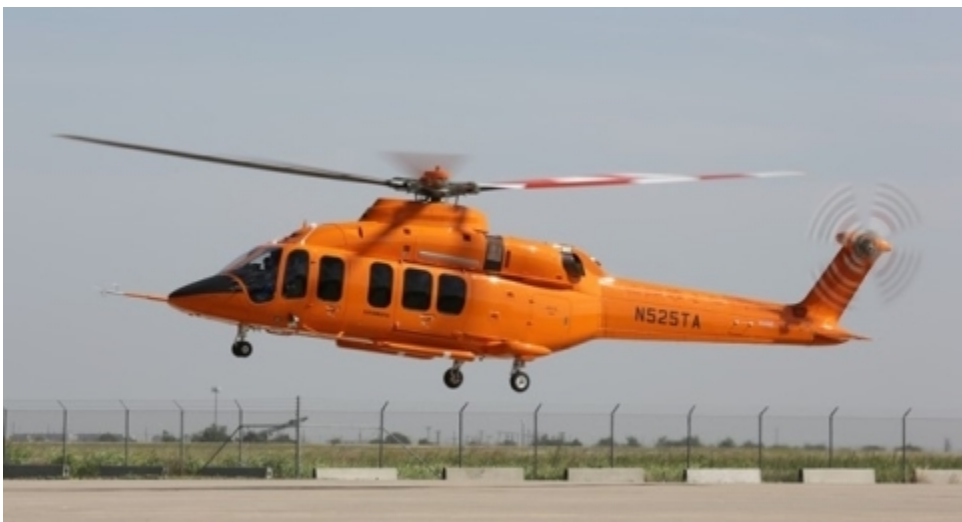
Figure 1. Accident helicopter (Bell 525, N525TA).

The accident helicopter was a conventional main rotor and tail rotor design (see figure 1). On April 25, 2016, the helicopter received its latest experimental research and development airworthiness certificate from the FAA. The helicopter was a manufacturing prototype being developed for certification as a transport-category helicopter in compliance with 14 *CFR* Part 29. As part of the airworthiness certificate, the FAA issued an operating limitations document (also dated April 25, 2016) that specified the following: pilots operating the helicopter must hold a temporary LOA issued by an FAA flight standards operations inspector to act as PIC, the helicopter must be maintained by an FAA-approved inspection program, day visual flight rules flight operations are authorized, and all flights must be conducted within the Arlington Initial Experimental Test Area. The helicopter was estimated to weigh about 19,975 lbs at the time of the accident.

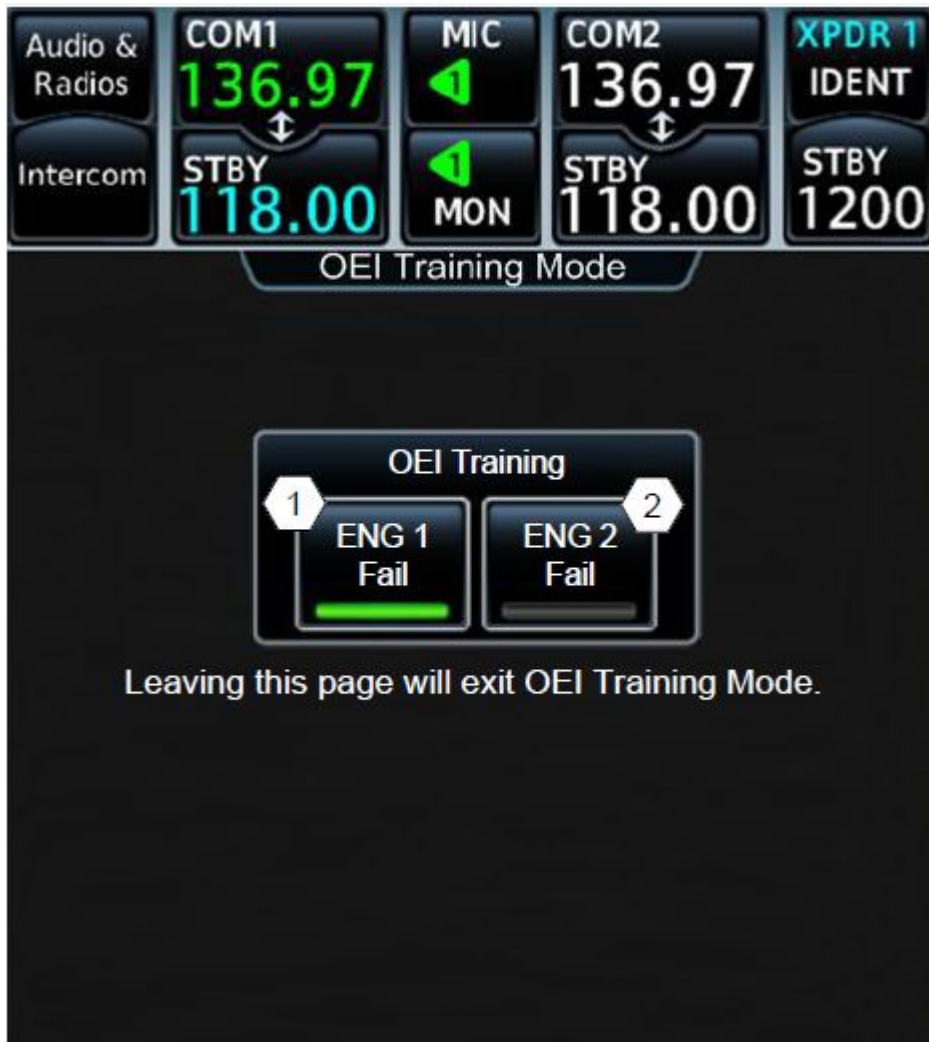
Figure 2. OEI training page on the GTC.

To engage OEI training, the pilot or copilot navigates to the OEI training page on the GTC and selects the engine to fail on the touch screen. Once selected, a green bar appears on the failed engine button to signal that OEI training mode was engaged (see figure 2). When OEI training mode is engaged, the pilot's side (right-seat) PFD displays simulated OEI engine values, and the copilot's side (left-seat) PFD displays the actual all-engines-operative (AEO) data.

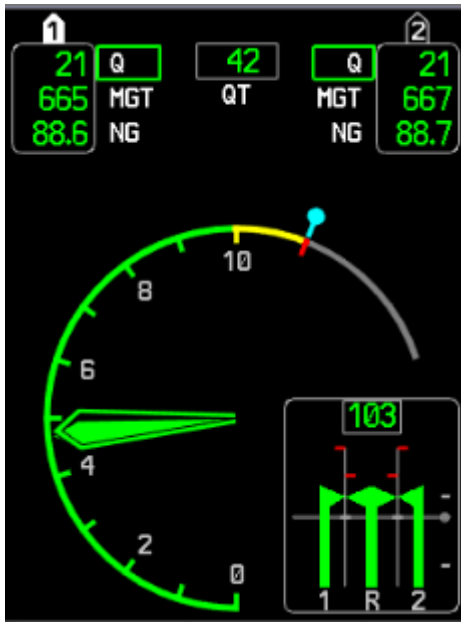
Figure 3. Example of PSI on the Bell 525.

The PSI was located in the bottom left corner of the PFD for each pilot. The bars in the bottom right corner of the PSI represented Np for the number 1 engine, Nr, and Np for the number 2 engine, respectively. The arc in the center of the display depicted the percentage of engine value compared to its limit (see figure 3).

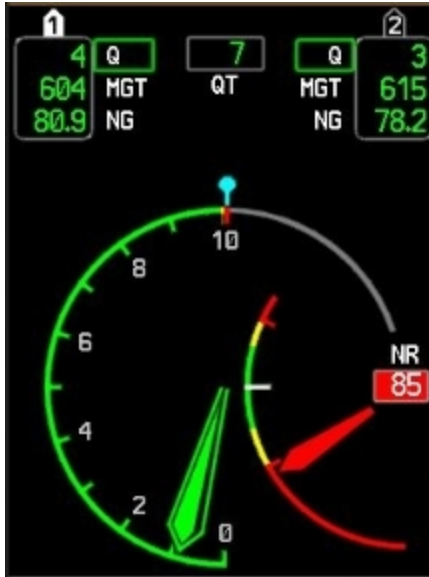
Figure 4. PSI displaying Nr as an arc.

The PSI displayed Nr as a vertical scale (center bar in lower right indicator) when Nr was above 90%, as shown in figure 3. If Nr dropped below 90%, the display changed to an analog needle that displayed a green arc for Nr between 100 and 90%, a yellow arc for Nr between 86 and 89% Nr, and a red arc below 86% Nr (see figure 4). (Overtorquing limits appear above 100%.)

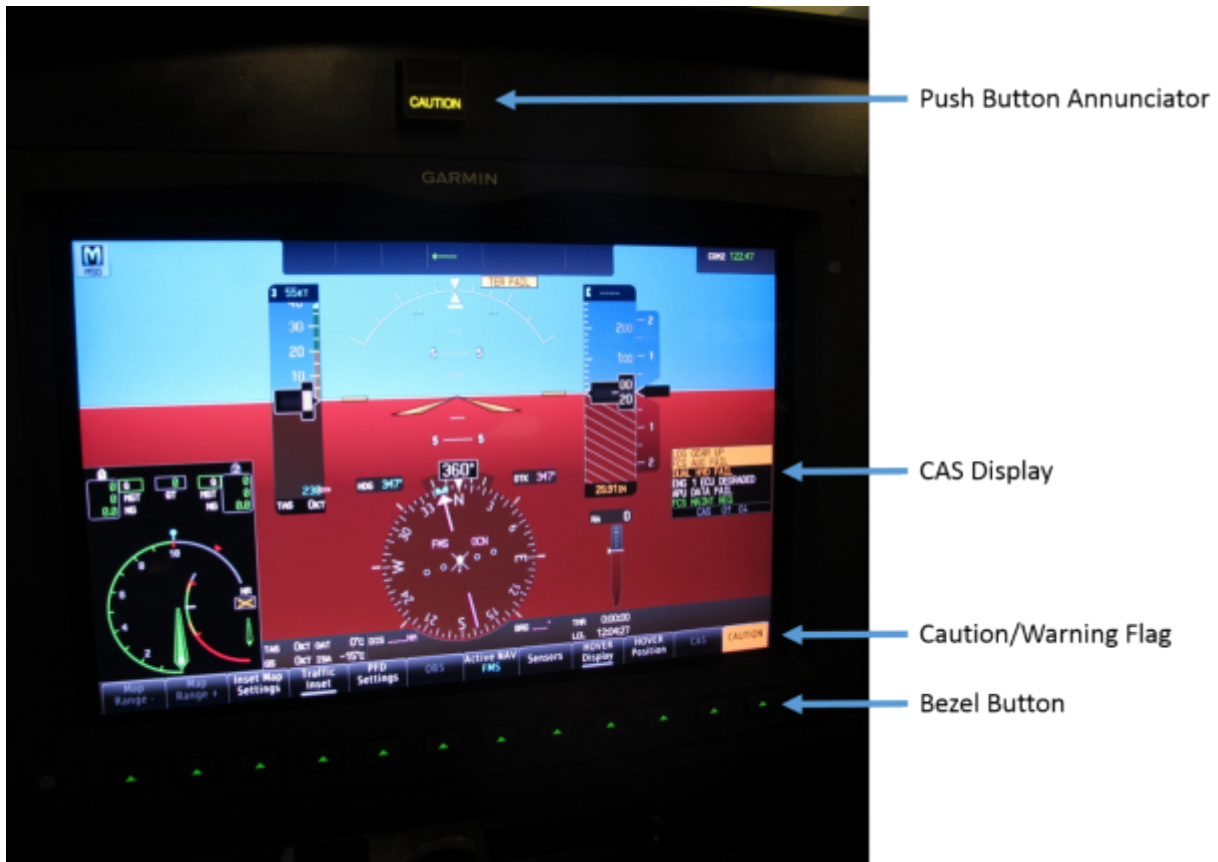
Figure 5. Location of visual CAS information available to crew.

The CAS was located in the middle right side of the PFD and displayed color-coded messages for status, advisory, caution, and warning alerts (see figure 5). The Bell 525 lead test pilot described warnings as items that need immediate attention and cautions as items that will need attention but not immediately. (Warnings were displayed as white text on red background, cautions were displayed as yellow text on black background, advisories were displayed as white text on black background, and status messages were displayed as green text on black background.) When warnings and caution alerts were triggered, the displayed messages would flash until either the cockpit master warning/caution push button annunciator (PBA) was pressed, the bezel button on the lower right corner of the PFD was pressed, or the triggered condition was inactive for more than 5 seconds. In addition, a caution/warning flag would appear in the lower right corner of the PFD, and a caution/warning light would illuminate on the PBA. For the accident helicopter, if Nr dropped below 90% (in AEO or OEI), a "ROTOR RPM LO" warning-level message appeared (see figure 6). Once the condition cleared, the message would immediately disappear.

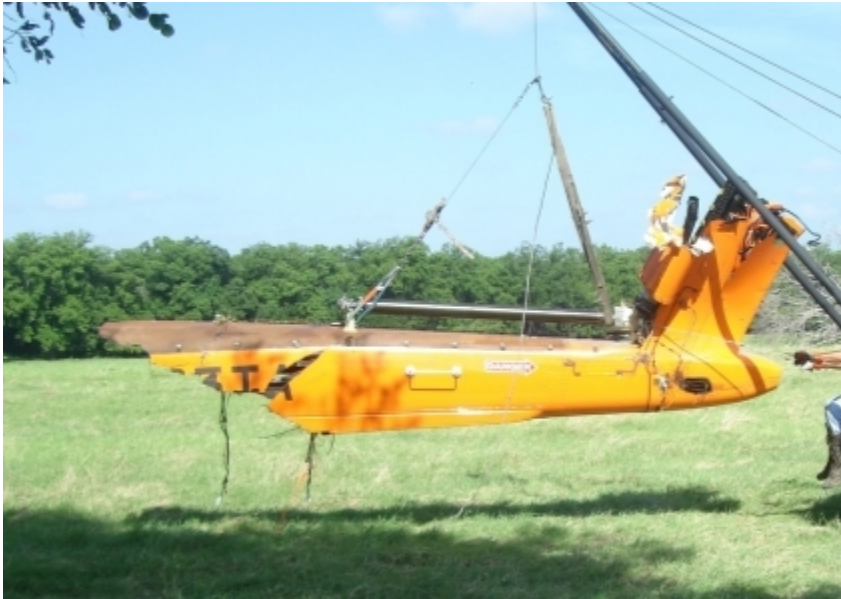
Figure 8. Angled cut line at the forward end of the aft section of the tail boom.

The main fuselage was highly fragmented and exhibited evidence of thermal damage. The cockpit wreckage did not sustain significant thermal damage. Fractured pieces of the cyclic and collective side sticks were observed within the cockpit wreckage. The lateral push-pull tubes were retained in the cockpit wreckage but exhibited fractures consistent with overload. Both engines remained installed on the engine deck and exhibited thermal distress from exposure to the postcrash fire. The forward portion of the tail boom exhibited an angled fracture line at its aft end consistent with main rotor blade contact. The tail boom attachment points to the main fuselage exhibited fractures near the upper left corner and lower right corner. The aft portion of the tail boom was found resting partially inverted, with the tail rotor head and one tail rotor blade wholly embedded into the ground and exhibited an angled cut line at

its forward end consistent with main rotor blade contact (see figure 8).

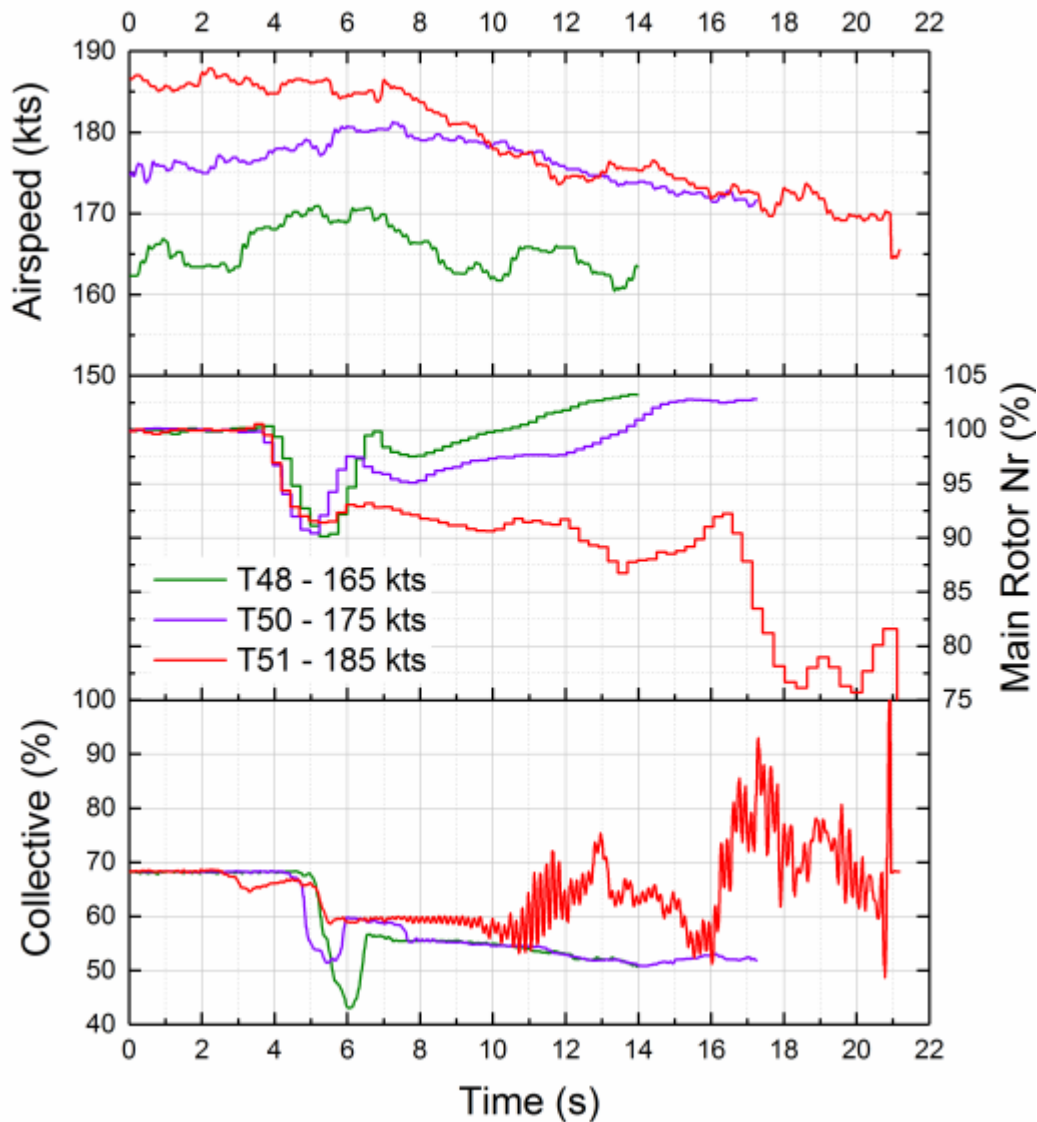
Figure 9. Plot comparing tests 48, 50, and 51.

In two prior successful OEI tests at 175 knots airspeed (record 50) and 165 knots airspeed (record 48), Nr decayed from 100% within about 3.5 to 4 seconds, consistent with initiation of the OEI test. Collective was reduced to 51% for test 50 and 43% for test 48. Nr stopped decreasing around 90% before recovering to 97% for test 50 and nearly 100% for test 48. The time from Nr decay to initial Nr recovery for both tests was between 2 and 3 seconds (see figure 9).

For test 51, Nr began to decay about 3.5 seconds after test initiation, similar to the prior tests. Collective was reduced to 58%, and Nr stabilized near 92% but did not return to 97% or higher as in the previous tests. After 6 seconds, a vibration near 6 Hz was seen in the collective and longitudinal cyclic inputs that was not present in the earlier tests. After 7 seconds, Nr stopped recovering. When collective was increased between 10 and 13 seconds and again between 16 and 17.5 seconds, Nr slowed, and, by 18 seconds, it had decreased to below 80%. After 10 seconds, cyclic input activity increased, as did the roll response. The helicopter's roll and pitch responded to cyclic input throughout the accident flight.
