Aviation Investigation Final Report

Location:	Italy, Texas	Accident Number:	DCA16FA199
Date & Time:	July 6, 2016, 11:48 Local	Registration:	N525TA
Aircraft:	Bell 525	Aircraft Damage:	Destroyed
Defining Event:	Aircraft structural failure	Injuries:	2 Fatal
Flight Conducted Under:	Part 91: General aviation - Flight test

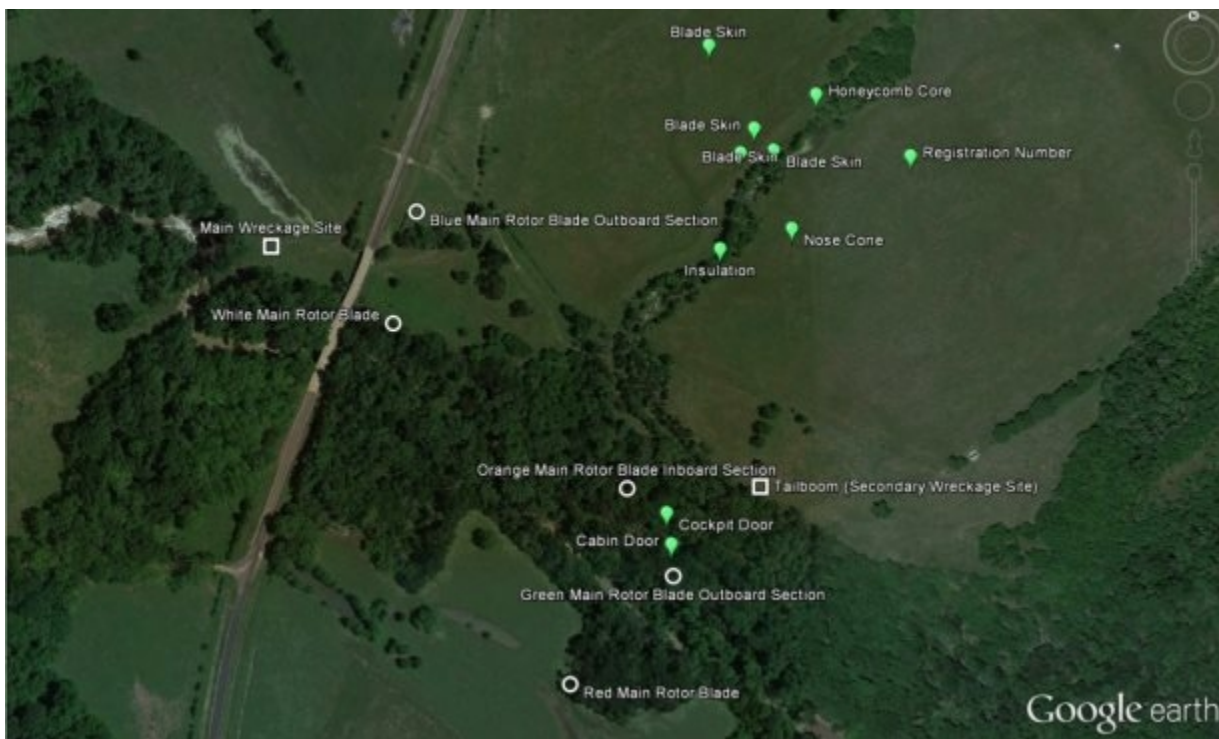
Figure 7. The location of the main wreckage site, secondary wreckage site, and selected items from the wreckage debris field.

The main wreckage field was 2,200 ft from the last transmitted GPS point, along the flightpath heading of 320°. The main wreckage site included an impact crater, remnants of the main fuselage, cockpit, main transmission and main rotor hub, two of the five main rotor blades (blue and green), the forward portion of the tail boom, and both engines. There was evidence of a postcrash fire at the main wreckage site. The wreckage debris path at the main wreckage site was about 200 ft in length and was oriented about 315° magnetic.

The secondary wreckage site was about 1,300 ft southeast of the main wreckage site and comprised the aft portion of the tail boom, which contained the tail rotor drive system, intermediate gearbox, tail rotor gearbox (TRGB), and tail rotor. A debris field extended between the last data point and the main wreckage covering about 4,000 ft (north to south) by 1,700 ft (east to west). Three of the five main rotor blades (orange, white, and red) and various pieces of forward cowlings, cockpit frames, and cabin doors were found separate from the main and secondary wreckage sites in the debris field. Additionally, lightweight debris, such as insulation and main rotor blade skin pieces, was found scattered to the northeast of the debris path between the main and secondary wreckage sites, with the farthest piece being found about 1,520 ft away from the debris path between the main and secondary wreckage sites (see figure 7).
