# Aviation Investigation Final Report

<b>Location:</b>	Hickory, Kentucky	<b>Accident Number:</b>	ERA16FA248
<b>Date &amp; Time:</b>	July 11, 2016, 11:23 Local	<b>Registration:</b>	N427TV
<b>Aircraft:</b>	BELL HELICOPTER TEXTRON CANADA 407	<b>Aircraft Damage:</b>	Substantial
<b>Defining Event:</b>	Flight control sys malf/fail	<b>Injuries:</b>	1 Fatal
<b>Flight Conducted Under:</b>	Part 91: General aviation

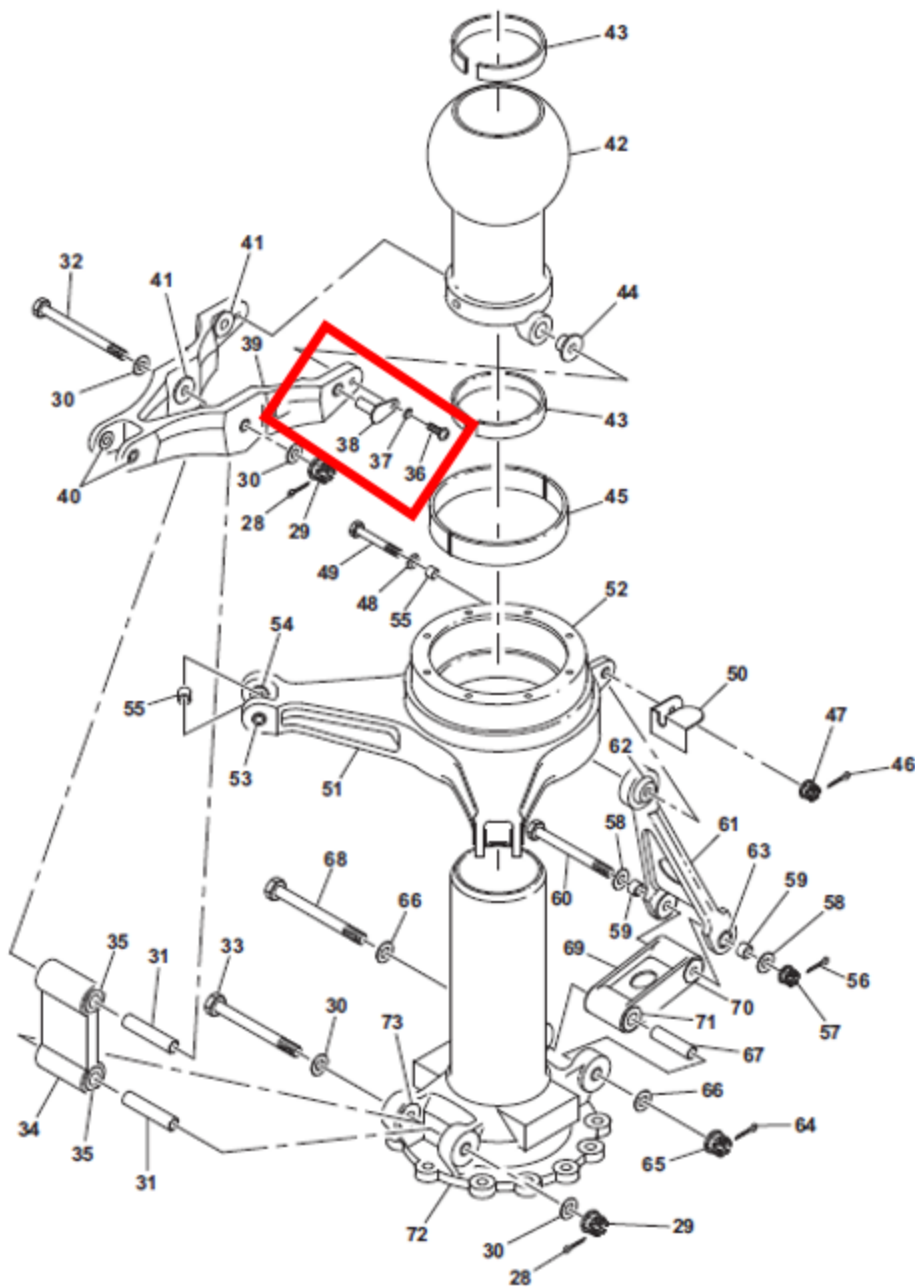
The collective lever was located at the front and bottom of the swashplate support. The collective lever and collective control link were designed to move the pivot sleeve vertically on the swashplate support to change the pitch on all the main rotor blades simultaneously. The collective lever was attached to the pivot sleeve with screws, washers, and pivot pins (see figure 1). Once attached, the and the specified torque was applied, locking wire would typically be affixed to the screw.

Figure 1 - Swashplate support assembly, with collective pitch lever attaching hardware outlined in red.

The left collective control was not installed. Collective control continuity was confirmed through the right collective and up through the servo actuators to the disconnected collective lever. The two collective lever pivot pins and screws that attached the collective lever to the pivot sleeve were not installed. The pivot pins and screws were found on the transmission deck and on the ground underneath the right side of the helicopter. The flat washers and lockwire were missing; the washers were later found during a subsequent examination of the wreckage.

The collective lever and attachment hardware were sent to the NTSB Materials Laboratory for further examination. The collective lever, collective lever pins, collective lever pin screws, and washers were examined visually and by optical microscopy. All components were intact. Threads on the collective lever pin screws and the mating threaded holes in the collective lever were intact with no evidence of stripping. Holes for attaching lockwire were present in the

heads of the screws and at an adjacent area on the collective lever, but no lockwire was observed attached at either location. Deformation at the edges of the lockwire holes was noted. Circumferential scoring was present across the entire face on one side of one of the washers. On one of the screws, thread peaks were flattened near the middle of the shank on one side of the screw consistent with contact with the collective lever pin hole bore with the screw partially threaded into place.
