Aviation Investigation Final Report

Location:	McCarthy, Alaska	Accident Number:	ANC16LA047
Date & Time:	July 19, 2016, 10:00 Local	Registration:	N151J
Aircraft:	AEROPRO CZ A220	Aircraft Damage:	Substantial
Defining Event:	Loss of engine power (partial)	Injuries:	1 None
Flight Conducted Under:	Part 91: General aviation - Personal

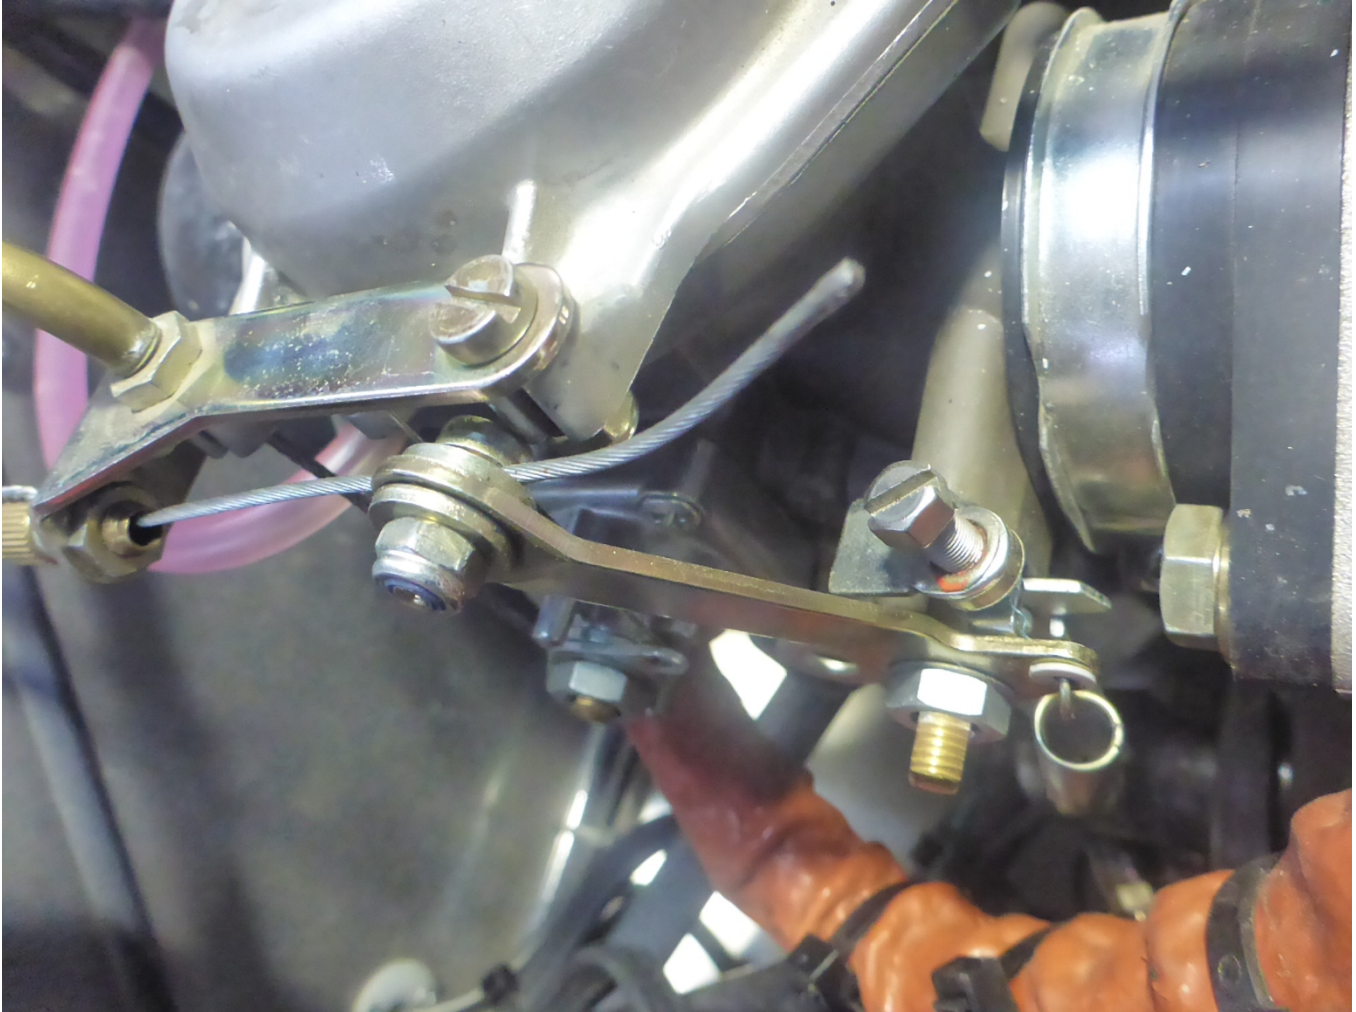
The pilot's failure to maintain directional control during the takeoff roll, which resulted in a loss of control and impact with terrain. Contributing to the accident were engine power surges due to the bent carburetor throttle valve lever.

A postaccident examination revealed that the throttle valve lever on the 1/3 carburetor was bent inwards and made contact with the carburetor chamber top. The throttle control was actuated inside the cockpit several times, and would eventually push the throttle valve lever past the point of contact on the carburetor chamber top. The throttle valve lever would travel just off the idle stop prior to contacting carburetor chamber top, resulting in the 1/3 carburetor near the idle position during the point of contact, as shown in this photo.

Figure 1: 1/3 carburetor contacting the chamber top
