Aviation Investigation Final Report

Location:	Springfield, Ohio	Accident Number:	CEN16LA281
Date & Time:	July 22, 2016, 10:40 Local	Registration:	N807LK
Aircraft:	Vans RV9	Aircraft Damage:	Destroyed
Defining Event:	Inflight upset	Injuries:	2 Fatal
Flight Conducted Under:	Part 91: General aviation - Personal

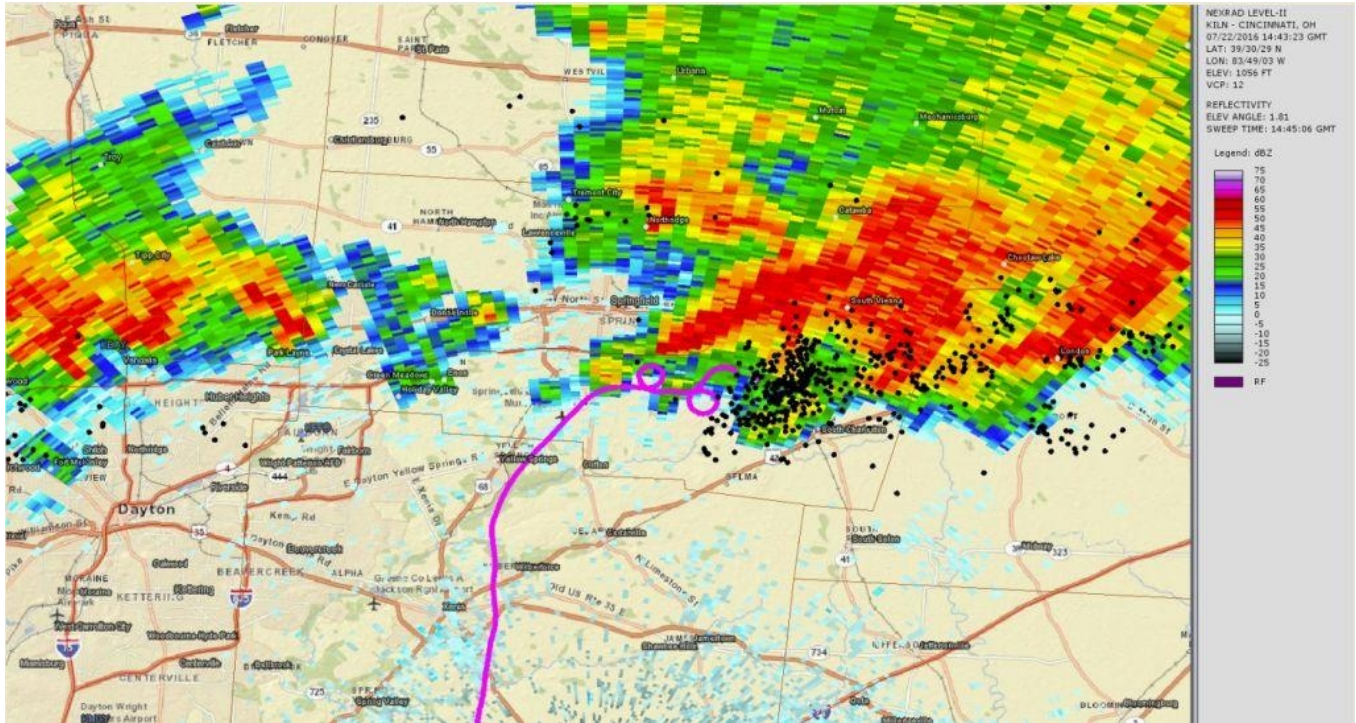
Figure 1 – Weather radar with flight track

A review of the air traffic control (ATC) and radar data revealed that while en route to ONZ, the pilot was in contact with ATC and attempted to navigate around the oncoming weather and precipitation. From 0957 to 1038 the pilot communicated with the controllers about avoiding the precipitation and requested assistance in doing so. The pilot stated that he could avoid the clouds if ATC could keep him out of the precipitation. The controllers gave the pilot several heading suggestions to the northwest to avoid the precipitation that they observed on their radar scopes. The pilot continued flying east toward the severe weather (figure 1).

The GPS flight track indicated that the airplane flew through an area of 10 to 40 dBZ reflectivity values located along the route of flight before the accident time. Reflectivity values of 25 to 40 dBZ were located north of the flight path. The accident flight flew into an area of defined thunderstorms while an

outflow boundary north of the accident site was moving south. As the outflow boundary moved south across the accident site there was a corresponding increase in the dBZ values in the base reflectivity data. There were lightning flashes and strikes surrounding the accident area with more than 900 lightning flashes associated with the thunderstorms between 1030 and 1040 EDT. The flight path was within 2 miles of the lightning flashes after 1037:02 EDT through the accident time (figure 1).

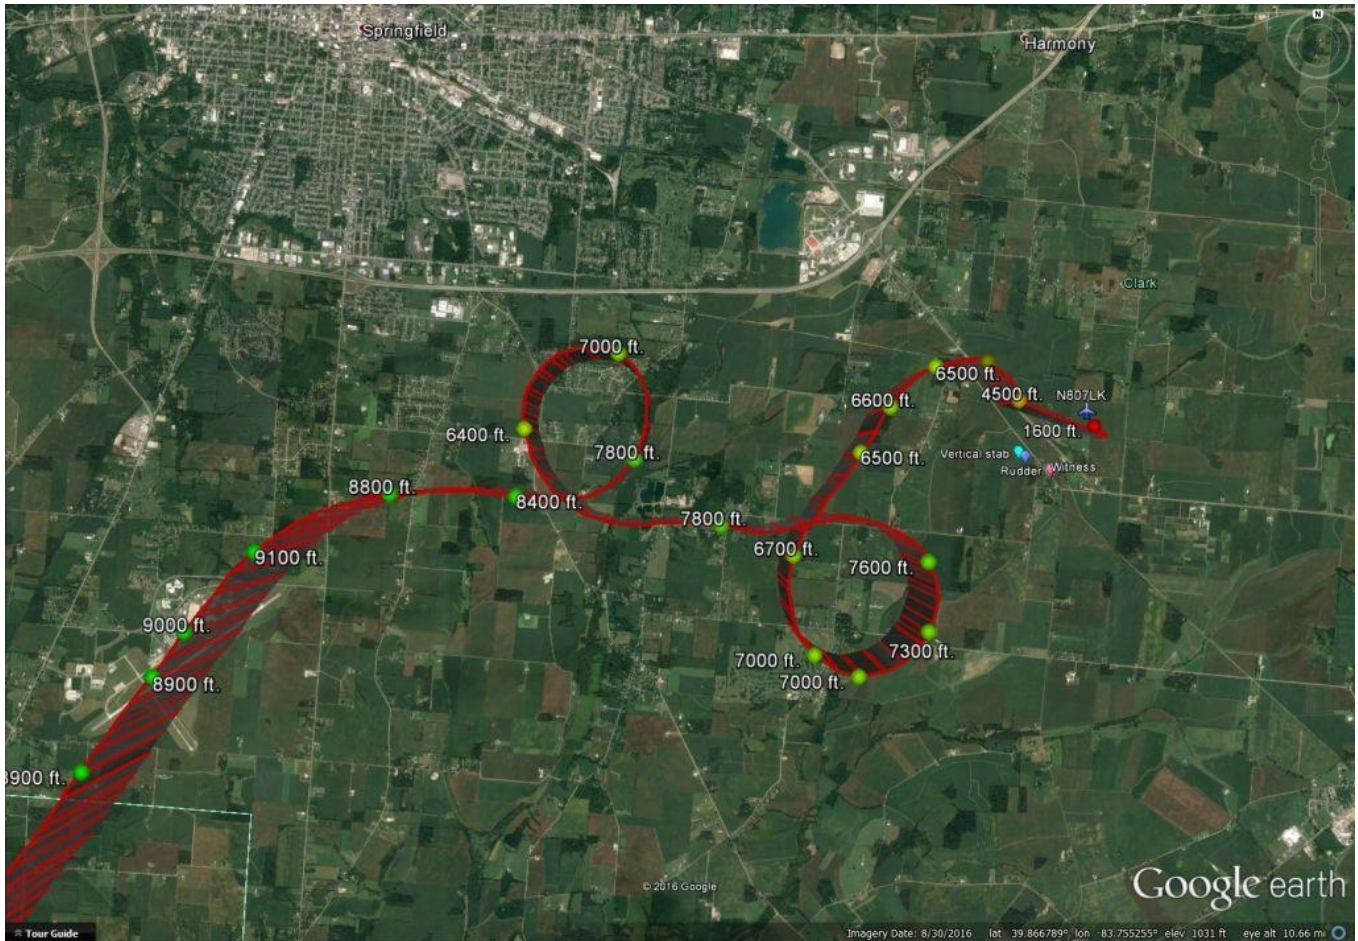
Figure 2 – Google Earth view of final flight path and witness location. Altitude in mean sea level (msl)

In the final 3.5 minutes of the flight while flying east, the airplane made a left 360° turn while descending about 2,900 ft per minute (fpm), then resumed a climb while heading east. Less than one minute later, the airplane made a right 310° turn, descending about 1,200 fpm. The airplane then flew northeast and descended about 4,600 fpm to an elevation of 3,440 ft above ground level (agl). The descent rate increased to about 6,450 fpm until radar contact was lost (figure 2).

A witness observed the accident airplane above her house as it flew east-northeast (figure 2). She stated that the airplane was in a steep descent and disappeared behind a tree line when she heard the sound of an impact. She heard the engine operating before the airplane disappeared behind the trees.

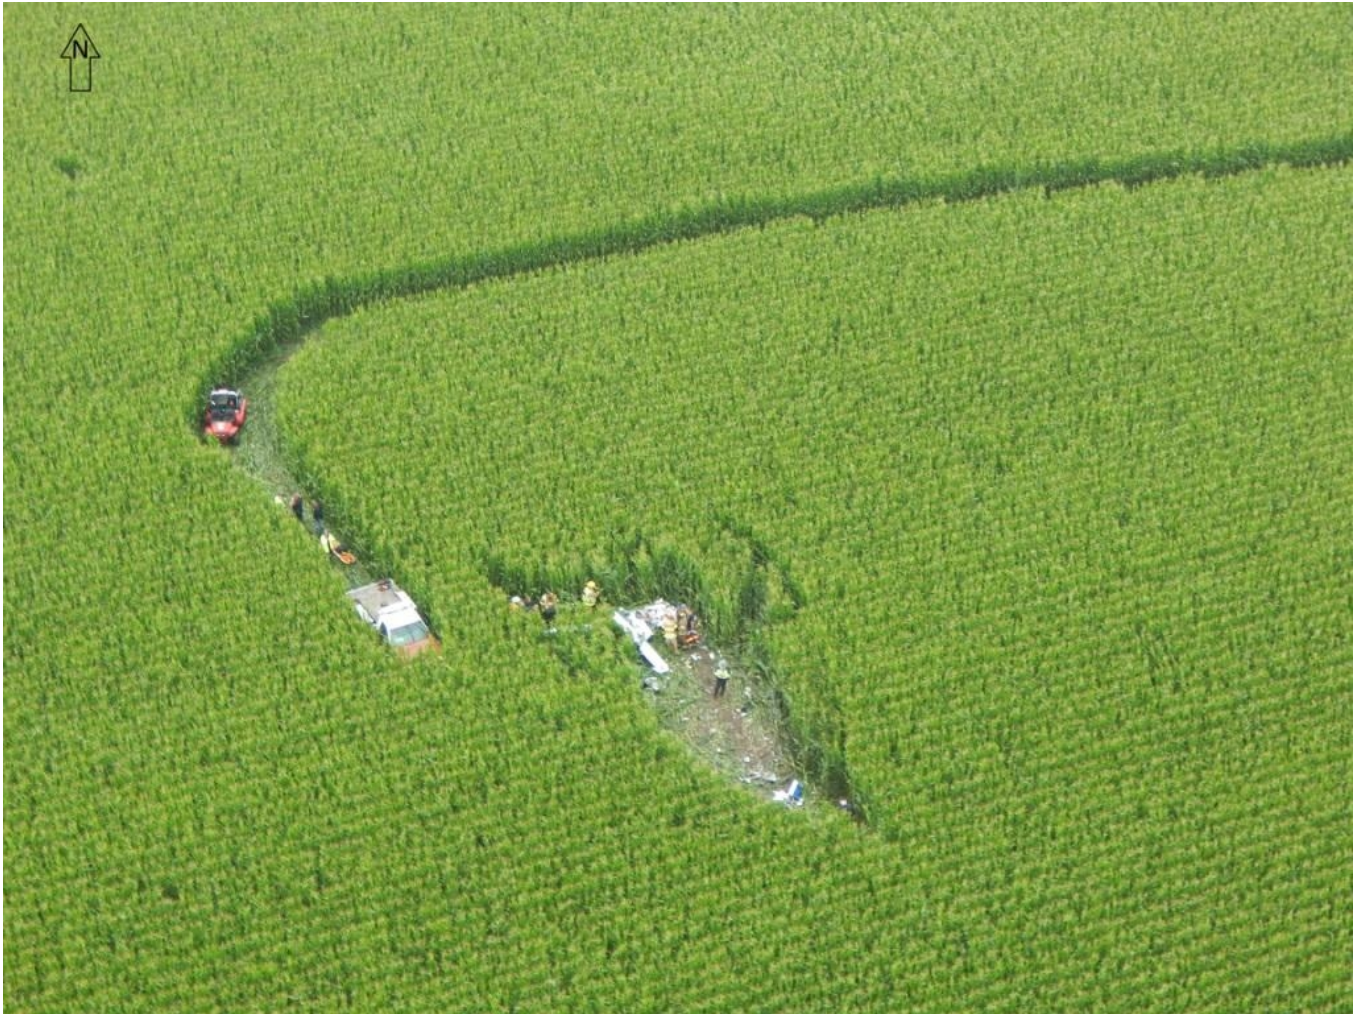
Figure 3 – Main wreckage in a mature corn field with first responders nearby

The responding Federal Aviation Administration (FAA) inspector reported that the airplane was found in a corn field (figure 3) about 7 statute miles east of Springfield-Beckley Municipal Airport (SGH), Springfield, Ohio.

The main wreckage debris path was generally oriented north and contained the engine, propeller, left and right wings, fuselage, and most of the empennage. The debris path was about 25 yards in length beginning with pieces of a wing and ended with the main wreckage. The instrument panel and forward cockpit area separated from the airplane and were found near the middle of the debris path. The throttle, mixture, and propeller knobs were found near the full forward position. The engine separated from its mounts and sustained impact damage. The propeller was separated from the engine and sustained leading edge damage, S-bending, and rearward bending.
