Aviation Investigation Final Report

Location:	Springfield, Ohio	Accident Number:	CEN16LA281
Date & Time:	July 22, 2016, 10:40 Local	Registration:	N807LK
Aircraft:	Vans RV9	Aircraft Damage:	Destroyed
Defining Event:	Inflight upset	Injuries:	2 Fatal
Flight Conducted Under:	Part 91: General aviation - Personal

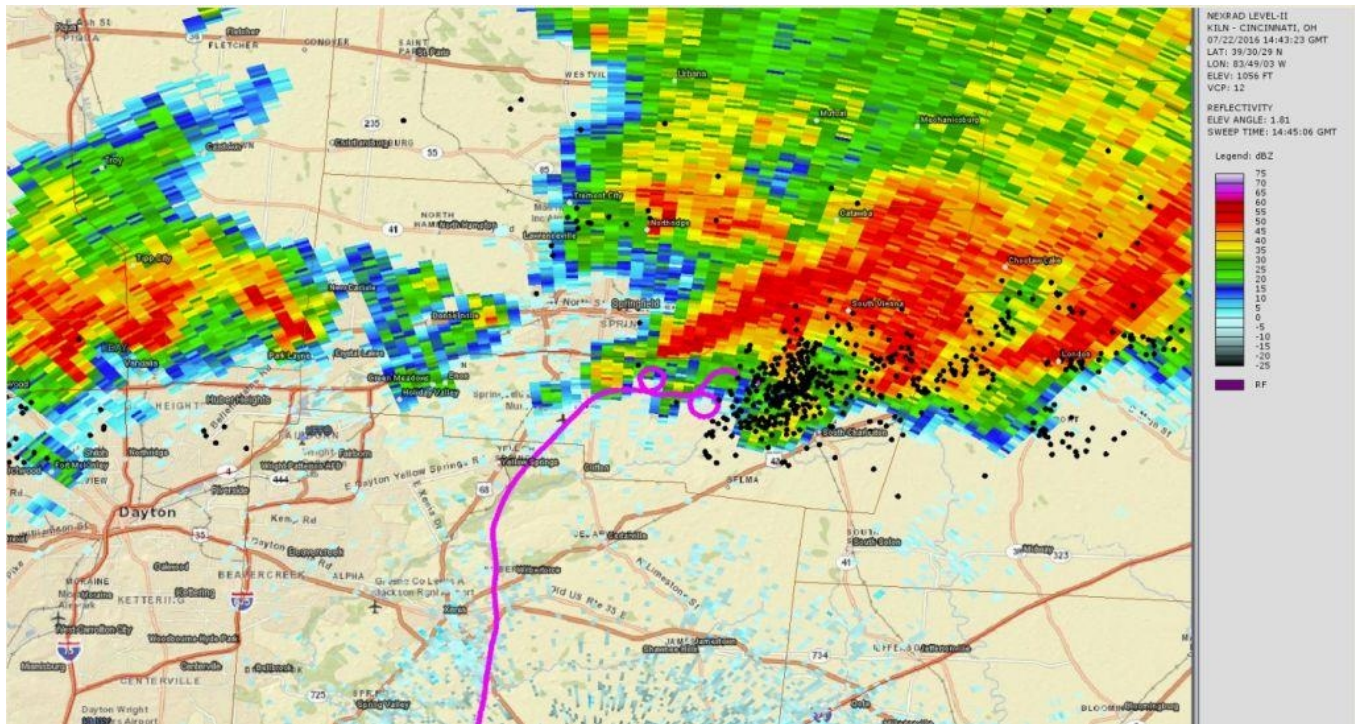
Figure 1 – Weather radar with flight track

A review of the air traffic control (ATC) and radar data revealed that while en route to ONZ, the pilot was in contact with ATC and attempted to navigate around the oncoming weather and precipitation. From 0957 to 1038 the pilot communicated with the controllers about avoiding the precipitation and requested assistance in doing so. The pilot stated that he could avoid the clouds if ATC could keep him out of the precipitation. The controllers gave the pilot several heading suggestions to the northwest to avoid the precipitation that they observed on their radar scopes. The pilot continued flying east toward the severe weather (figure 1).

The GPS flight track indicated that the airplane flew through an area of 10 to 40 dBZ reflectivity values located along the route of flight before the accident time. Reflectivity values of 25 to 40 dBZ were located north of the flight path. The accident flight flew into an area of defined thunderstorms while an

outflow boundary north of the accident site was moving south. As the outflow boundary moved south across the accident site there was a corresponding increase in the dBZ values in the base reflectivity data. There were lightning flashes and strikes surrounding the accident area with more than 900 lightning flashes associated with the thunderstorms between 1030 and 1040 EDT. The flight path was within 2 miles of the lightning flashes after 1037:02 EDT through the accident time (figure 1).

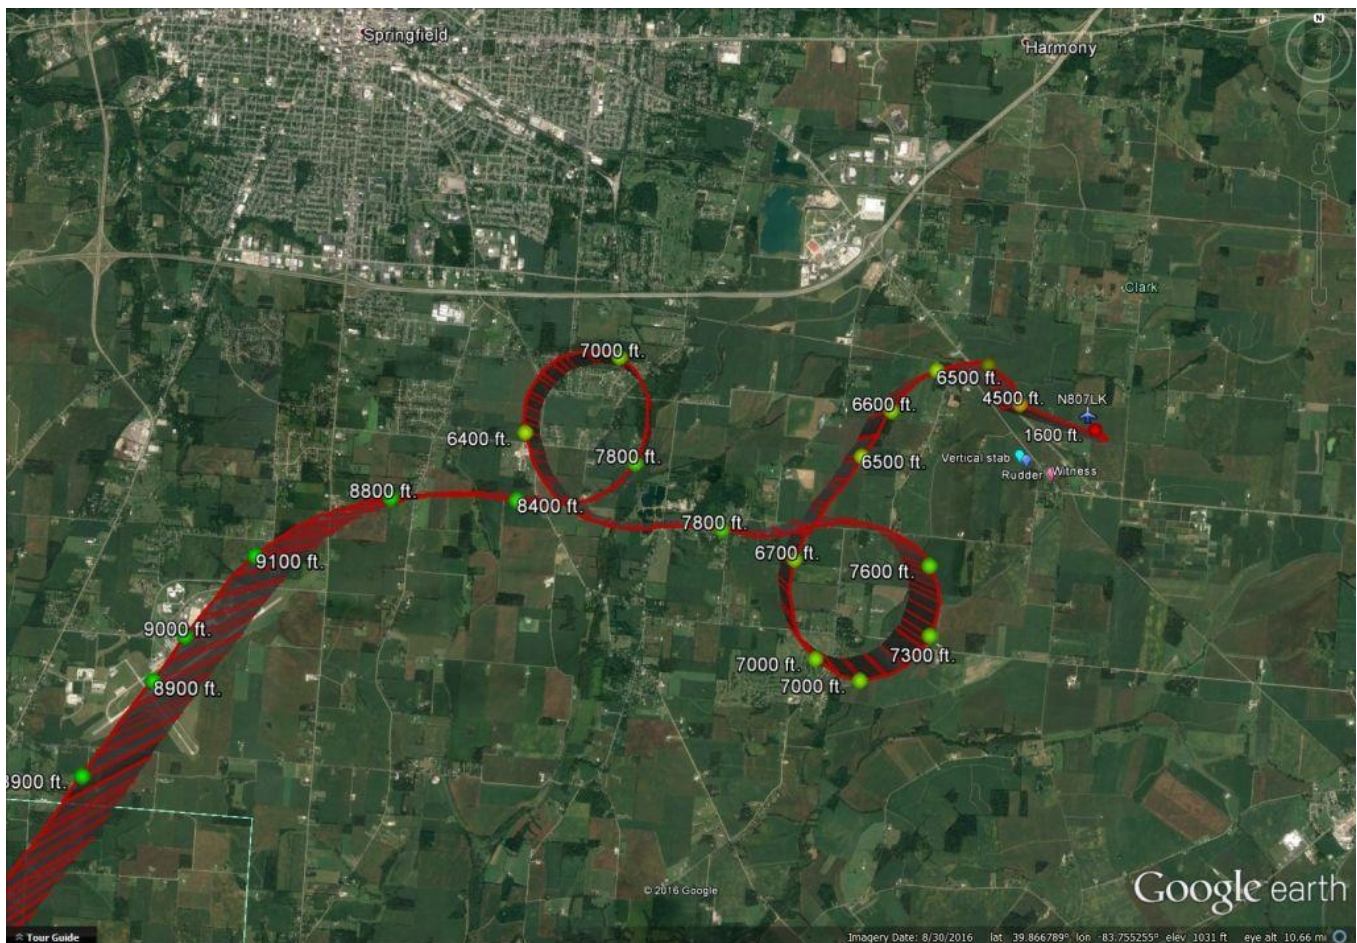
Figure 2 – Google Earth view of final flight path and witness location. Altitude in mean sea level (msl)

In the final 3.5 minutes of the flight while flying east, the airplane made a left 360° turn while descending about 2,900 ft per minute (fpm), then resumed a climb while heading east. Less than one minute later, the airplane made a right 310° turn, descending about 1,200 fpm. The airplane then flew northeast and descended about 4,600 fpm to an elevation of 3,440 ft above ground level (agl). The descent rate increased to about 6,450 fpm until radar contact was lost (figure 2).

A witness observed the accident airplane above her house as it flew east-northeast (figure 2). She stated that the airplane was in a steep descent and disappeared behind a tree line when she heard the sound of an impact. She heard the engine operating before the airplane disappeared behind the trees.

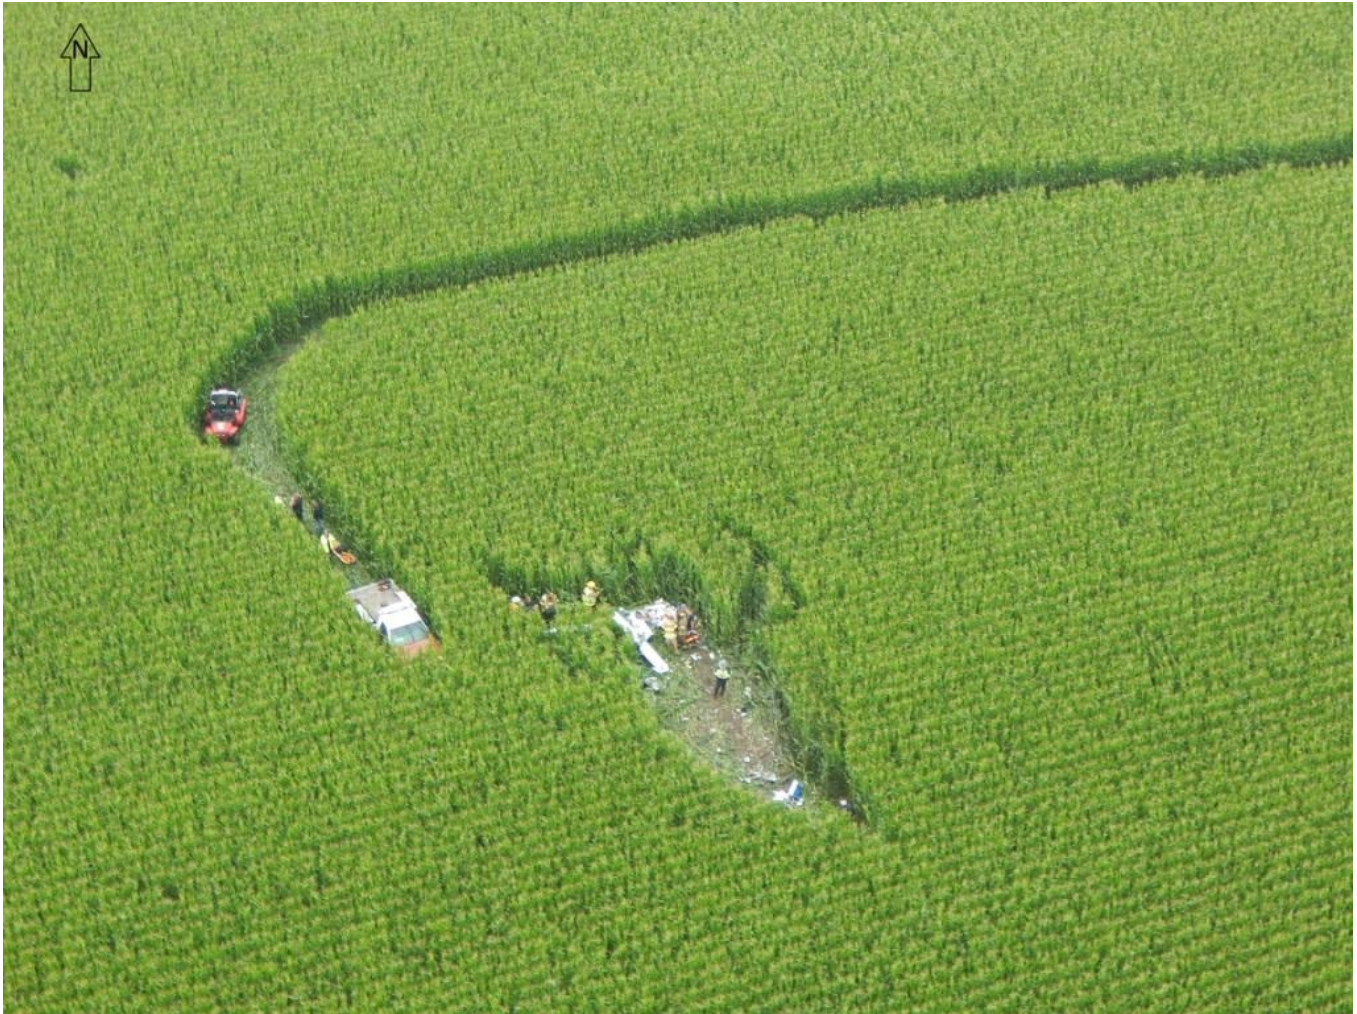
The responding Federal Aviation Administration (FAA) inspector reported that the airplane was found in a corn field (figure 3) about 7 statute miles east of Springfield-Beckley Municipal Airport (SGH), Springfield, Ohio.

Figure 3 – Main wreckage in a mature corn field with first responders nearby

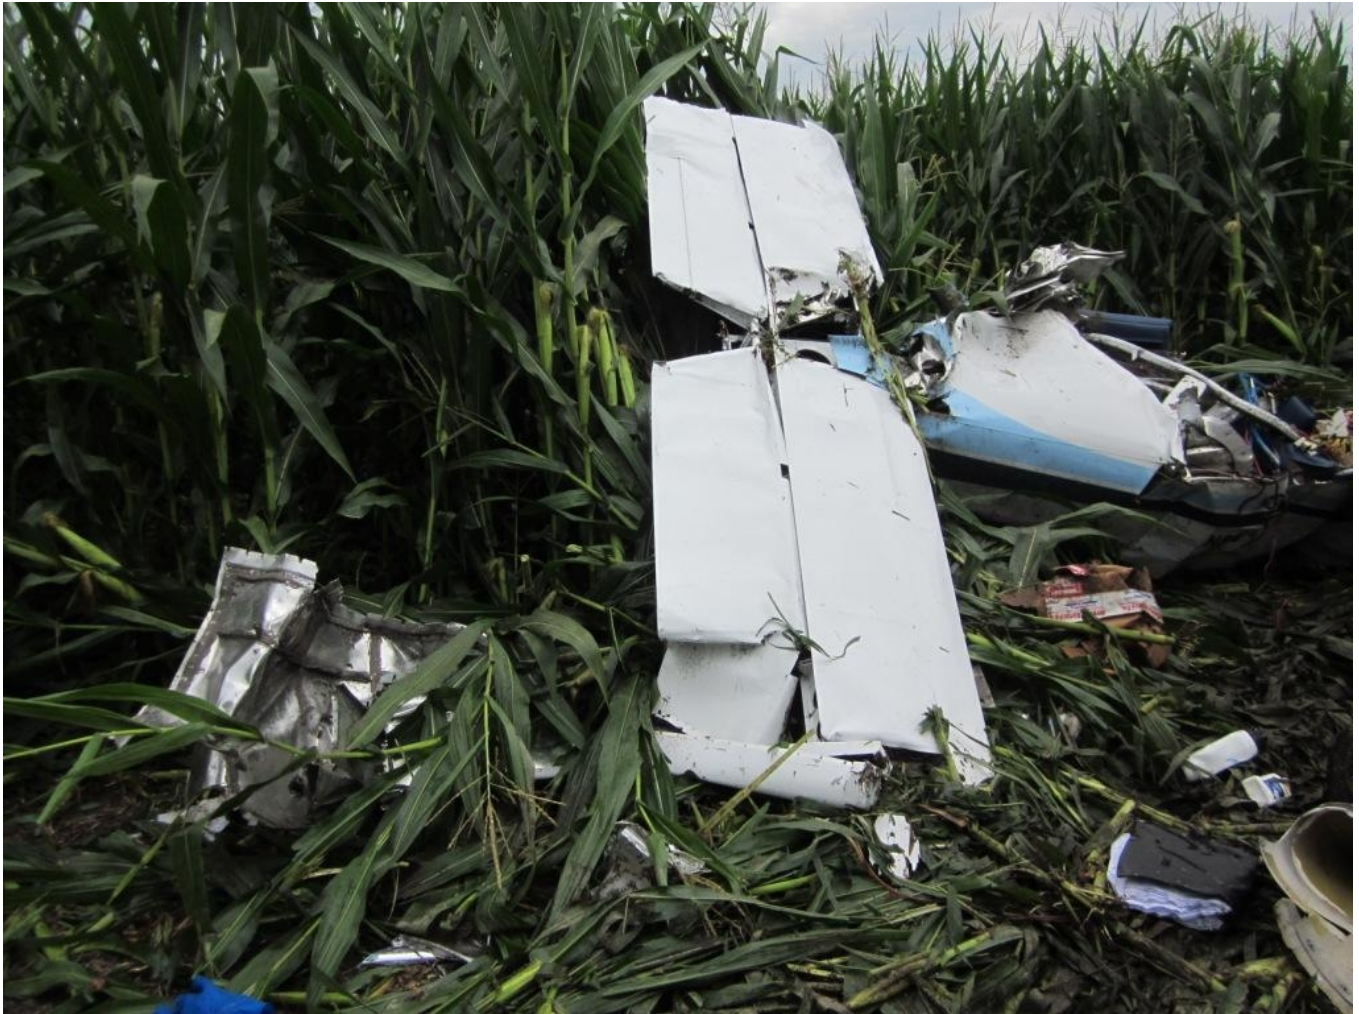
The main wreckage debris path was generally oriented north and contained the engine, propeller, left and right wings, fuselage, and most of the empennage. The debris path was about 25 yards in length beginning with pieces of a wing and ended with the main wreckage. The instrument panel and forward cockpit area separated from the airplane and were found near the middle of the debris path. The throttle, mixture, and propeller knobs were found near the full forward position. The engine separated from its mounts and sustained impact damage. The propeller was separated from the engine and sustained leading edge damage, S-bending, and rearward bending.

Figure 4 – Right side view of the main wreckage in a mature corn field. The vertical stabilizer and rudder are missing from the empennage.

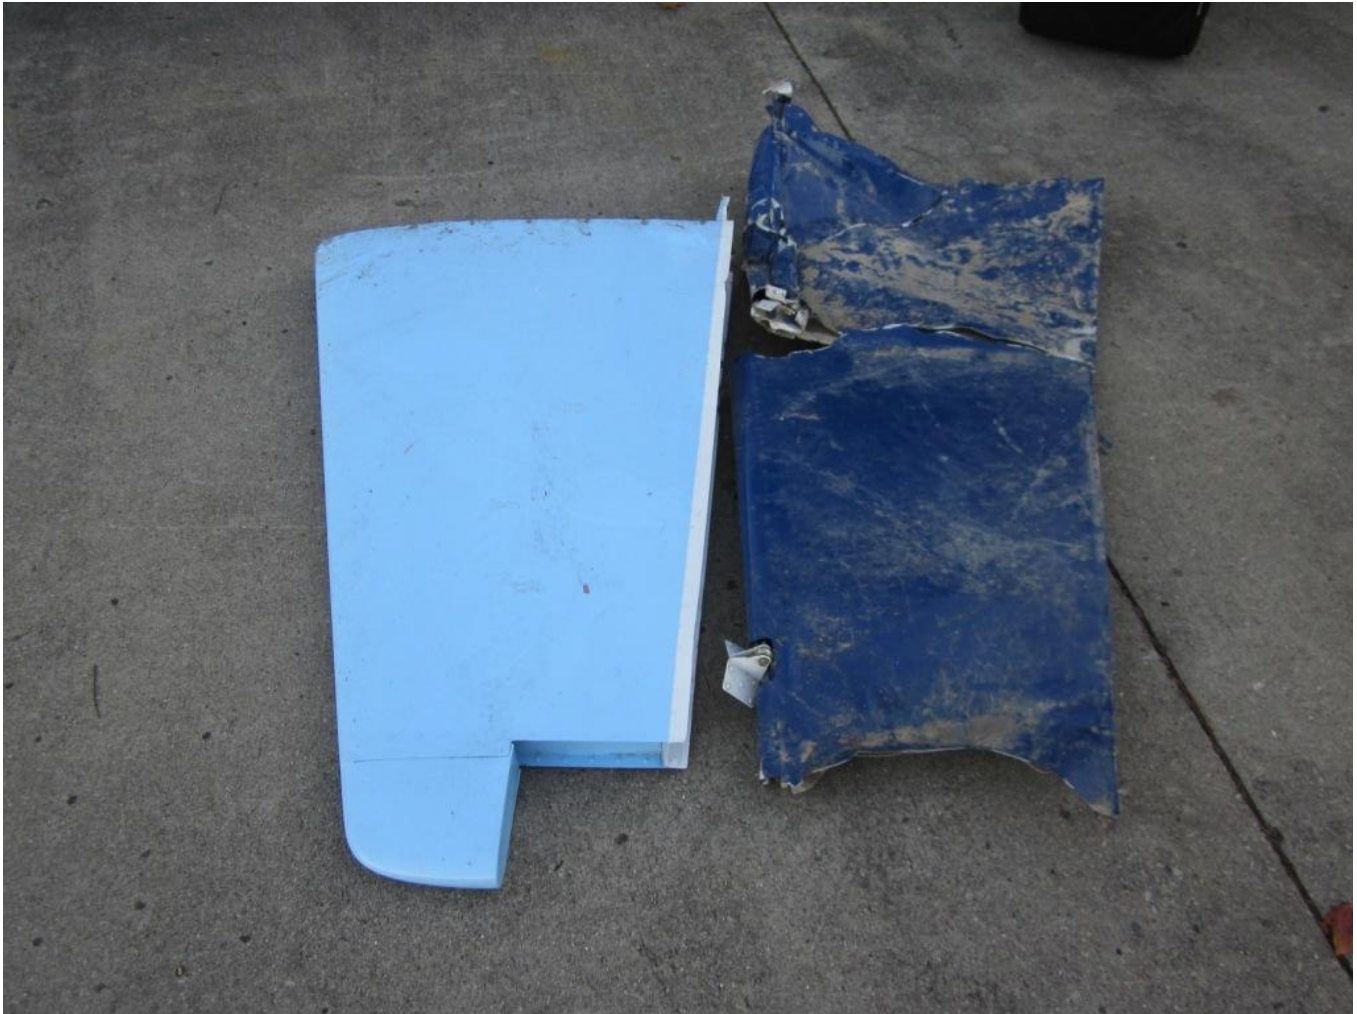
Figure 5 – Vertical stabilizer and rudder

The vertical stabilizer, rudder, and several small pieces separated from the empennage and came to rest in separate locations 0.61 to 0.63 nautical miles southwest of the main wreckage. The vertical stabilizer and rudder (figure 5) and were found with overload signatures at all separation points. The vertical stabilizer separated near the bottom of the rear spar. The rudder was found separated in two large pieces with several small pieces also identified. The counterweight was laterally separated from the top of the rudder. The rudder hinge brackets remained attached to the control rod ends. Most of the hinge bracket rivets were pulled through the vertical stabilizer.
