Aviation Investigation Final Report

Location:	Springfield, Ohio	Accident Number:	CEN16LA281
Date & Time:	July 22, 2016, 10:40 Local	Registration:	N807LK
Aircraft:	Vans RV9	Aircraft Damage:	Destroyed
Defining Event:	Inflight upset	Injuries:	2 Fatal
Flight Conducted Under:	Part 91: General aviation - Personal

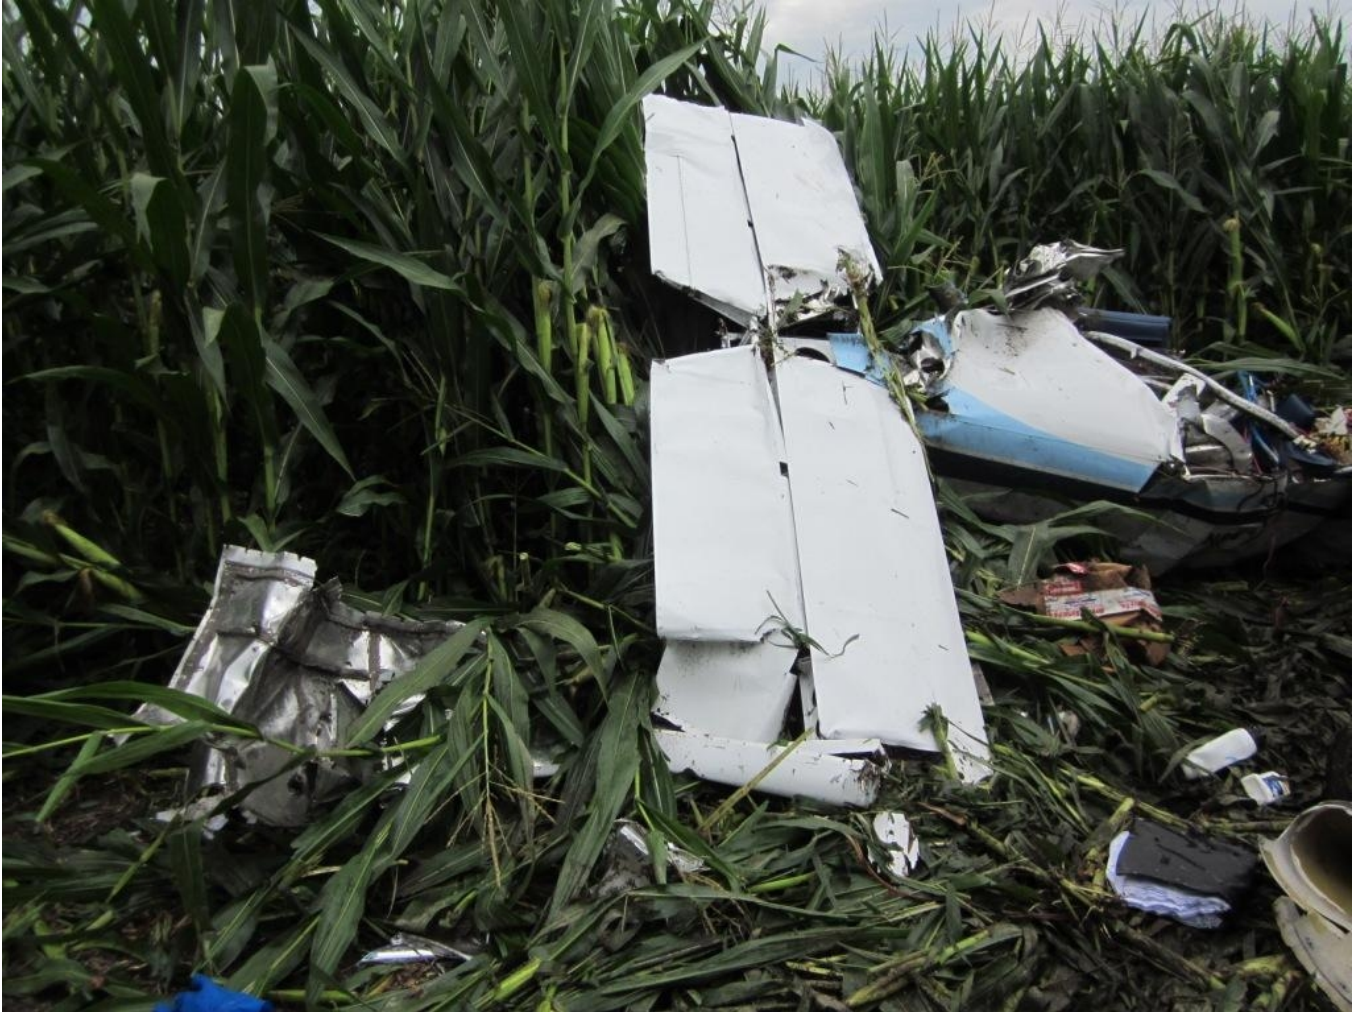
The main wreckage debris path was generally oriented north and contained the engine, propeller, left and right wings, fuselage, and most of the empennage. The debris path was about 25 yards in length beginning with pieces of a wing and ended with the main wreckage. The instrument panel and forward cockpit area separated from the airplane and were found near the middle of the debris path. The throttle, mixture, and propeller knobs were found near the full forward position. The engine separated from its mounts and sustained impact damage. The propeller was separated from the engine and sustained leading edge damage, S-bending, and rearward bending.

Figure 4 – Right side view of the main wreckage in a mature corn field. The vertical stabilizer and rudder are missing from the empennage.
