Aviation Investigation Final Report

Location:	McKinleyville, California	Accident Number:	WPR16FA153
Date & Time:	July 29, 2016, 01:05 Local	Registration:	N661TC
Aircraft:	Piper PA-31T	Aircraft Damage:	Destroyed
Defining Event:	Fire/smoke (non-impact)	Injuries:	4 Fatal
Flight Conducted Under:	Part 135: Air taxi & commuter - Non-scheduled - Air Medical (Medical emergency)

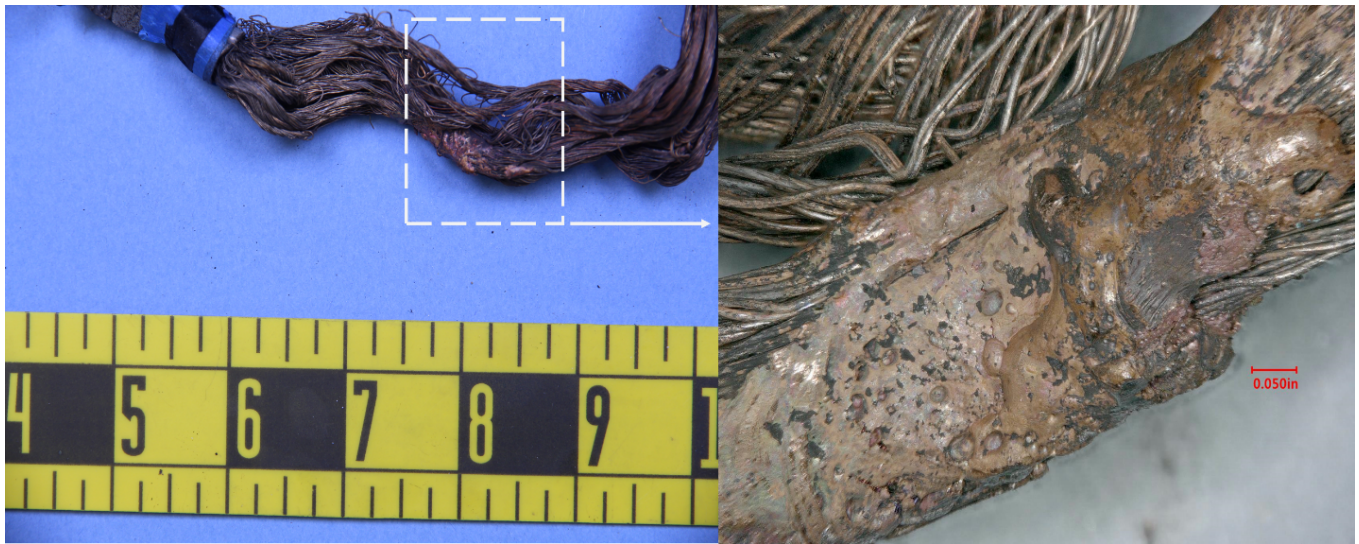
The wire identified as P3H contained both terminal ends. The entire wire section was missing insulation. A large area of welded conductors/arcing was present about 2 inches and 4.5 inches from the terminal ends. (See figure 1 and figure 2.)

Figure 1 - Photograph of welded area on P3H

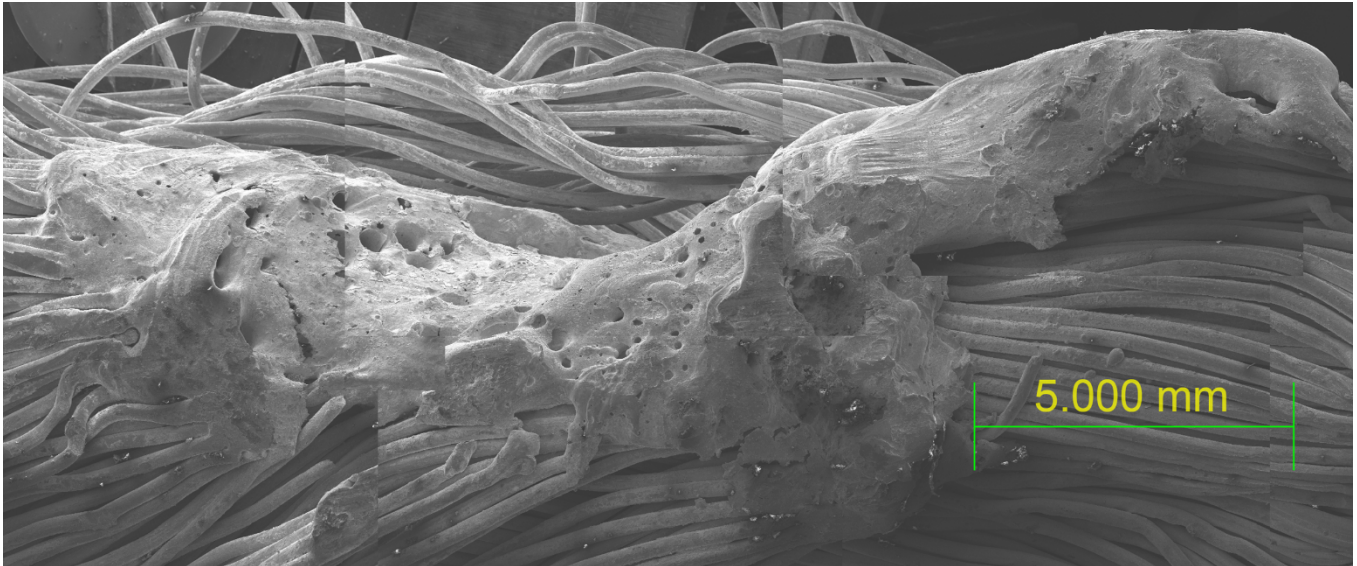
Figure 2 - Micrograph of welded area on P3H

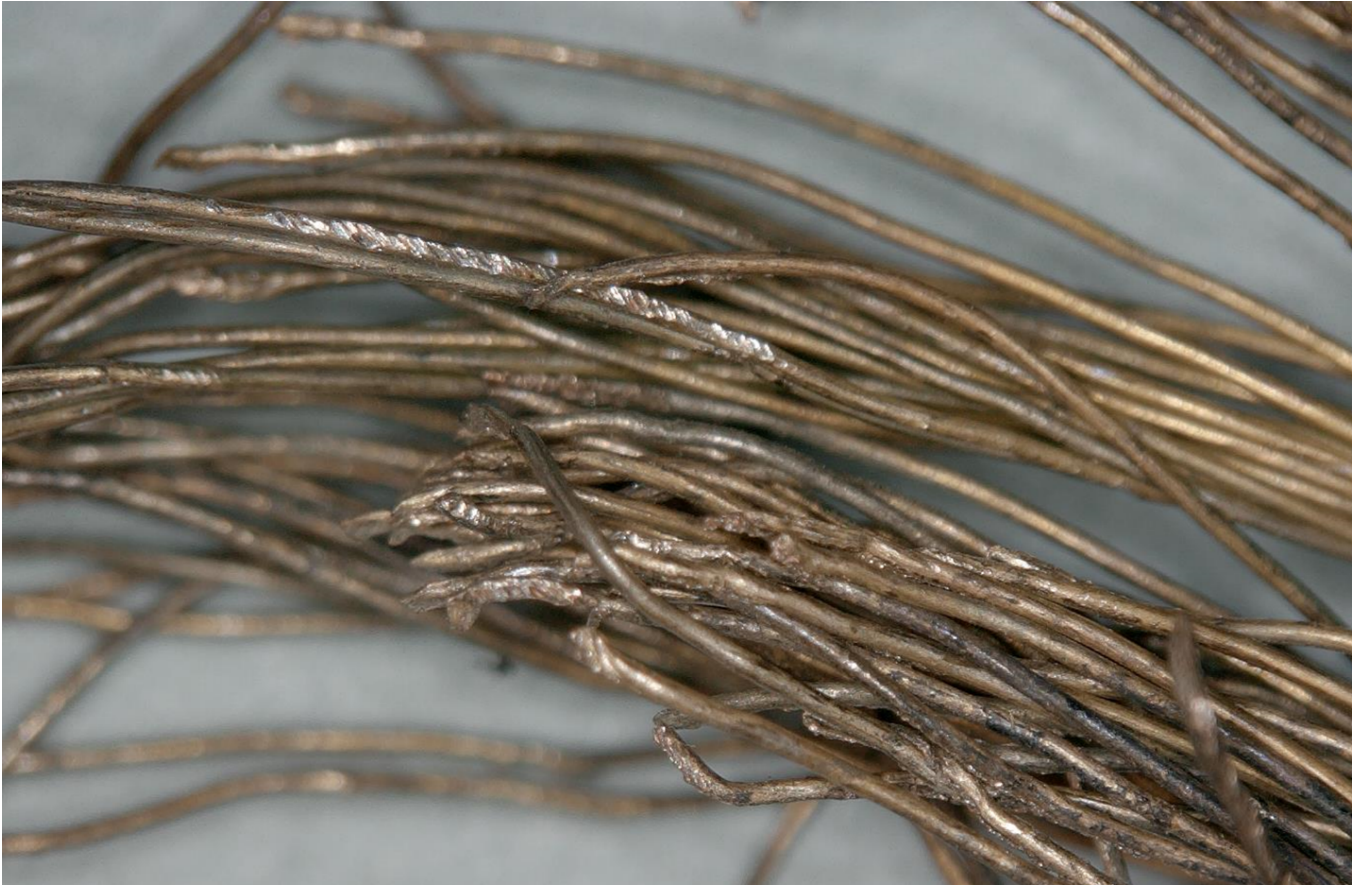
The wire identified as L Main 2 was trapped inside a section of aircraft structure. A portion of the circuit breaker remained attached to the wire. About 11 inches of wire insulation were missing from the fractured end of the wire. The remaining insulation exhibited thermal discoloration and shrinking. Signs of thermal damage were present and decreased in severity moving away from the main bus tie circuit breaker end. The fractured end was frayed, and the exposed conductor exhibited notching. The fractured end was examined using a scanning electron microscope. No obvious signs of arcing on exposed sections of conductor were found. Several areas of the cross diameter on several conductors were flattened and appeared to have missing material. In addition, the fractured end was examined using electron dispersive spectroscopy to look for the presence of foreign materials on the wire conductors. No foreign material was found. (See figure 3 and figure 4.)

Figure 3 - Photograph of fractured end of L Main 2

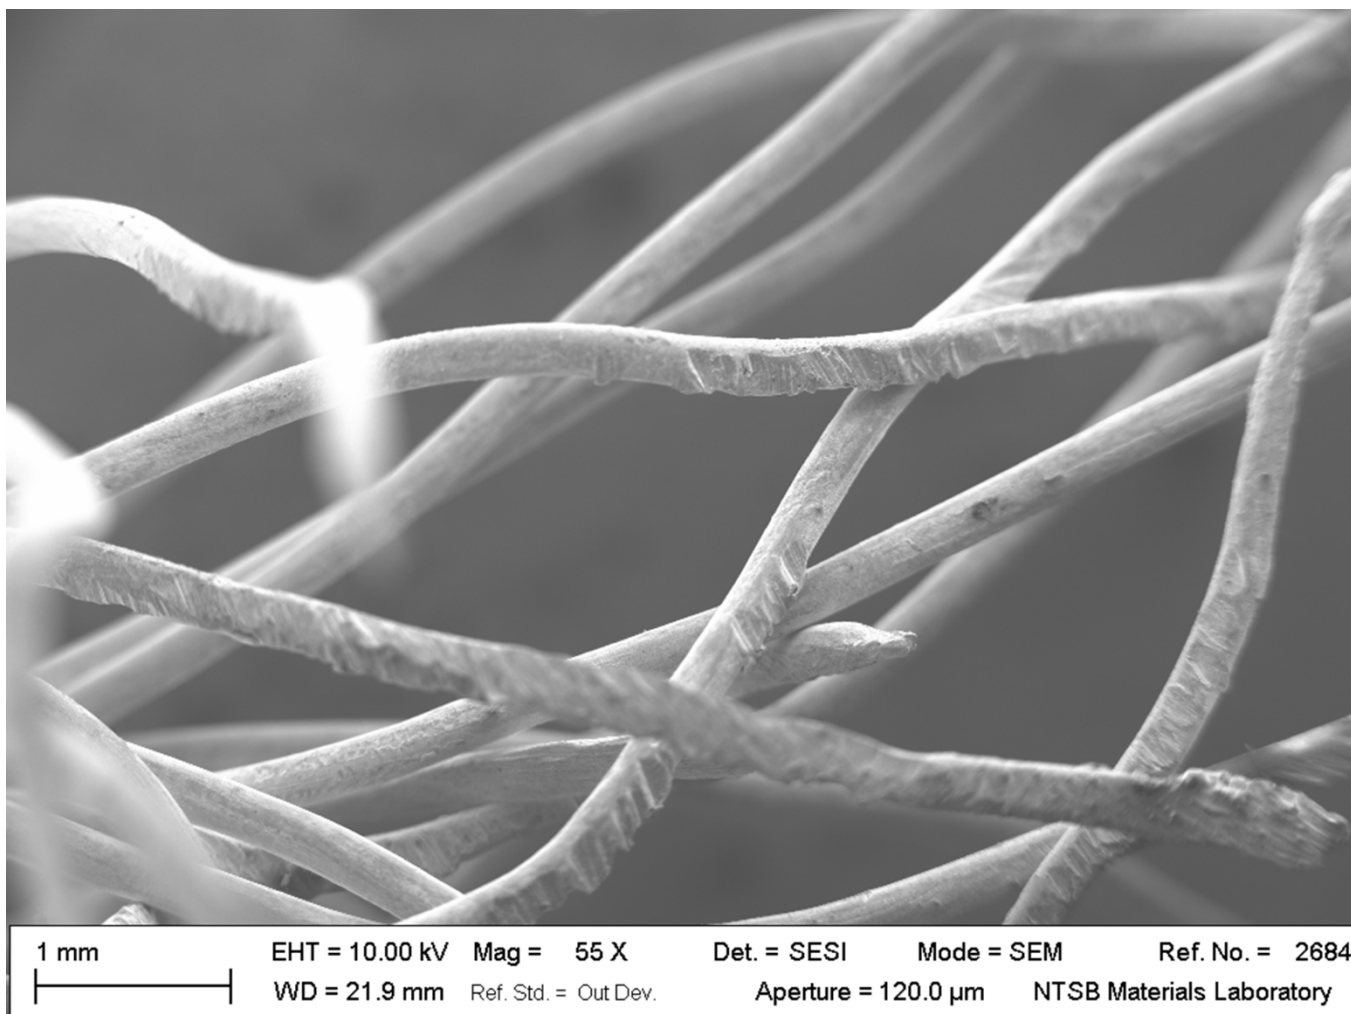
Figure 4 - Micrograph of notching on conductor surface of L Main 2
