Aviation Investigation Final Report

Location:	Van Nuys, California	Accident Number:	WPR16FA157
Date & Time:	August 2, 2016, 13:22 Local	Registration:	N341AL
Aircraft:	ARION AIRCRAFT LLC LIGHTNING LS-1	Aircraft Damage:	Substantial
Defining Event:	Aerodynamic stall/spin	Injuries:	1 Fatal
Flight Conducted Under:	Part 91: General aviation - Personal

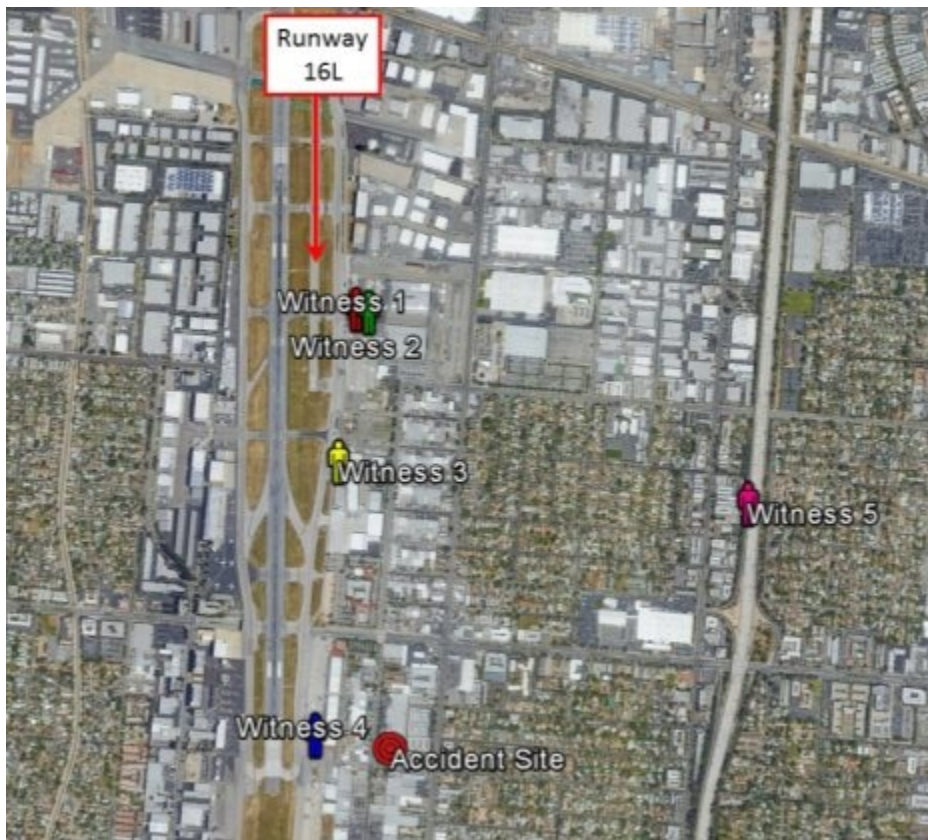
Figure 1 – Witness Locations

Several witnesses observed the airplane during its departure from VNY. One witness (Witness 3 in Figure 1) observed a piece of the left main landing gear hanging from the airplane as it climbed from runway 16L. The airplane then began a left turn from the departure end of the runway that initially looked normal, but then the airplane decelerated. At this time, two witnesses who had listened to the exchange between the pilot and the controller (Witnesses 1 & 2), reported that, seconds after the pilot's final communication, they observed the airplane enter a hard left turn. One witness described the turn as a "knife edge." The airplane's nose yawed left to a nose-down attitude and the airplane rapidly descended toward the ground. Witness 5, who was a passenger in a helicopter at the time of the accident, reported that the airplane entered the descent from an altitude about 350 ft above ground level and impacted an industrial park below. Witness 4 reported hearing a sputtering engine about 7 seconds
