# Aviation Investigation Final Report

| <b>Location:</b> | Fullerton, California | <b>Accident Number:</b> | WPR16LA167 |
| <b>Date &amp; Time:</b> | August 24, 2016, 18:00 Local | <b>Registration:</b> | N16FD |
| <b>Aircraft:</b> | SIAI-MARCHETTI SF260 | <b>Aircraft Damage:</b> | Substantial |

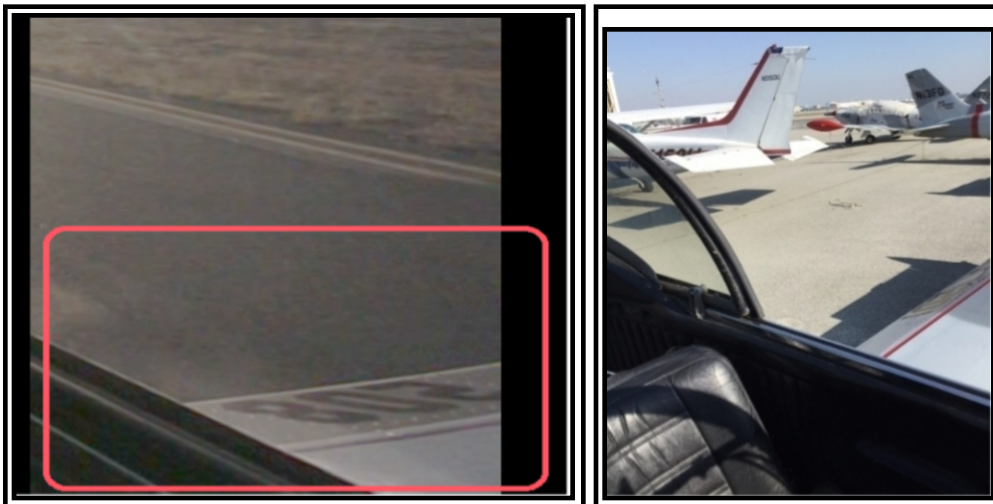
A review of onboard video revealed that, as the airplane was taxiing to the runway hold line, the left flap was in the neutral (or retracted) position. Furthermore, the pilot and the passenger discussed the takeoff, but make no mention of the flap position before takeoff.

The airplane operations manual and the Before Take-off checklist state that the takeoff flap setting was 20. However, video evidence shows that the pilot failed to set the flaps to the takeoff setting before takeoff which would have resulted in decreased lift, and an increased stall speed. The pilot was likely unaware of the flap setting as the airplane aerodynamic stalled and the pilot was not able to maintain airplane control.

The operator knew before the accident flight that the airplane's flap gauge was inoperative. Therefore, the flaps were set to the takeoff position by matching them to a fully deflected aileron on the same side of the wing. Using this technique to set the flaps for takeoff in a same type of airplane with a functional flap gauge, the flap setting was observed to be about 17°. The airplane's operations manual states that

the takeoff flap setting is 20°. Furthermore, the manual and the Before Take-off checklist state to set flaps to 20° before takeoff.

Figure 1: Accident airplane's

takeoff flap position. Figure 2: Exemplar airplane's flaps set to takeoff position.

A Federal Aviation Administration inspector examined and took pictures of an exemplar Siai-Marchetti SF260 airplane and observed the flap position from a rearward angle, which was similar to the angle of the accident airplane's video camera that faced rearward (see figures 1 and 2). The examination revealed that when the flaps were set to the takeoff flap setting of 20°, the flaps were easily discernable to be partially extended, in the exemplar airplane, which is the same type as the accident airplane.
