Aviation Investigation Final Report

Location:	Pensacola, Florida	Accident Number:	DCA16FA217
Date & Time:	August 27, 2016, 09:30 Local	Registration:	N766SW
Aircraft:	Boeing 737-700	Aircraft Damage:	Substantial
Defining Event:	Powerplant sys/comp malf/fail	Injuries:	104 None
Flight Conducted Under:	Part 121: Air carrier - Scheduled

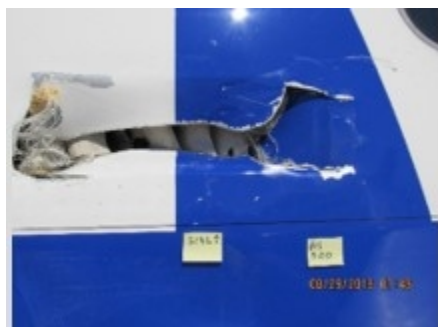
Figure 4. Close-up view of through-puncture on left side of fuselage.

Postaccident examination of the airplane revealed a 16-by-5-inch through-puncture on the left side of the fuselage, as shown in figure 4. The through-puncture was just below the cabin windows by rows 11 and 12, as indicated by the yellow tape in figure 5, with no corresponding damage on the interior cabin sidewall. Numerous impacts were observed along the left side of the fuselage, the left wing, and the left horizontal stabilizer, and the left winglet front spar was partially severed.

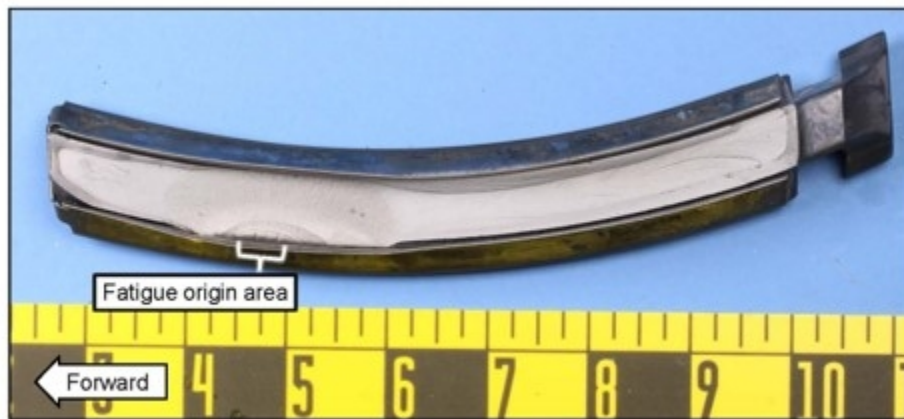
Figure 7. Fan blade No. 23 fracture surface.

All of the fan blades were found in their as-installed (full length) positions in the fan disk except for fan blade No. 23, which had fractured at the blade root with the dovetail remaining in the fan disk. The blade dovetail is shown in figure 7; the blade airfoil was missing and was not subsequently recovered. All of the intact fan blades exhibited hard-body impact damage, tears, missing material, and airfoil curling or distortion. Most of the blade platform for fan blade No. 22 (which was adjacent to fan blade No. 23 in the counterclockwise direction) was missing.

For fan blade No. 23, chipped and missing coating on the convex side of the dovetail was observed. Dimensional measurements showed that the coating damage was centered about 2 inches aft of the leading edge of the dovetail and spanned about 1.3 to 2.7 inches from the leading edge. According to Boeing's *737-600/700/800/900 Aircraft Maintenance Manual*, the coating on the dovetail is to be visually inspected for any missing and/or chipped coating in the contact area on both the concave and convex sides of the blades. This visual inspection is typically performed during relubrications of the dovetail. If a coating loss is found during the inspection, the affected fan blades are either removed from service or allowed to

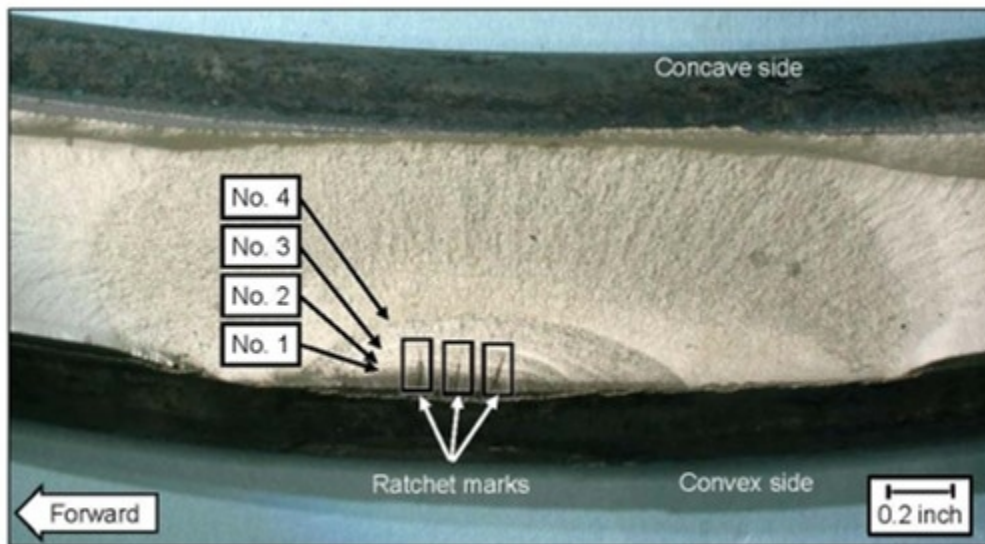
Figure 8. Fatigue region and crack arrest lines.

Part of the fracture surface on fan blade No. 23 was relatively smooth with well-defined curving crack arrest lines, which were consistent with fatigue, as shown in figure 8. (Crack arrest lines generally represent changes in the stress state, environment, or time interval associated with fatigue crack growth.) Fracture features emanated from an origin area centered about 2.1 inches from the leading edge face on the convex side of the blade. Ratchet marks (which are formed when two adjacent fatigue cracks originate on slightly offset planes) were observed in the origin area, consistent with multiple fatigue origins. The fracture had initiated at the contact face just inboard of the outboard edge (relative to the fan disk rotational axis) of the dovetail coating. The coating was missing and spalled in several locations on the convex side of the blade, including an area adjacent to the fracture and a larger area directly inboard from the fracture origin.

The progressive crack growth region extended up to 2.277 inches axially and was 0.695 inch deep. Beyond the boundary of the progressive crack growth region, the fracture surface had a lighter gray appearance with prominent shear lips, which was consistent with ductile overstress fracture.

The fan blade No. 23 fracture surface was further examined using a SEM. The four crack arrest lines found during the visual and optical examination (shown in figure 8) were observed on the fracture surface. The depths of crack arrest lines Nos. 1 through 4 were 0.072 inch, 0.093 inch, 0.139 inch, and 0.228 inch, respectively. A possible crack arrest line was observed between arrest lines Nos. 3 and 4, especially near the aft side of the fatigue region, but there was no distinct boundary around the entire front of the crack.

At higher SEM magnifications, striations consistent with low-cycle fatigue crack growth were observed. (Striations are linear features on a fatigue fracture surface that indicate how far a crack advanced with each stress cycle.) The striation spacing generally became larger as the depth of the crack increased. Immediately beyond the crack arrest lines, the striation spacing changed abruptly; the spacing between striations was shorter than the spacing before the arrest lines, which was consistent with a temporary reduction in crack growth rate after each arrest line had formed.

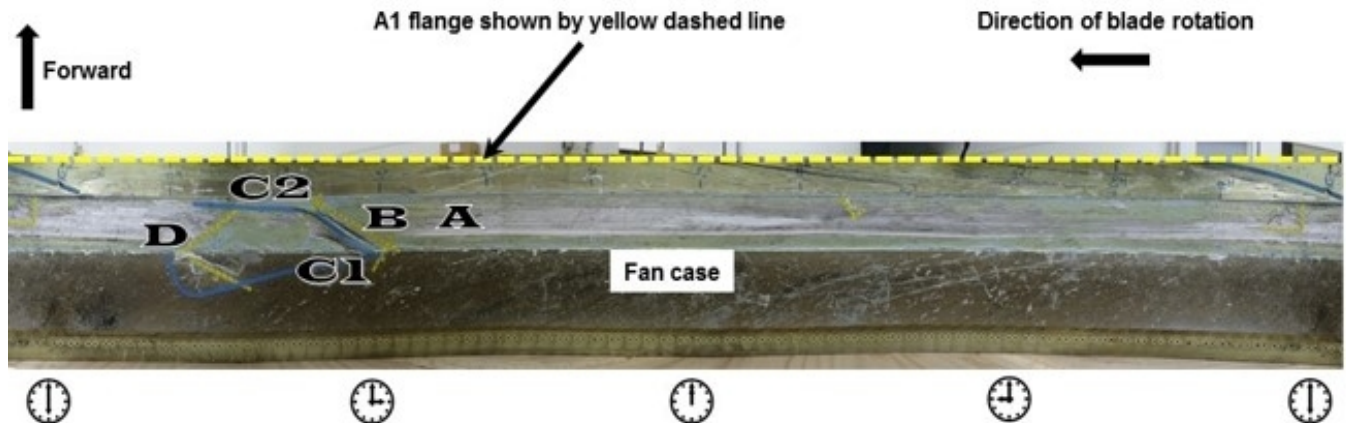
Figure 9. Fan case impact damage.

CFM performed a detailed examination of the fan case to assess the impact damage. The greatest amount of deformation on the A1 flange was observed along the four-to-ten o'clock arc. Rub marks were noted along the entire circumference in line with the fan blade rotational plane except for the area between the three and five o'clock positions. CFM determined that, after fan blade No. 23 released and impacted the fan case, the blade fractured into three (or possibly four) pieces, which created the four major and distinct fan case impact marks shown in figure 9 and several different exit paths and trajectories.

The first fan case impact, labeled impact mark A in figure 9, was a shallow blade tip scuff mark located near the two o'clock position. According to CFM, this initial fan blade impact caused the blade tip to bend, snap off, and travel forward and out of the engine. CFM considered this initial impact to be a "low energy" event due to the small radial clearance between the blade tip and fan case (resulting in a low radial release velocity) and the lack of a deep gouge or any related distortion of the fan case in this area.

According to CFM, after the blade tip fractured, the remaining fan blade continued to travel and created two "high energy" crescent-shaped impact marks (labeled B and C1) located between the three and four o'clock positions on the fan case. The impact marks coincided with observed fan case distortion and tears and was near the largest A1 flange distortion. CFM determined that the blade airfoil fractured at these locations, indicating that the impact was created by a different fan blade fracture surface. CFM also determined that the deep scuffing damage by impact mark C1 (labeled C2) could have been the result of an additional impact and airfoil fracture.

Another "high energy" impact mark (labeled D) was located at the five o'clock position on the fan case. This impact mark appeared to have the outline/imprint of the blade root trailing edge (profile view). The impact mark coincided with the observed fan case distortion and tears.
