Aviation Investigation Final Report

Location:	Pensacola, Florida	Accident Number:	DCA16FA217
Date & Time:	August 27, 2016, 09:30 Local	Registration:	N766SW
Aircraft:	Boeing 737-700	Aircraft Damage:	Substantial
Defining Event:	Powerplant sys/comp malf/fail	Injuries:	104 None
Flight Conducted Under:	Part 121: Air carrier - Scheduled

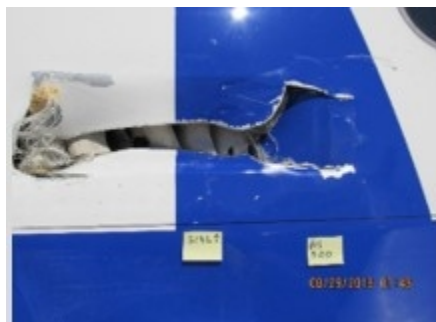
Figure 4. Close-up view of through-puncture on left side of fuselage.

Postaccident examination of the airplane revealed a 16-by-5-inch through-puncture on the left side of the fuselage, as shown in figure 4. The through-puncture was just below the cabin windows by rows 11 and 12, as indicated by the yellow tape in figure 5, with no corresponding damage on the interior cabin sidewall. Numerous impacts were observed along the left side of the fuselage, the left wing, and the left horizontal stabilizer, and the left winglet front spar was partially severed.

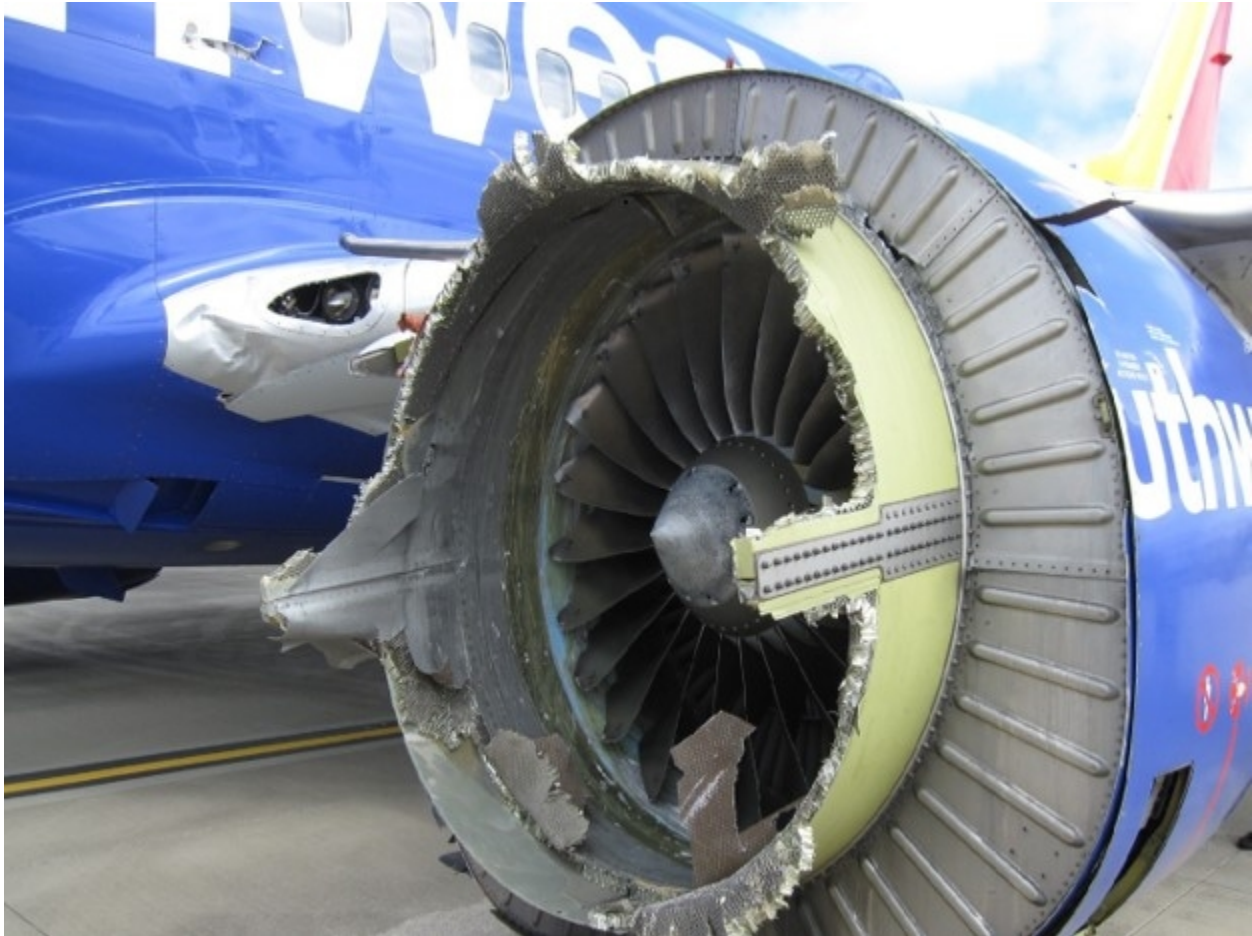
Figure 6. Inlet damage.

Almost all of the left engine inlet was missing, including the outer barrel, the inlet lip, the forward bulkhead, and the inner barrel forward of the containment shield. The part of the inlet that remained was severely damaged, as shown in figure 6. The aft bulkhead remained in place, but rivets connecting it to the attach ring were sheared 360° around the ring. A 360° section of the inlet inner barrel forward of the containment shield separated from the rest of the inlet about 17 inches forward of the A1 flange.

Although both inner barrel splice plates (located at the three and nine o'clock positions) remained intact, the splice plate at the nine o'clock position exhibited impact damage and outward deformation. The inner barrel honeycomb core and the inner skin that remained were torn and flared outward. Gaps between the inlet attach ring and the fan case A1 flange were observed at several locations around the circumference of the interface between the two parts.

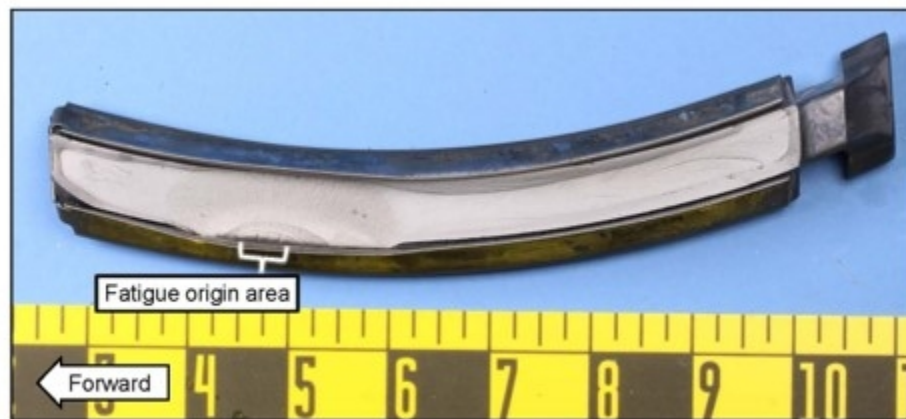
Figure 7. Fan blade No. 23 fracture surface.

All of the fan blades were found in their as-installed (full length) positions in the fan disk except for fan blade No. 23, which had fractured at the blade root with the dovetail remaining in the fan disk. The blade dovetail is shown in figure 7; the blade airfoil was missing and was not subsequently recovered. All of the intact fan blades exhibited hard-body impact damage, tears, missing material, and airfoil curling or distortion. Most of the blade platform for fan blade No. 22 (which was adjacent to fan blade No. 23 in the counterclockwise direction) was missing.

For fan blade No. 23, chipped and missing coating on the convex side of the dovetail was observed. Dimensional measurements showed that the coating damage was centered about 2 inches aft of the leading edge of the dovetail and spanned about 1.3 to 2.7 inches from the leading edge. According to Boeing's *737-600/700/800/900 Aircraft Maintenance Manual*, the coating on the dovetail is to be visually inspected for any missing and/or chipped coating in the contact area on both the concave and convex sides of the blades. This visual inspection is typically performed during relubrications of the

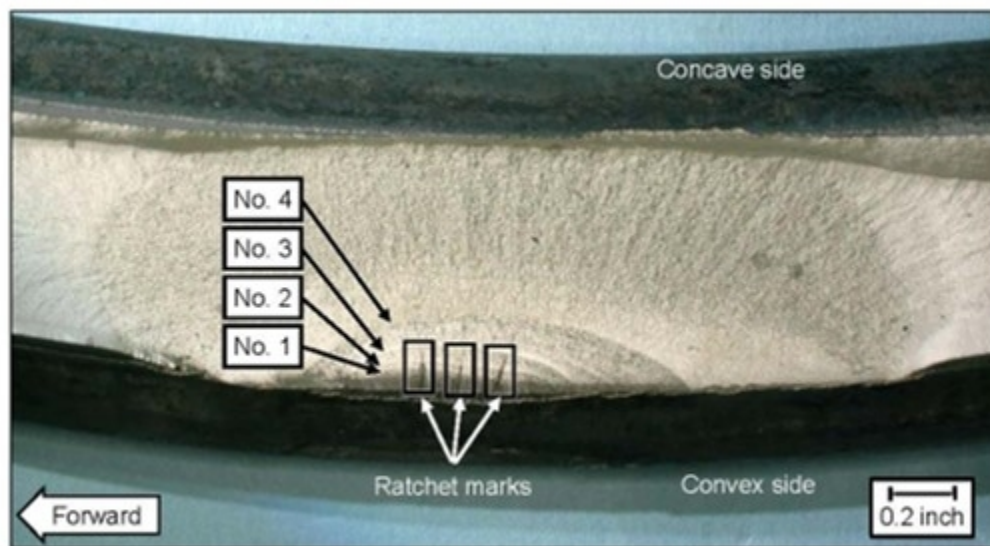
Figure 8. Fatigue region and crack arrest lines.

Part of the fracture surface on fan blade No. 23 was relatively smooth with well-defined curving crack arrest lines, which were consistent with fatigue, as shown in figure 8. (Crack arrest lines generally represent changes in the stress state, environment, or time interval associated with fatigue crack growth.) Fracture features emanated from an origin area centered about 2.1 inches from the leading edge face on the convex side of the blade. Ratchet marks (which are formed when two adjacent fatigue cracks originate on slightly offset planes) were observed in the origin area, consistent with multiple fatigue origins. The fracture had initiated at the contact face just inboard of the outboard edge (relative to the fan disk rotational axis) of the dovetail coating. The coating was missing and spalled in several locations on the convex side of the blade, including an area adjacent to the fracture and a larger area directly inboard from the fracture origin.

The progressive crack growth region extended up to 2.277 inches axially and was 0.695 inch deep. Beyond the boundary of the progressive crack growth region, the fracture surface had a lighter gray appearance with prominent shear lips, which was consistent with ductile overstress fracture.

The fan blade No. 23 fracture surface was further examined using a SEM. The four crack arrest lines found during the visual and optical examination (shown in figure 8) were observed on the fracture surface. The depths of crack arrest lines Nos. 1 through 4 were 0.072 inch, 0.093 inch, 0.139 inch, and 0.228 inch, respectively. A possible crack arrest line was observed between arrest lines Nos. 3 and 4, especially near the aft side of the fatigue region, but there was no distinct boundary around the entire front of the crack.

At higher SEM magnifications, striations consistent with low-cycle fatigue crack growth were observed. (Striations are linear features on a fatigue fracture surface that indicate how far a crack advanced with each stress cycle.) The striation spacing generally became larger as the depth of the crack increased. Immediately beyond the crack arrest lines, the striation spacing changed abruptly; the spacing between striations was shorter than the spacing before the arrest lines, which was consistent with a temporary reduction in crack growth rate after each arrest line had formed.

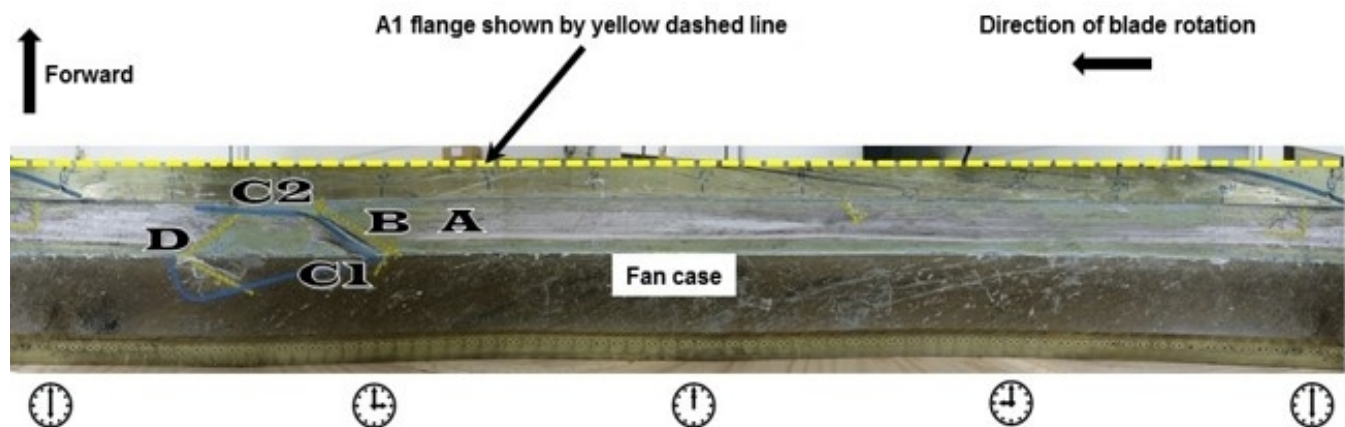
Figure 9. Fan case impact damage.

CFM performed a detailed examination of the fan case to assess the impact damage. The greatest amount of deformation on the A1 flange was observed along the four-to-ten o'clock arc. Rub marks were noted along the entire circumference in line with the fan blade rotational plane except for the area between the three and five o'clock positions. CFM determined that, after fan blade No. 23 released and impacted the fan case, the blade fractured into three (or possibly four) pieces, which created the four major and distinct fan case impact marks shown in figure 9 and several different exit paths and trajectories.

The first fan case impact, labeled impact mark A in figure 9, was a shallow blade tip scuff mark located near the two o'clock position. According to CFM, this initial fan blade impact caused the blade tip to bend, snap off, and travel forward and out of the engine. CFM considered this initial impact to be a "low energy" event due to the small radial clearance between the blade tip and fan case (resulting in a low radial release velocity) and the lack of a deep gouge or any related distortion of the fan case in this area.

According to CFM, after the blade tip fractured, the remaining fan blade continued to travel and created two "high energy" crescent-shaped impact marks (labeled B and C1) located between the three and four o'clock positions on the fan case. The impact marks coincided with observed fan case distortion and tears and was near the largest A1 flange distortion. CFM determined that the blade airfoil fractured at these locations, indicating that the impact was created by a different fan blade fracture surface. CFM also determined that the deep scuffing damage by impact mark C1 (labeled C2) could have been the result of an additional impact and airfoil fracture.
