Aviation Investigation Final Report

Location:	Pensacola, Florida	Accident Number:	DCA16FA217
Date & Time:	August 27, 2016, 09:30 Local	Registration:	N766SW
Aircraft:	Boeing 737-700	Aircraft Damage:	Substantial
Defining Event:	Powerplant sys/comp malf/fail	Injuries:	104 None
Flight Conducted Under:	Part 121: Air carrier - Scheduled

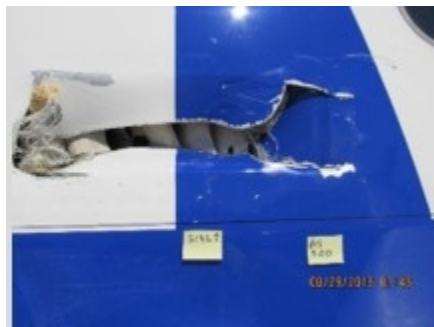
Figure 4. Close-up view of through-puncture on left side of fuselage.

Postaccident examination of the airplane revealed a 16-by-5-inch through-puncture on the left side of the fuselage, as shown in figure 4. The through-puncture was just below the cabin windows by rows 11 and 12, as indicated by the yellow tape in figure 5, with no corresponding damage on the interior cabin sidewall. Numerous impacts were observed along the left side of the fuselage, the left wing, and the left horizontal stabilizer, and the left winglet front spar was partially severed.

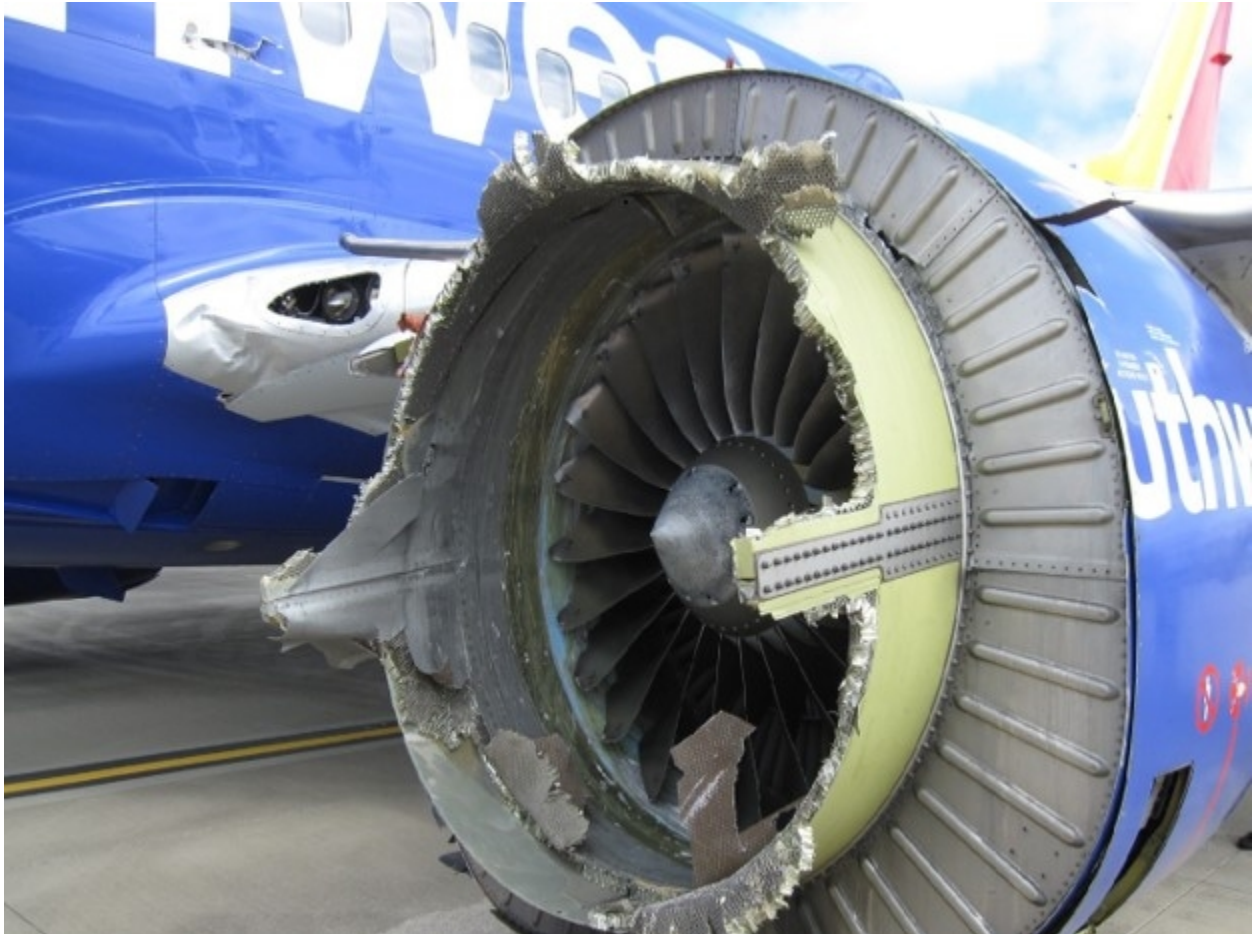
Figure 6. Inlet damage.

Almost all of the left engine inlet was missing, including the outer barrel, the inlet lip, the forward bulkhead, and the inner barrel forward of the containment shield. The part of the inlet that remained was severely damaged, as shown in figure 6. The aft bulkhead remained in place, but rivets connecting it to the attach ring were sheared 360° around the ring. A 360° section of the inlet inner barrel forward of the containment shield separated from the rest of the inlet about 17 inches forward of the A1 flange. Although both inner barrel splice plates (located at the three and nine o'clock positions) remained intact, the splice

plate at the nine o'clock position exhibited impact damage and outward deformation. The inner barrel honeycomb core and the inner skin that remained were torn and flared outward. Gaps between the inlet attach ring and the fan case A1 flange were observed at several locations around the circumference of the interface between the two parts.

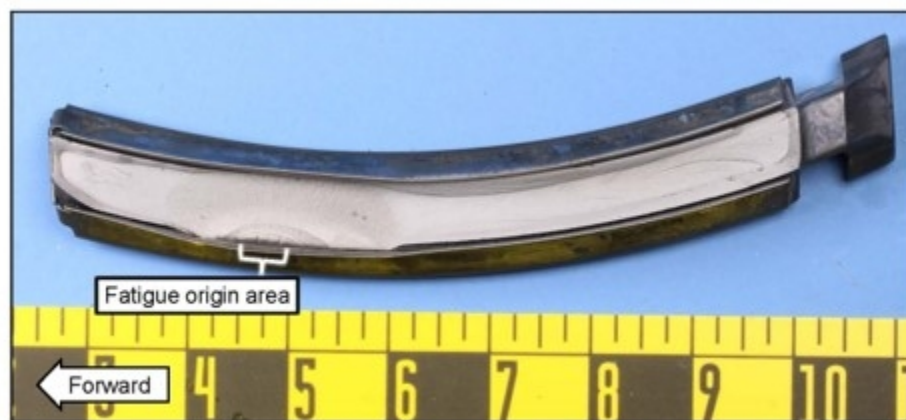
Figure 7. Fan blade No. 23 fracture surface.

All of the fan blades were found in their as-installed (full length) positions in the fan disk except for fan blade No. 23, which had fractured at the blade root with the dovetail remaining in the fan disk. The blade dovetail is shown in figure 7; the blade airfoil was missing and was not subsequently recovered. All of the intact fan blades exhibited hard-body impact damage, tears, missing material, and airfoil curling or distortion. Most of the blade platform for fan blade No. 22 (which was adjacent to fan blade No. 23 in the counterclockwise direction) was missing.

For fan blade No. 23, chipped and missing coating on the convex side of the dovetail was observed. Dimensional measurements showed that the coating damage was centered about 2 inches aft of the leading edge of the dovetail and spanned about 1.3 to 2.7 inches from the leading edge. According to Boeing's *737-600/700/800/900 Aircraft Maintenance Manual*, the coating on the dovetail is to be visually inspected for any missing and/or chipped coating in the contact area on both the concave and convex sides of the blades. This visual inspection is typically performed during relubrications of the dovetail. If a coating loss is found during the inspection, the affected fan blades are either removed from service or allowed to

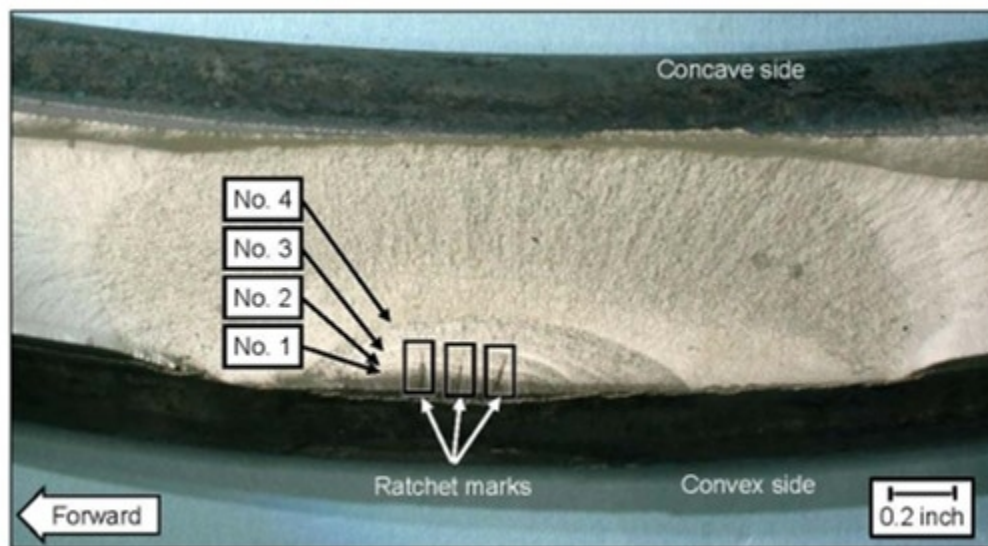
Figure 8. Fatigue region and crack arrest lines.

Part of the fracture surface on fan blade No. 23 was relatively smooth with well-defined curving crack arrest lines, which were consistent with fatigue, as shown in figure 8. (Crack arrest lines generally represent changes in the stress state, environment, or time interval associated with fatigue crack growth.) Fracture features emanated from an origin area centered about 2.1 inches from the leading edge face on the convex side of the blade. Ratchet marks (which are formed when two adjacent fatigue cracks originate on slightly offset planes) were observed in the origin area, consistent with multiple fatigue origins. The fracture had initiated at the contact face just inboard of the outboard edge (relative to the fan disk rotational axis) of the dovetail coating. The coating was missing and spalled in several locations on the convex side of the blade, including an area adjacent to the fracture and a larger area directly inboard from the fracture origin.

The progressive crack growth region extended up to 2.277 inches axially and was 0.695 inch deep. Beyond the boundary of the progressive crack growth region, the fracture surface had a lighter gray appearance with prominent shear lips, which was consistent with ductile overstress fracture.

The fan blade No. 23 fracture surface was further examined using a SEM. The four crack arrest lines found during the visual and optical examination (shown in figure 8) were observed on the fracture surface. The depths of crack arrest lines Nos. 1 through 4 were 0.072 inch, 0.093 inch, 0.139 inch, and 0.228 inch, respectively. A possible crack arrest line was observed between arrest lines Nos. 3 and 4, especially near the aft side of the fatigue region, but there was no distinct boundary around the entire front of the crack.

At higher SEM magnifications, striations consistent with low-cycle fatigue crack growth were observed. (Striations are linear features on a fatigue fracture surface that indicate how far a crack advanced with each stress cycle.) The striation spacing generally became larger as the depth of the crack increased. Immediately beyond the crack arrest lines, the striation spacing changed abruptly; the spacing between striations was shorter than the spacing before the arrest lines, which was consistent with a temporary reduction in crack growth rate after each arrest line had formed.

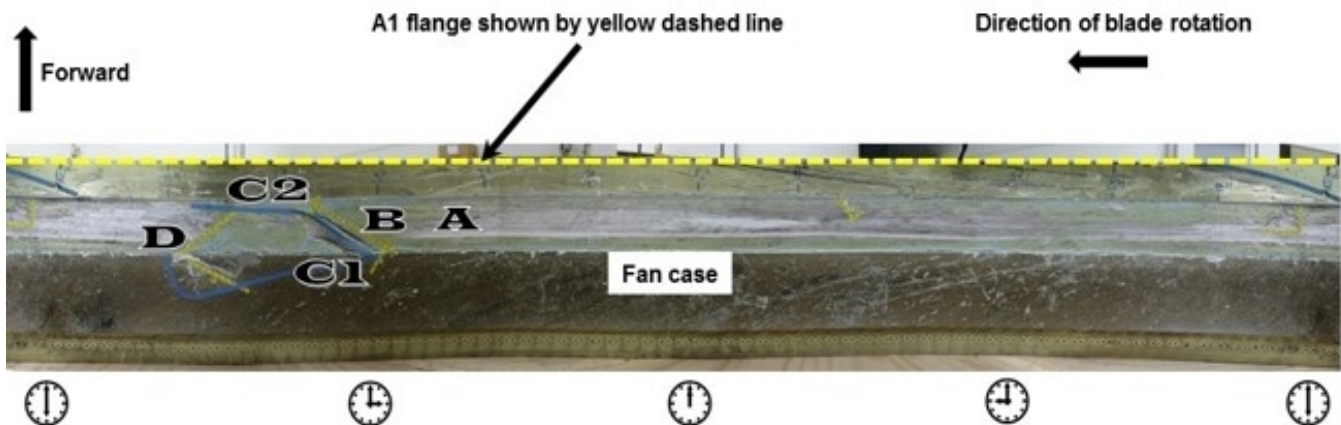
Figure 9. Fan case impact damage.

CFM performed a detailed examination of the fan case to assess the impact damage. The greatest amount of deformation on the A1 flange was observed along the four-to-ten o'clock arc. Rub marks were noted along the entire circumference in line with the fan blade rotational plane except for the area between the three and five o'clock positions. CFM determined that, after fan blade No. 23 released and impacted the fan case, the blade fractured into three (or possibly four) pieces, which created the four major and distinct fan case impact marks shown in figure 9 and several different exit paths and trajectories.

The first fan case impact, labeled impact mark A in figure 9, was a shallow blade tip scuff mark located near the two o'clock position. According to CFM, this initial fan blade impact caused the blade tip to bend, snap off, and travel forward and out of the engine. CFM considered this initial impact to be a "low energy" event due to the small radial clearance between the blade tip and fan case (resulting in a low radial release velocity) and the lack of a deep gouge or any related distortion of the fan case in this area.

According to CFM, after the blade tip fractured, the remaining fan blade continued to travel and created two "high energy" crescent-shaped impact marks (labeled B and C1) located between the three and four o'clock positions on the fan case. The impact marks coincided with observed fan case distortion and tears and was near the largest A1 flange distortion. CFM determined that the blade airfoil fractured at these locations, indicating that the impact was created by a different fan blade fracture surface. CFM also determined that the deep scuffing damage by impact mark C1 (labeled C2) could have been the result of an additional impact and airfoil fracture.

Another "high energy" impact mark (labeled D) was located at the five o'clock position on the fan case. This impact mark appeared to have the outline/imprint of the blade root trailing edge (profile view). The impact mark coincided with the observed fan case distortion and tears.
