# Aviation Investigation Final Report

<b>Location:</b>	Chariton, Iowa	<b>Accident Number:</b>	CEN16FA361
<b>Date &amp; Time:</b>	September 7, 2016, 12:19 Local	<b>Registration:</b>	N465JM
<b>Aircraft:</b>	Piper PA 46-310P	<b>Aircraft Damage:</b>	Substantial
<b>Defining Event:</b>	Loss of control in flight	<b>Injuries:</b>	1 Fatal
<b>Flight Conducted Under:</b>	Part 91: General aviation - Personal

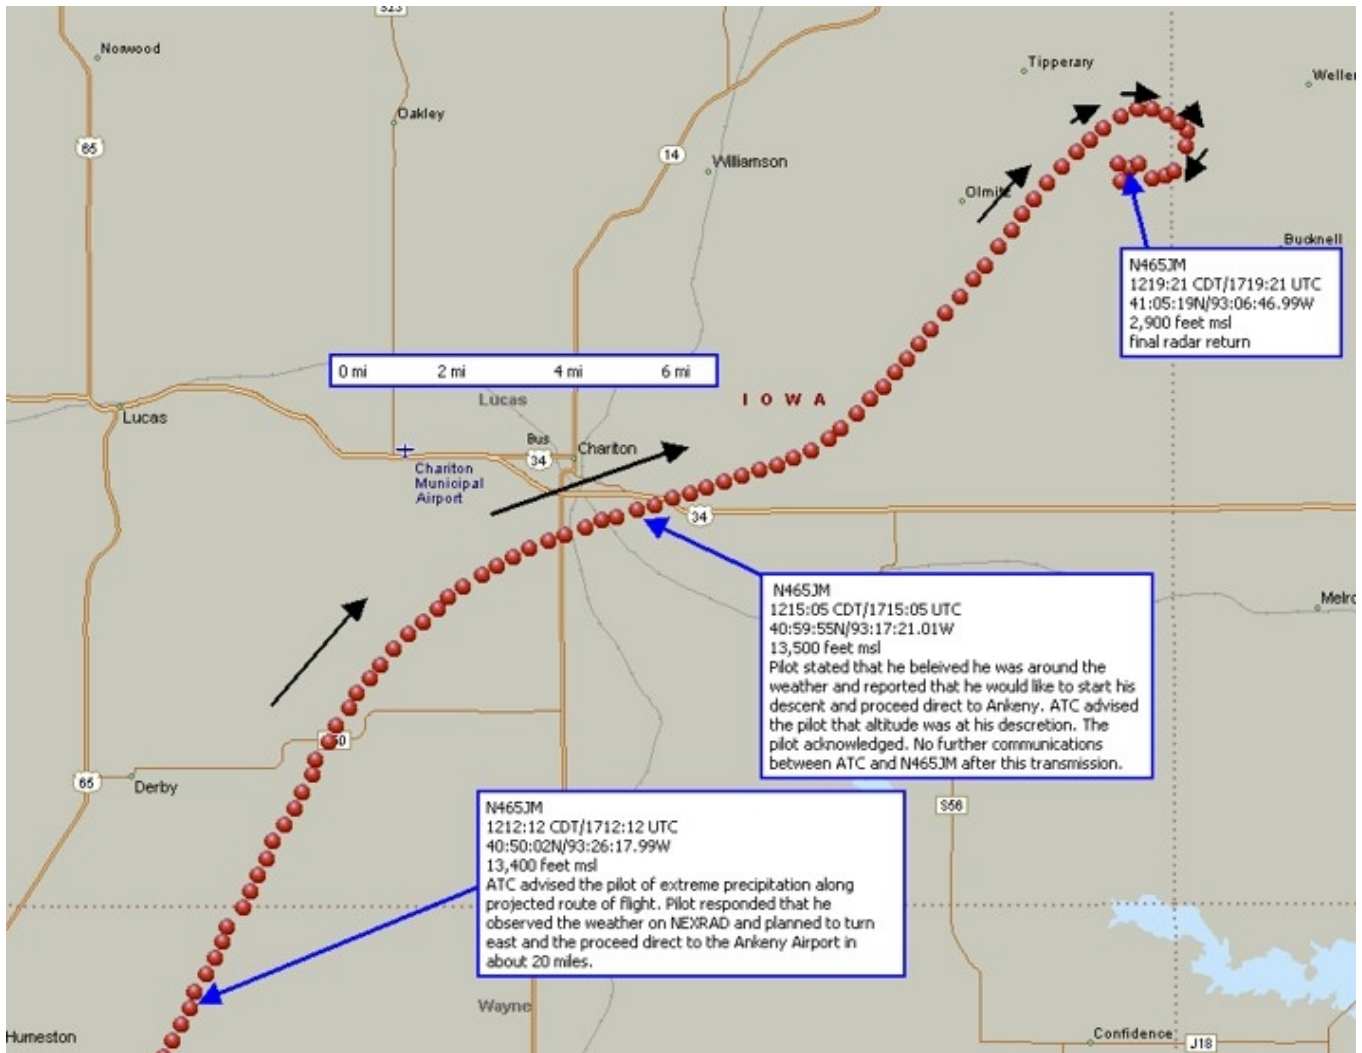
According to radar data and air traffic control communications information from the Federal Aviation Administration (FAA), the pilot was receiving visual flight rules (VFR) flight following from the Chicago Air Route Traffic Control Center (ARTCC) at a cruise altitude of 13,500 ft mean sea level (msl). The pilot had deviated around convective weather earlier in the flight and was proceeding direct to IKV. The controller issued a weather advisory to the pilot about areas of moderate to extreme precipitation along his route, and the pilot responded that he had weather information on the airplane's NEXRAD system. About 3 minutes later, the pilot reported to the controller that he was around the weather and requested to start a descent direct to IKV. The controller responded that the descent altitude was at the pilot's discretion, then instructed the pilot to contact Des Moines Air Traffic Control Tower. The controller received no response from the pilot, and subsequent attempts to contact him were unsuccessful. Radar data showed the airplane making a descending right turn before radar contact was lost (Figure 1). The last radar return showed the airplane about 2,900 ft msl.

Figure 1. The radar flight track of N465JM is indicated by red dots. The direction of flight is indicated by black arrows.

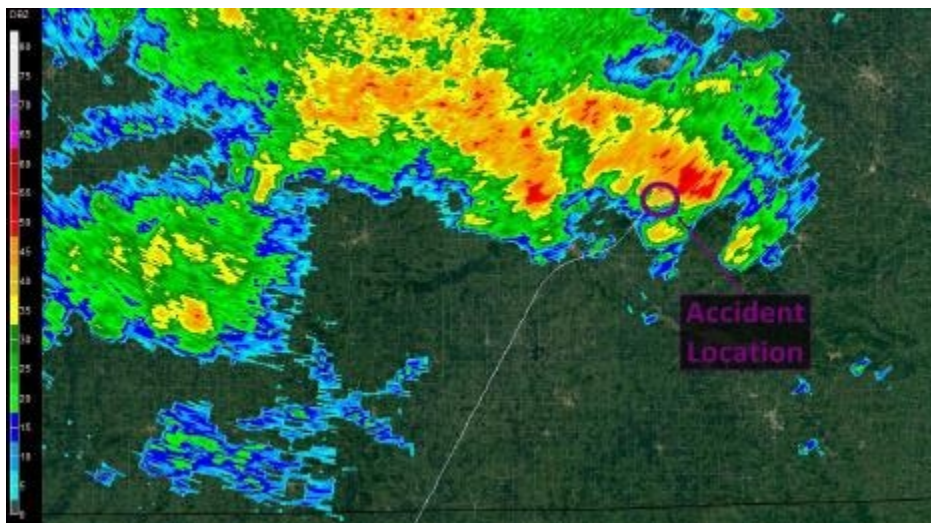
Given the pilot's discussions with ATC during the flight, the pilot was aware of and was trying to avoid convective weather along his route of flight. The airplane most likely would have encountered instrument meteorological conditions (IMC) during the last several minutes of flight. Figure 2 shows the airplane's flight path into storms. Additional details can be found in the weather study in the docket.

Figure 2. Level-II reflectivity product from a sweep initiated at 1223:06 CDT. Accident flight path through the accident time denoted by white line with accident location marked.

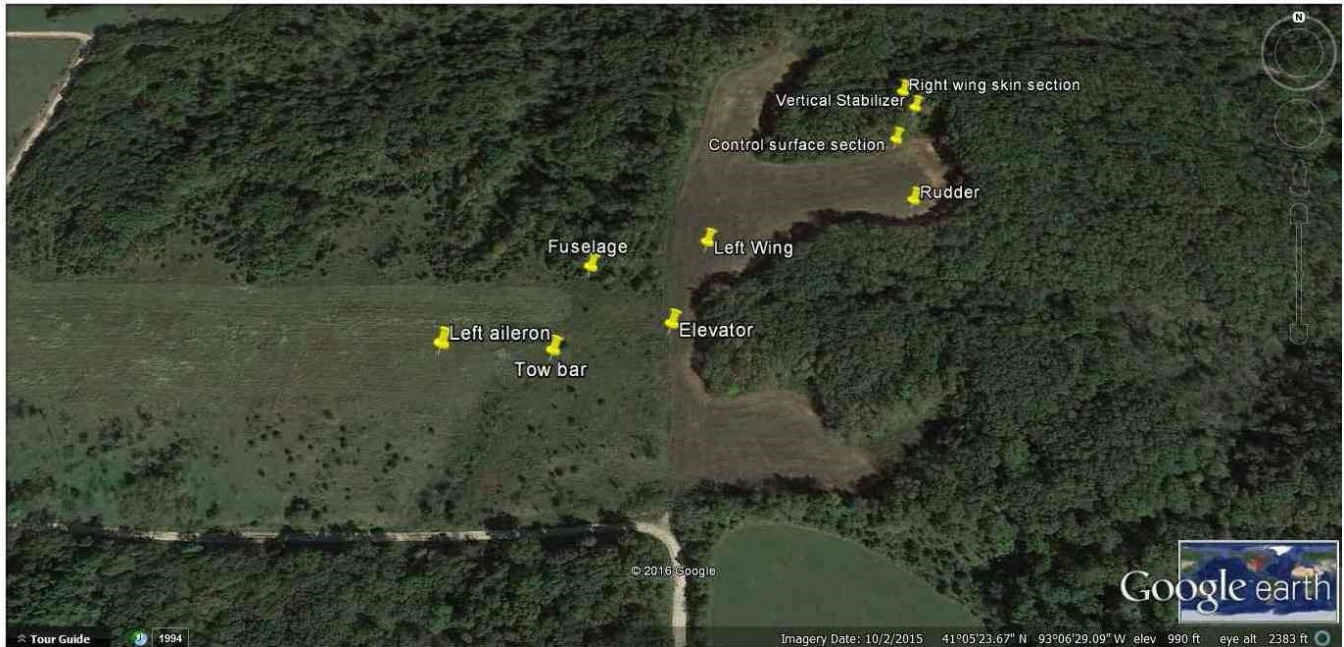
Figure 3. Wreckage Distribution

The airplane impacted a mature corn field, and components of the wings and empennage were scattered along a path about 1/4-mile long (see figure 3). The main wreckage (cabin and fuselage) came to rest along a stand of trees adjacent to the corn field. The distribution of the wreckage was consistent with an in-flight breakup.
