Aviation Investigation Final Report

Location:	Wickenburg, Arizona	Accident Number:	WPR16FA176
Date & Time:	September 9, 2016, 07:00 Local	Registration:	N126P
Aircraft:	Cessna 310N	Aircraft Damage:	Substantial
Defining Event:	Fuel starvation	Injuries:	4 Serious
Flight Conducted Under:	Part 91: General aviation - Personal

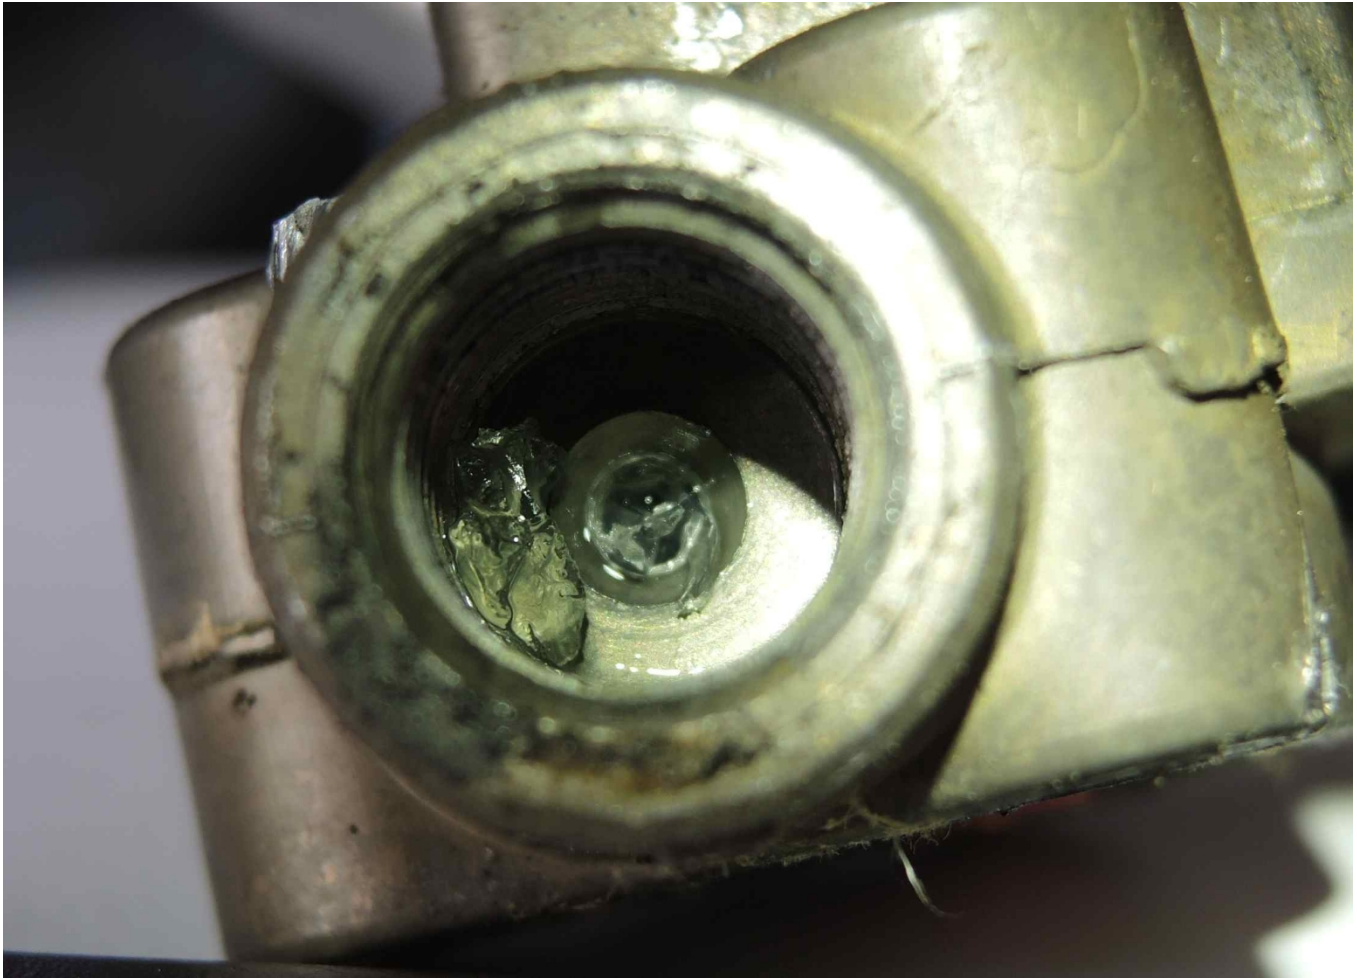
Photo 1 - Fuel Flow Transducer Inlet Port

Examination of the right engine revealed that a clear, gelatinous substance had blocked the inlet port of the fuel flow transducer, leading to fuel starvation. The substance was determined to be silicone, most likely room-temperature-vulcanization silicone sealant. There were no indications that this material had been used anywhere within the fuel system, nor were there any signs of recent maintenance that could have resulted in the introduction of this contaminant. To get to the fuel flow transducer, the silicone would have had to pass through multiple fine mesh filters, which was unlikely based on the material's size when dry. However, silicone becomes semi-soluble once in contact with aviation gasoline, and it is possible that it was extruded through the filters in this state, and eventually coalesced in the flow divider inlet port. Smaller fragments of the silicone were found in the fuel manifold valve, beyond the flow divider, and a fuel injector valve port was partially occluded, possibly with the same material.

Total loss of power to the right engine during takeoff due to a fuel contaminant, which blocked the fuel flow transducer and resulted in fuel starvation to the engine.

Disassembly of the fuel lines revealed that a clear gelatinous substance had completely blocked the fuel flow transducer inlet port (metering orifice) (Photo 1). The material was removed, and had a slimy wet texture. After one hour of exposure to air, the material had hardened and took on a texture similar to room-temperature-vulcanization (RTV) silicone. Six fragments were recovered, which, after drying for 24 hours, ranged in size from 1 to 3 mm. Further examination of the fuel manifold valve revealed a similar fragment of the material within the manifold cavity on the pre-filtered side of its screen.

The rubber-like material was sent to the NTSB Materials Laboratory Division for analysis using a Fourier Transform Infrared spectrometer. The results revealed spectral peaks, which when evaluated, were a strong match to polydimethylsiloxane, also known as silicone.
