Aviation Investigation Final Report

Location:	Alexandria, Minnesota	Accident Number:	CEN16FA372
Date & Time:	September 17, 2016, 02:04 Local	Registration:	N91NM
Aircraft:	Agusta A109	Aircraft Damage:	Destroyed
Defining Event:	Loss of control in flight	Injuries:	3 Serious
Flight Conducted Under:	Part 135: Air taxi & commuter - Non-scheduled - Air Medical (Medical emergency)

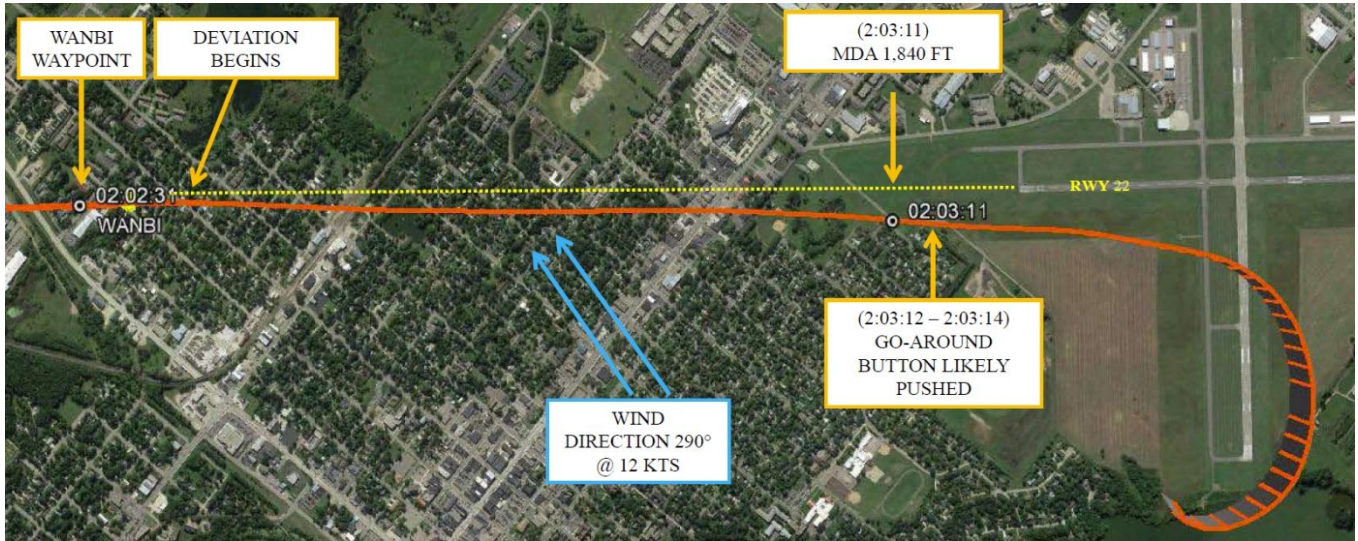
Figure 3 – Flight Path

A review of the recorded flight data revealed that the flight path was in line with the GPS approach course and followed the respective waypoints. The helicopter intercepted the approach's last waypoint, WANBI, at 02:02:31 then the flight path started to deviate right of course (figure 3). The flight path continued toward AXN while maintaining the slight right deviation until 02:03:11 when the helicopter reached 1,840 ft, which is the approach's minimum descent altitude. Between 02:03:12 and 02:03:14 the collective position percentage increases, which is consistent with the reported go-around maneuver (figure 4). The helicopter descends to 1,740 ft until a climb began at 02:03:17. The helicopter climbed and turned right with a maximum bank angle of 50°. The flight path continued right as the helicopter then descended and the collective position continued to increase.
