# Aviation Investigation Final Report

<b>Location:</b>	Alexandria, Minnesota	<b>Accident Number:</b>	CEN16FA372
<b>Date &amp; Time:</b>	September 17, 2016, 02:04 Local	<b>Registration:</b>	N91NM
<b>Aircraft:</b>	Agusta A109	<b>Aircraft Damage:</b>	Destroyed
<b>Defining Event:</b>	Loss of control in flight	<b>Injuries:</b>	3 Serious
<b>Flight Conducted Under:</b>	Part 135: Air taxi & commuter - Non-scheduled - Air Medical (Medical emergency)

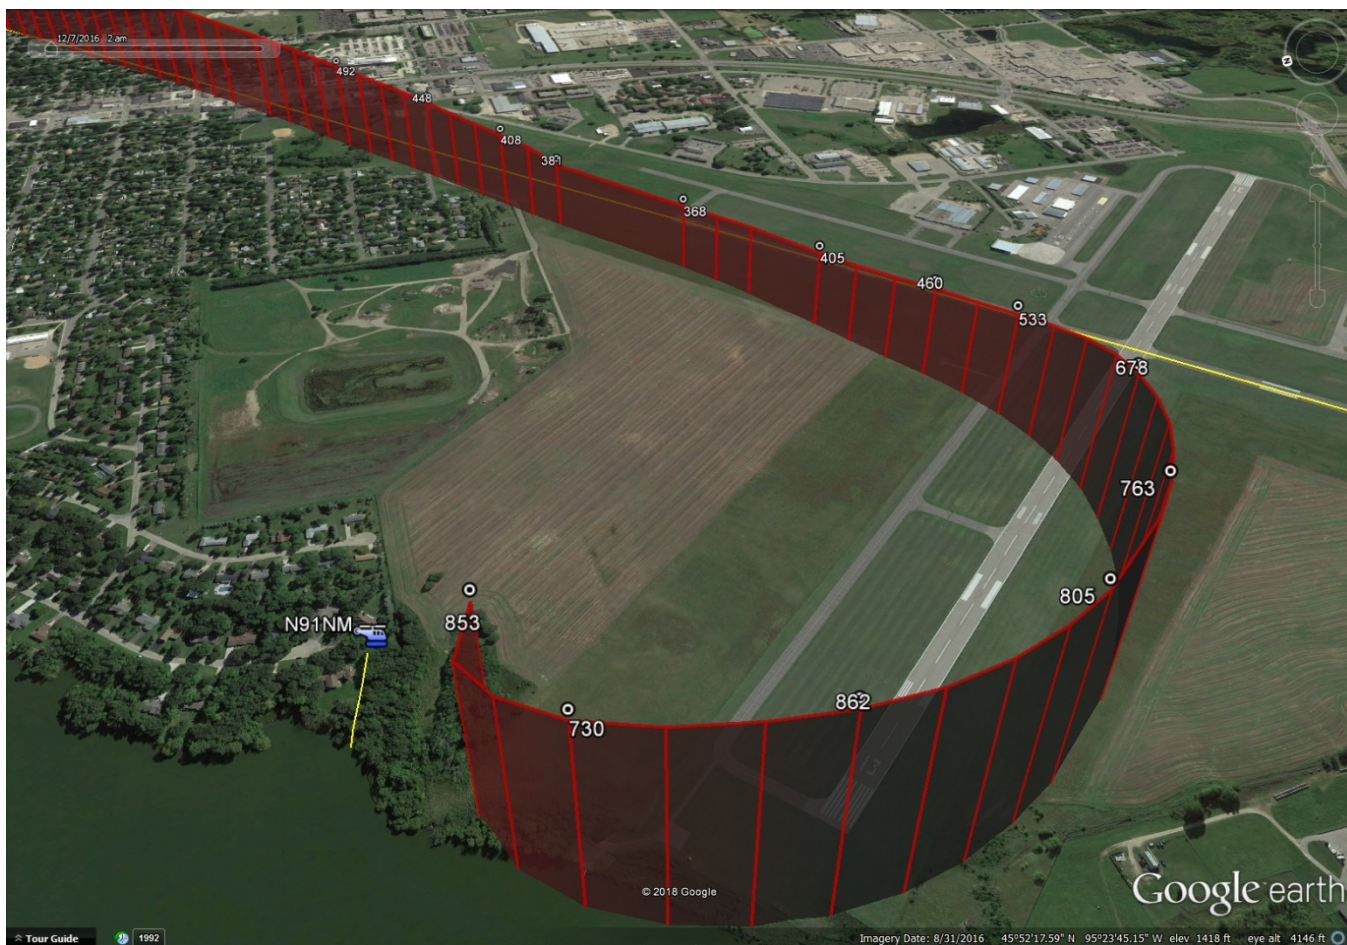
Figure 1 – Final Flight Path

The pilot contacted ATC and requested to proceed direct to KILVE, the initial approach fix for the RNAV (GPS) approach to runway 22 at AXN. The controller cleared the pilot for the approach and instructed him to maintain 4,000 ft until established on the approach. One minute later ATC lost radar contact with the helicopter and instructed the pilot to report when established on the approach. Ten minutes later the pilot reported inbound on KILVE. Additional radar data later indicated that the helicopter made a slight left turn which corresponded to an extended line of the final approach course to runway 22. The controller, who was still not in radar contact with the helicopter, approved a frequency change and requested that the pilot report the cancellation of the IFR flight plan, to which the pilot acknowledged; no further communications from the pilot were recorded. Radar data later indicated that the helicopter remained on the final approach course while descending until the last radar target was recorded at 0201:06; 4.75 nautical miles from the runway about 2,050 ft agl. An onboard device recorded the accident flight coordinates; figure 1 shows the helicopter's final flight path.

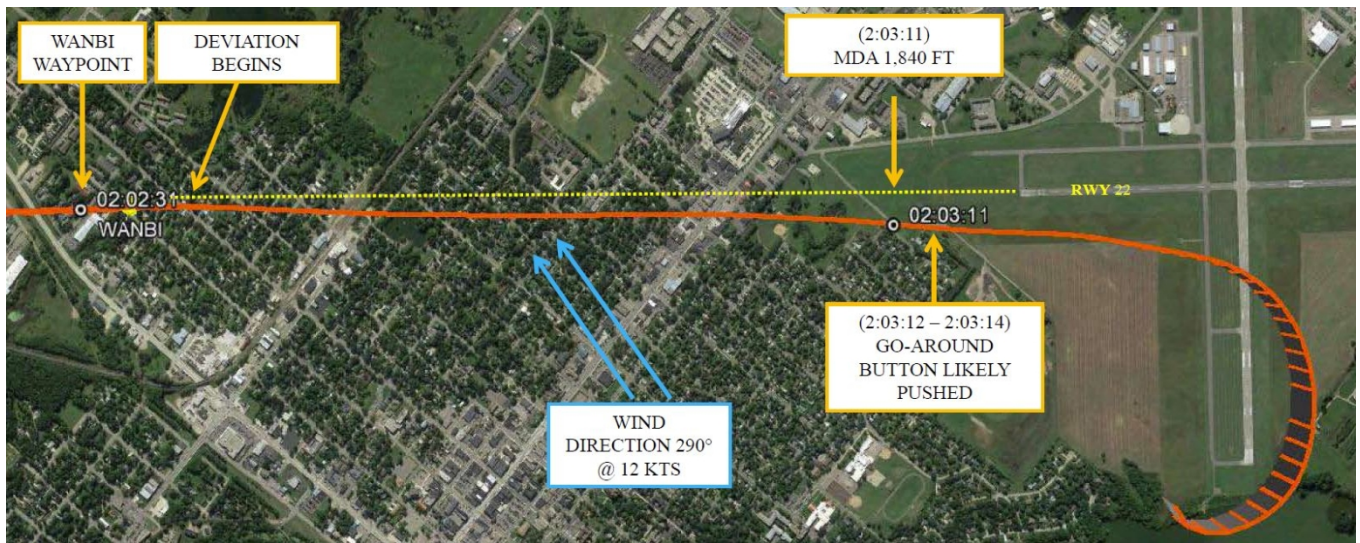
Figure 3 – Flight Path

A review of the recorded flight data revealed that the flight path was in line with the GPS approach course and followed the respective waypoints. The helicopter intercepted the approach's last waypoint, WANBI, at 02:02:31 then the flight path started to deviate right of course (figure 3). The flight path continued toward AXN while maintaining the slight right deviation until 02:03:11 when the helicopter reached 1,840 ft, which is the approach's minimum descent altitude. Between 02:03:12 and 02:03:14 the collective position percentage increases, which is consistent with the reported go-around maneuver (figure 4). The helicopter descends to 1,740 ft until a climb began at 02:03:17. The helicopter climbed and turned right with a maximum bank angle of 50°. The flight path continued right as the helicopter then descended and the collective position continued to increase.

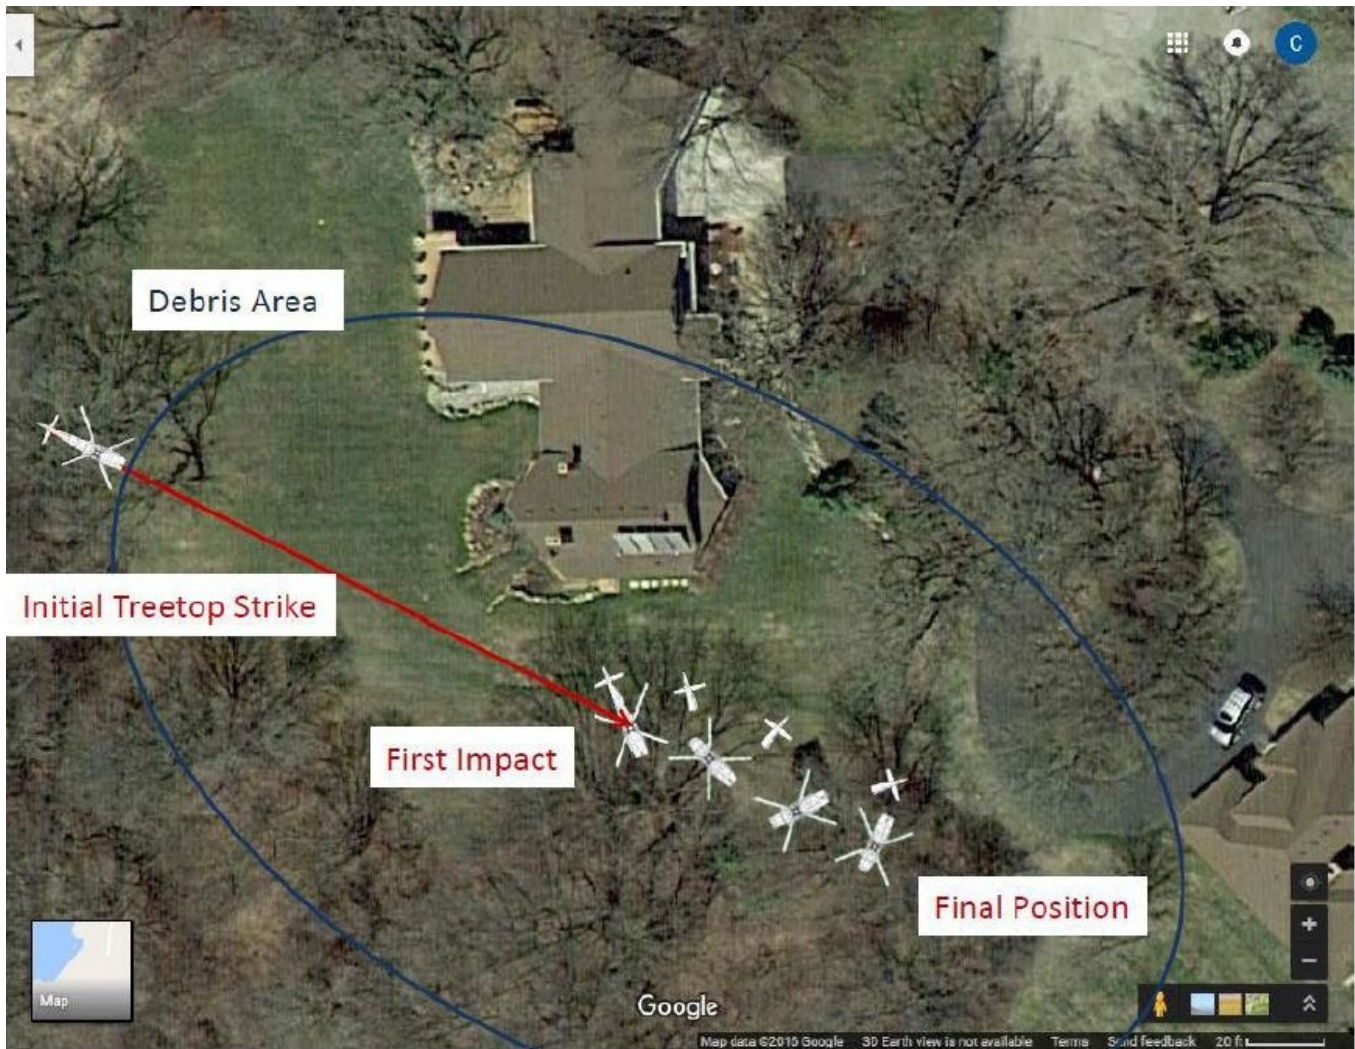
Figure 5 – Wreckage Diagram

The accident site was located in a residential area surrounded by trees about 1,000 yards northwest of the approach end of AXN's runway 22 (figure 5). The debris path was about 130 yards long and began with lopped tree tops (95 to 100 ft tall) and ended about 30 yards beyond the main wreckage. The middle of the debris path was in a back yard of a residence and consisted of lopped tree tranches, fragmented main rotor blades, and pieces of the helicopter. The initial impact marks were several parallel ground scars followed by the helicopter's tail skid in an impact crater. The debris path continued with a large ground impact area that contained helicopter pieces, followed by the main wreckage. The fuselage came to rest on its left side, was separated aft of the engines, and wrapped around two trees. The right side of the fuselage exhibited ground impact damage and mud smearing. The tail and aft portion of the rear fuselage were pointing in an opposite direction from the fuselage. The bottom of the tail contained mud smearing and splatter marks near the tail rotor. The right pilot seat and one passenger seat pan had separated from their respective mounts.
