# Aviation Investigation Final Report

<b>Location:</b>	Alexandria, Minnesota	<b>Accident Number:</b>	CEN16FA372
<b>Date &amp; Time:</b>	September 17, 2016, 02:04 Local	<b>Registration:</b>	N91NM
<b>Aircraft:</b>	Agusta A109	<b>Aircraft Damage:</b>	Destroyed
<b>Defining Event:</b>	Loss of control in flight	<b>Injuries:</b>	3 Serious
<b>Flight Conducted Under:</b>	Part 135: Air taxi & commuter - Non-scheduled - Air Medical (Medical emergency)

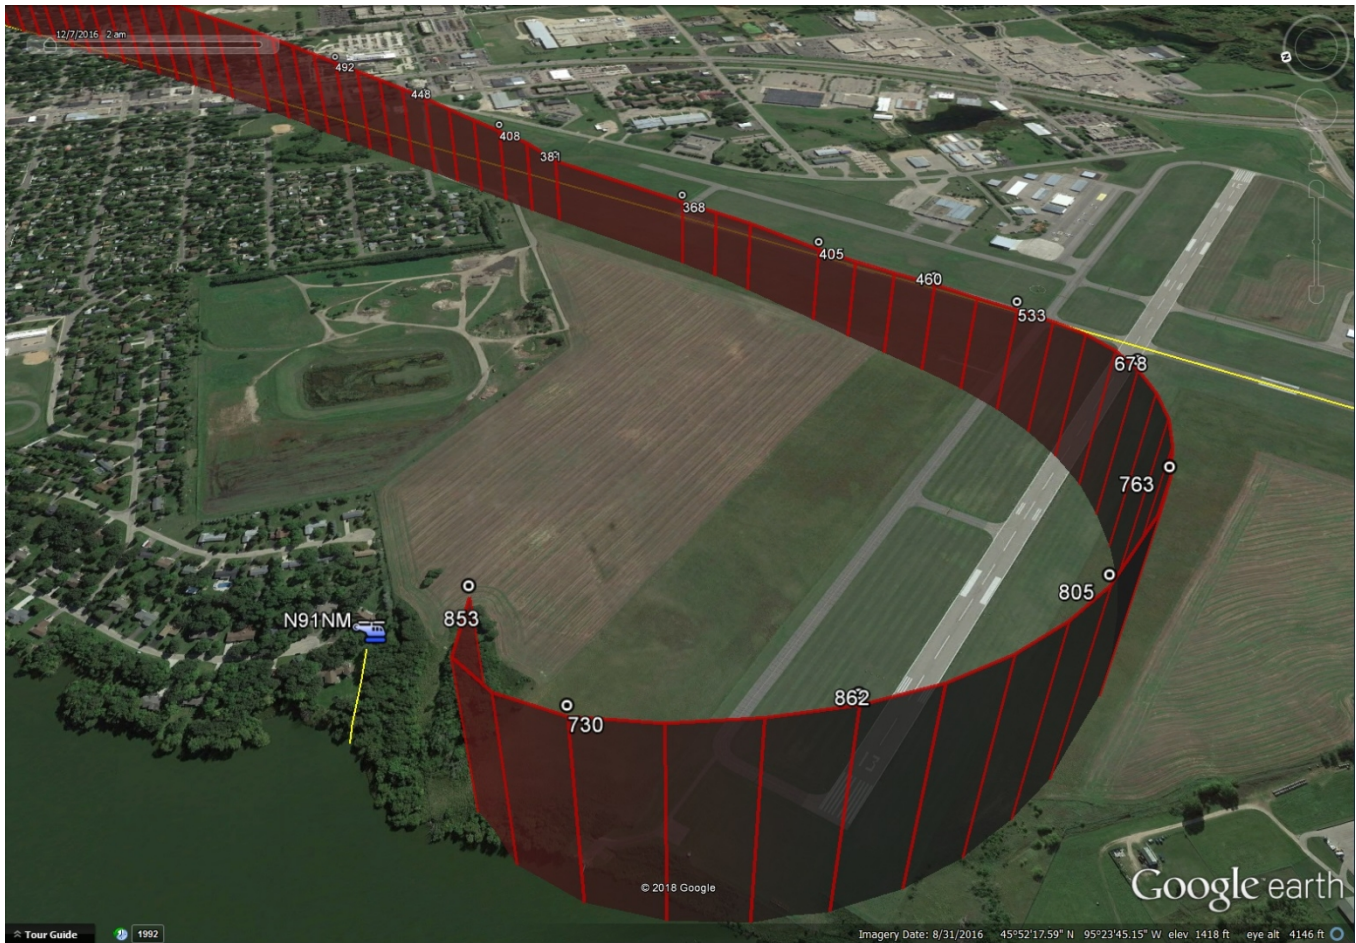
Figure 1 – Final Flight Path

The pilot contacted ATC and requested to proceed direct to KILVE, the initial approach fix for the RNAV (GPS) approach to runway 22 at AXN. The controller cleared the pilot for the approach and instructed him to maintain 4,000 ft until established on the approach. One minute later ATC lost radar contact with the helicopter and instructed the pilot to report when established on the approach. Ten minutes later the pilot reported inbound on KILVE. Additional radar data later indicated that the helicopter made a slight left turn which corresponded to an extended line of the final approach course to runway 22. The controller, who was still not in radar contact with the helicopter, approved a frequency change and requested that the pilot report the cancellation of the IFR flight plan, to which the pilot acknowledged; no further communications from the pilot were recorded. Radar data later indicated that the helicopter remained on the final approach course while descending until the last radar target was recorded at 0201:06; 4.75 nautical miles from the runway about 2,050 ft agl. An onboard device recorded the accident flight coordinates; figure 1 shows the helicopter's final flight path.

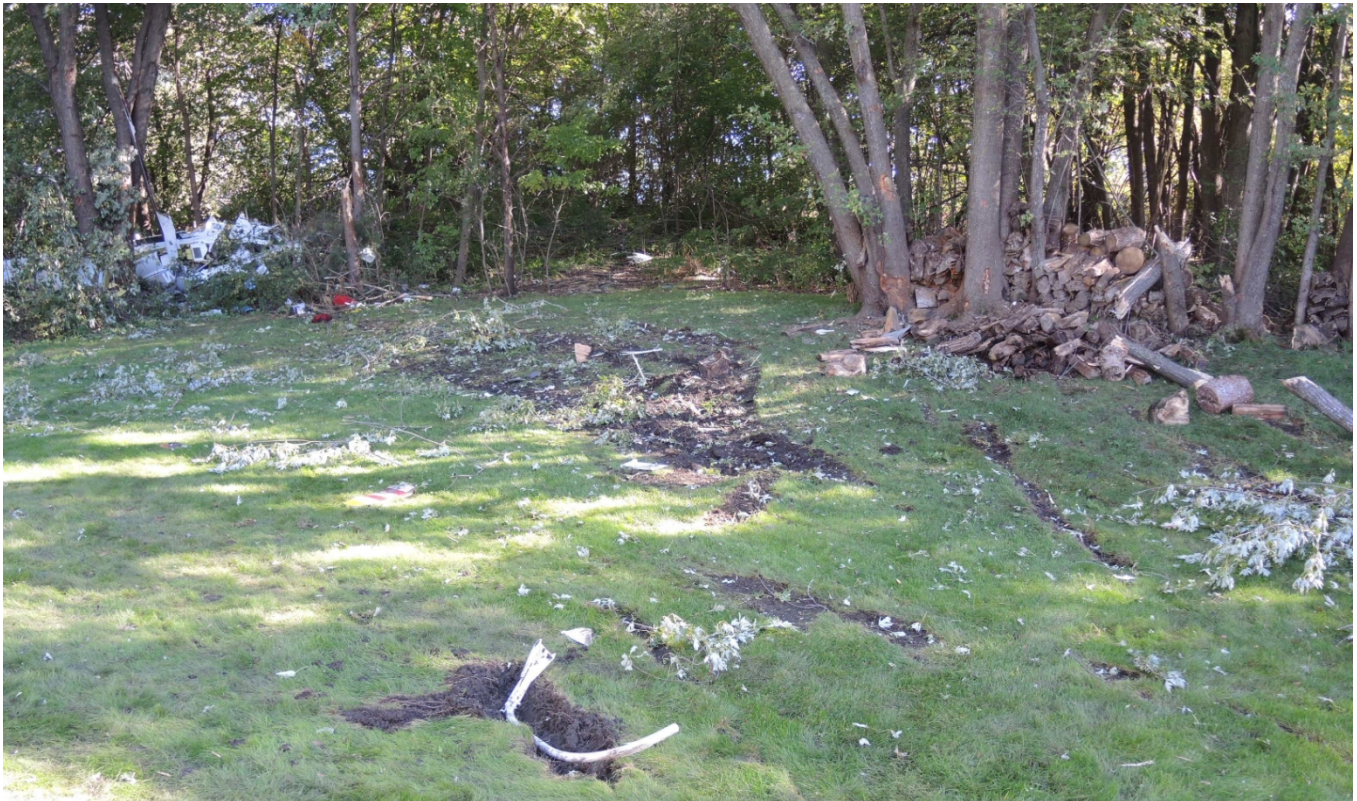
Figure 2 – Accident Site

The helicopter impacted the tops of several tall trees and the ground, then continued into a wooded area (figure 2). Several nearby residents were awake at the time of the accident and heard the helicopter's engines and then the sound of the impact.

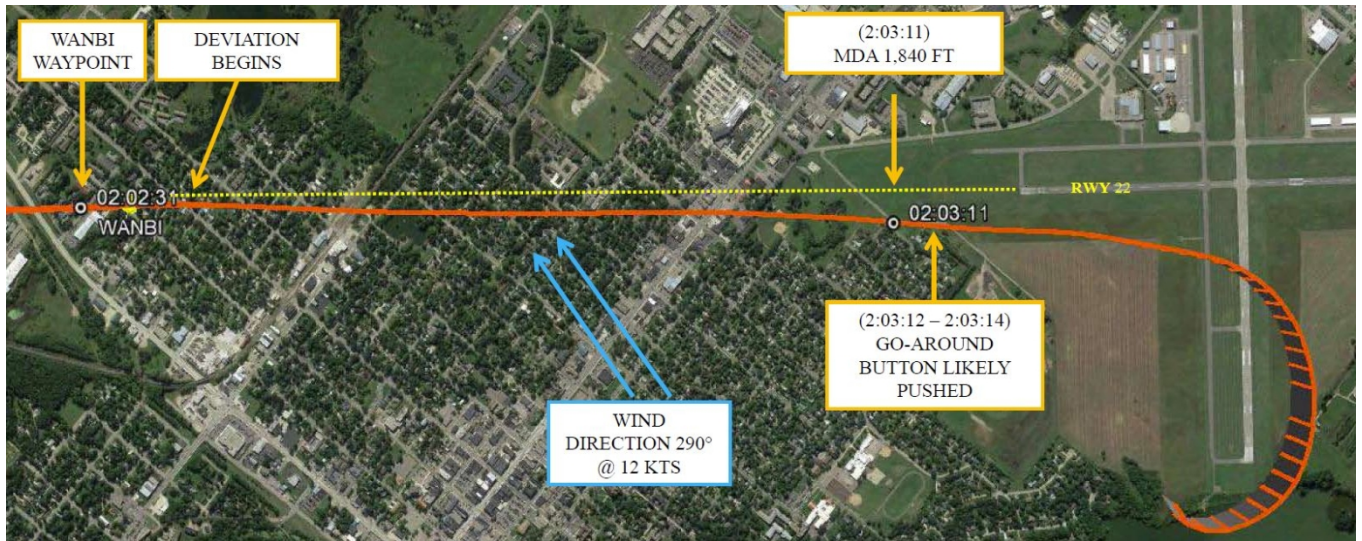
Figure 3 – Flight Path

A review of the recorded flight data revealed that the flight path was in line with the GPS approach course and followed the respective waypoints. The helicopter intercepted the approach's last waypoint, WANBI, at 02:02:31 then the flight path started to deviate right of course (figure 3). The flight path continued toward AXN while maintaining the slight right deviation until 02:03:11 when the helicopter reached 1,840 ft, which is the approach's minimum descent altitude. Between 02:03:12 and 02:03:14 the collective position percentage increases, which is consistent with the reported go-around maneuver (figure 4). The helicopter descends to 1,740 ft until a climb began at 02:03:17. The helicopter climbed and turned right with a maximum bank angle of 50°. The flight path continued right as the helicopter then descended and the collective position continued to increase.

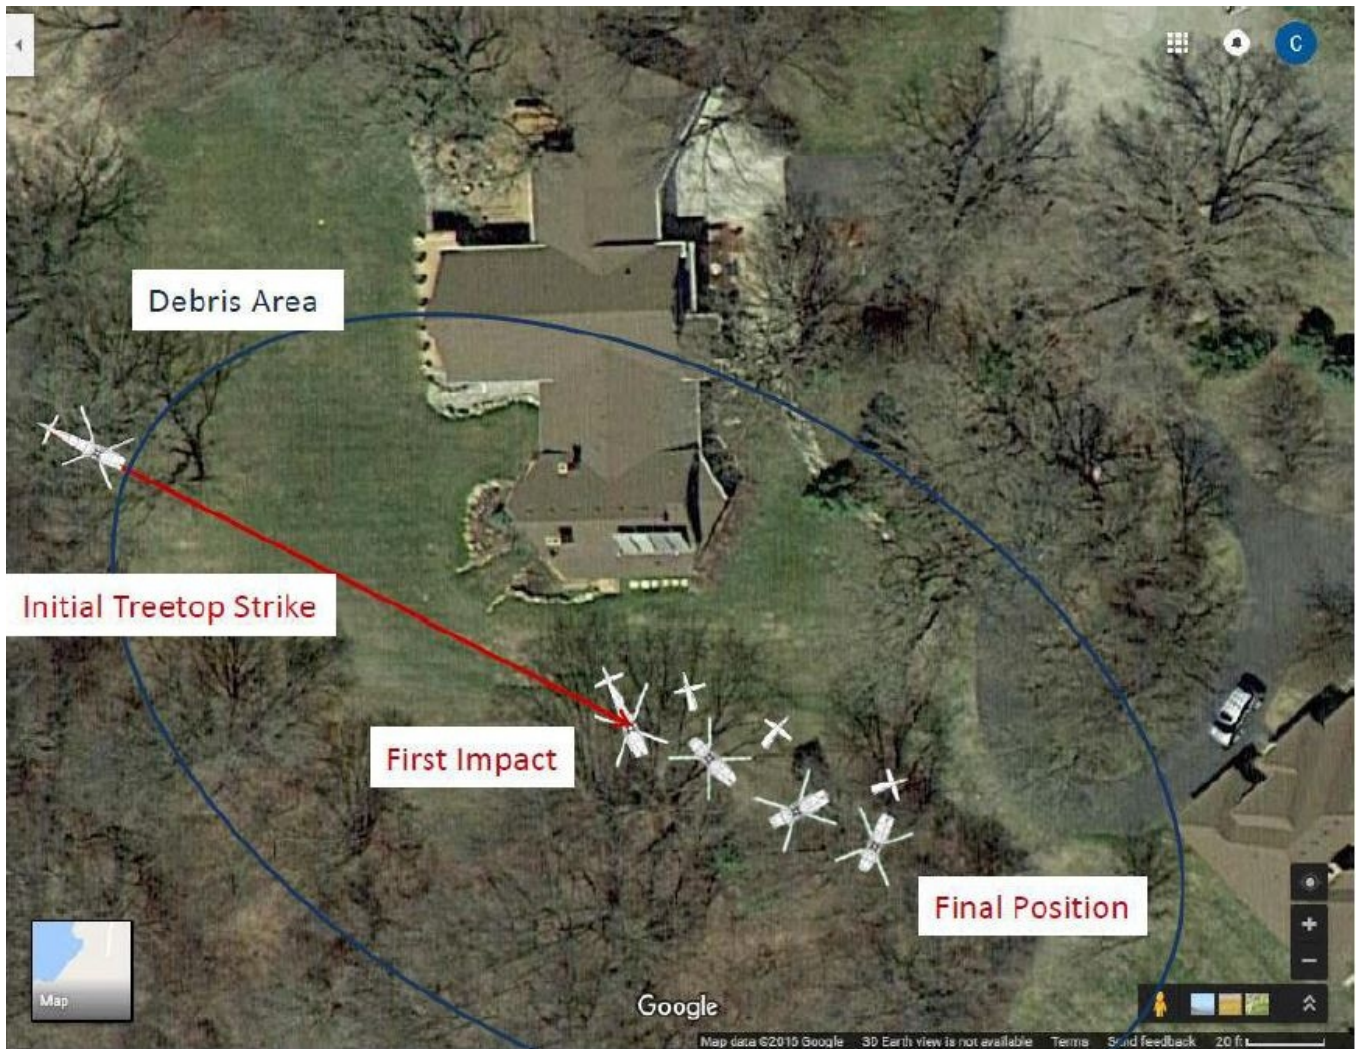
Figure 5 – Wreckage Diagram

The accident site was located in a residential area surrounded by trees about 1,000 yards northwest of the approach end of AXN's runway 22 (figure 5). The debris path was about 130 yards long and began with lopped tree tops (95 to 100 ft tall) and ended about 30 yards beyond the main wreckage. The middle of the debris path was in a back yard of a residence and consisted of lopped tree tranches, fragmented main rotor blades, and pieces of the helicopter. The initial impact marks were several parallel ground scars followed by the helicopter's tail skid in an impact crater. The debris path continued with a large ground impact area that contained helicopter pieces, followed by the main wreckage. The fuselage came to rest on its left side, was separated aft of the engines, and wrapped around two trees. The right side of the fuselage exhibited ground impact damage and mud smearing. The tail and aft portion of the rear fuselage were pointing in an opposite direction from the fuselage. The bottom of the tail contained mud smearing and splatter marks near the tail rotor. The right pilot seat and one passenger seat pan had separated from their respective mounts.
