Aviation Investigation Final Report

Location:	Alexandria, Minnesota	Accident Number:	CEN16FA372
Date & Time:	September 17, 2016, 02:04 Local	Registration:	N91NM
Aircraft:	Agusta A109	Aircraft Damage:	Destroyed
Defining Event:	Loss of control in flight	Injuries:	3 Serious
Flight Conducted Under:	Part 135: Air taxi & commuter - Non-scheduled - Air Medical (Medical emergency)

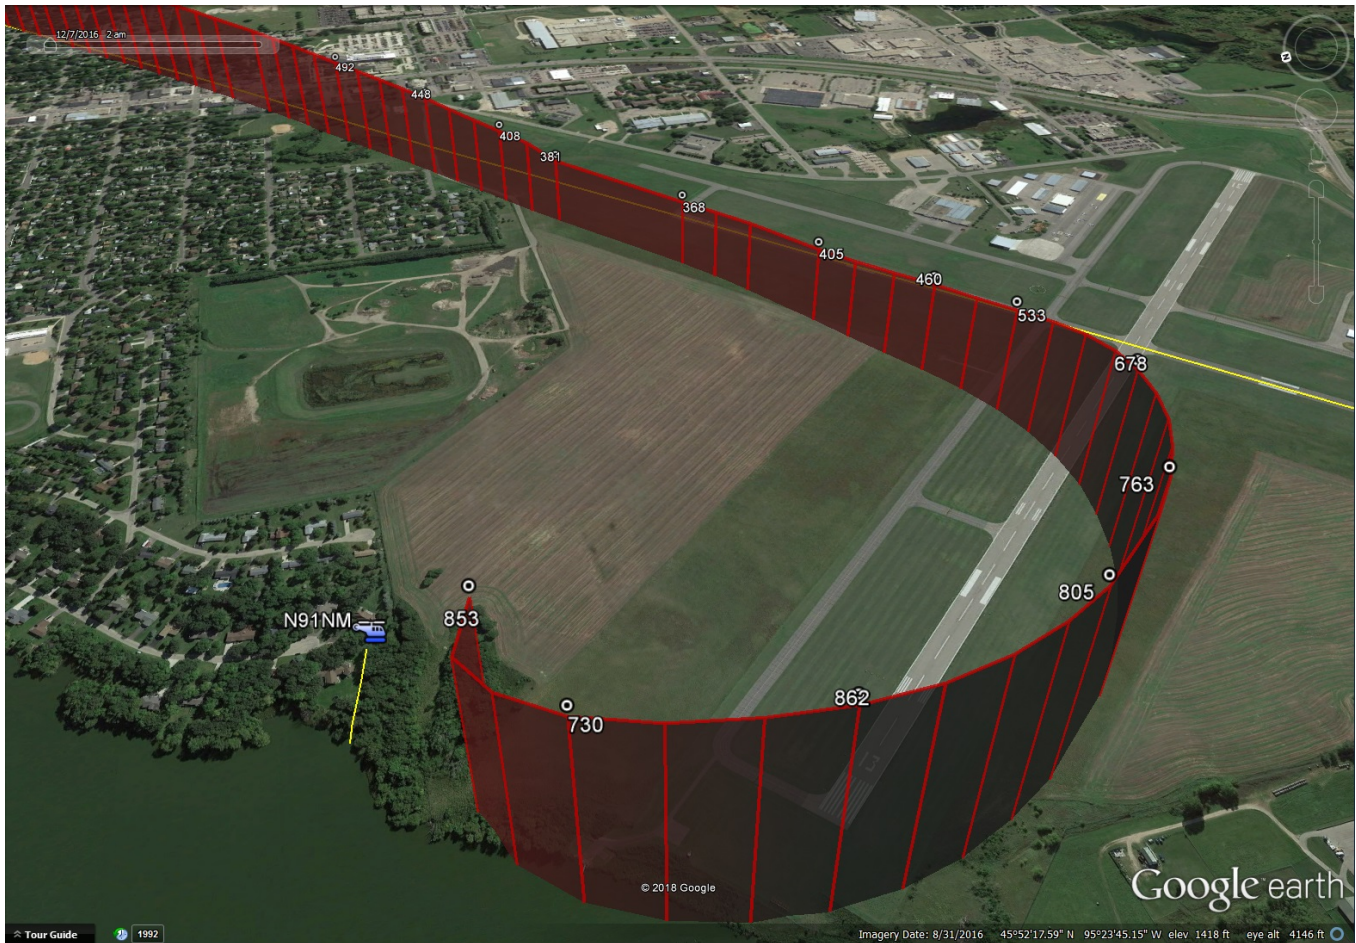
Figure 1 – Final Flight Path

The pilot contacted ATC and requested to proceed direct to KILVE, the initial approach fix for the RNAV (GPS) approach to runway 22 at AXN. The controller cleared the pilot for the approach and instructed him to maintain 4,000 ft until established on the approach. One minute later ATC lost radar contact with the helicopter and instructed the pilot to report when established on the approach. Ten minutes later the pilot reported inbound on KILVE. Additional radar data later indicated that the helicopter made a slight left turn which corresponded to an extended line of the final approach course to runway 22. The controller, who was still not in radar contact with the helicopter, approved a frequency change and requested that the pilot report the cancellation of the IFR flight plan, to which the pilot acknowledged; no further communications from the pilot were recorded. Radar data later indicated that the helicopter remained on the final approach course while descending until the last radar target was recorded at 0201:06; 4.75 nautical miles from the runway about 2,050 ft agl. An onboard device recorded the accident flight coordinates; figure 1 shows the helicopter's final flight path.

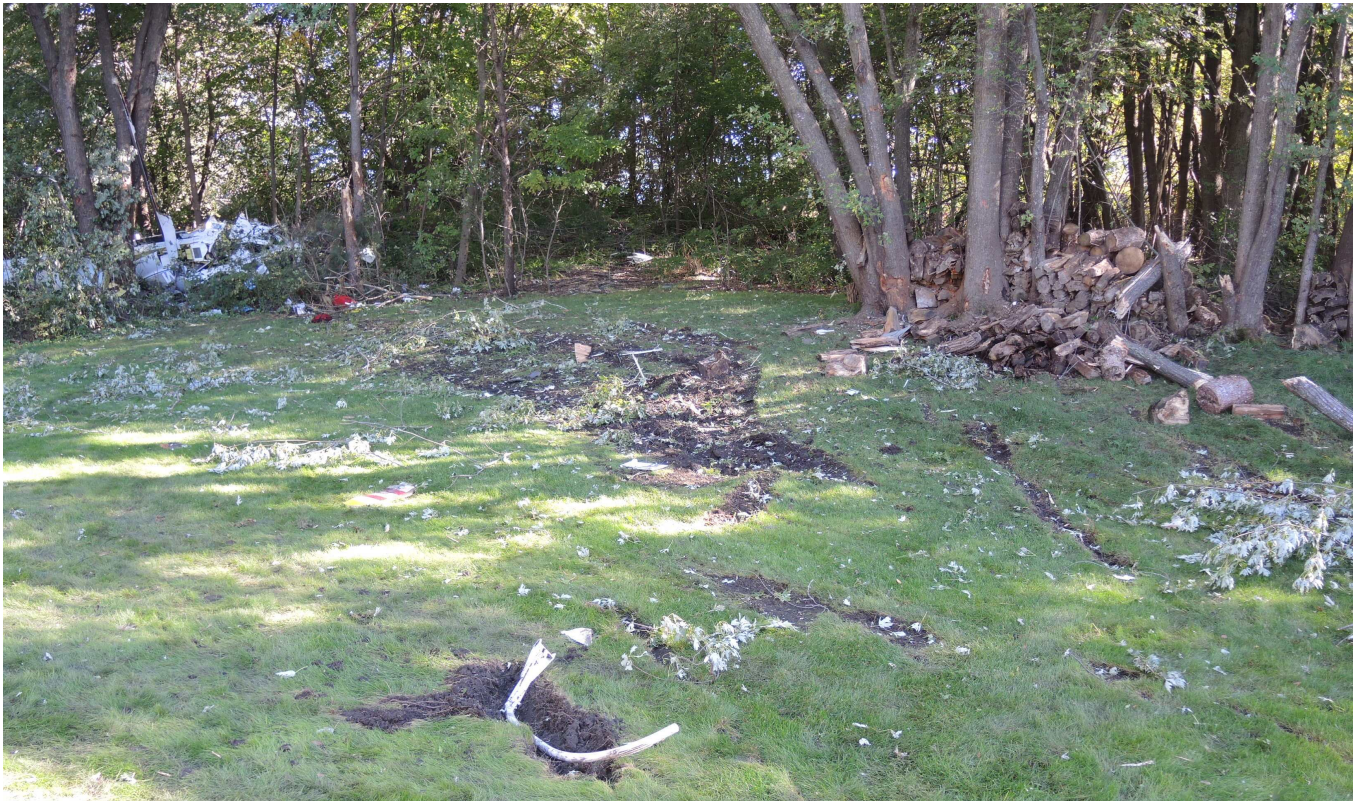
Figure 2 – Accident Site

The helicopter impacted the tops of several tall trees and the ground, then continued into a wooded area (figure 2). Several nearby residents were awake at the time of the accident and heard the helicopter's engines and then the sound of the impact.

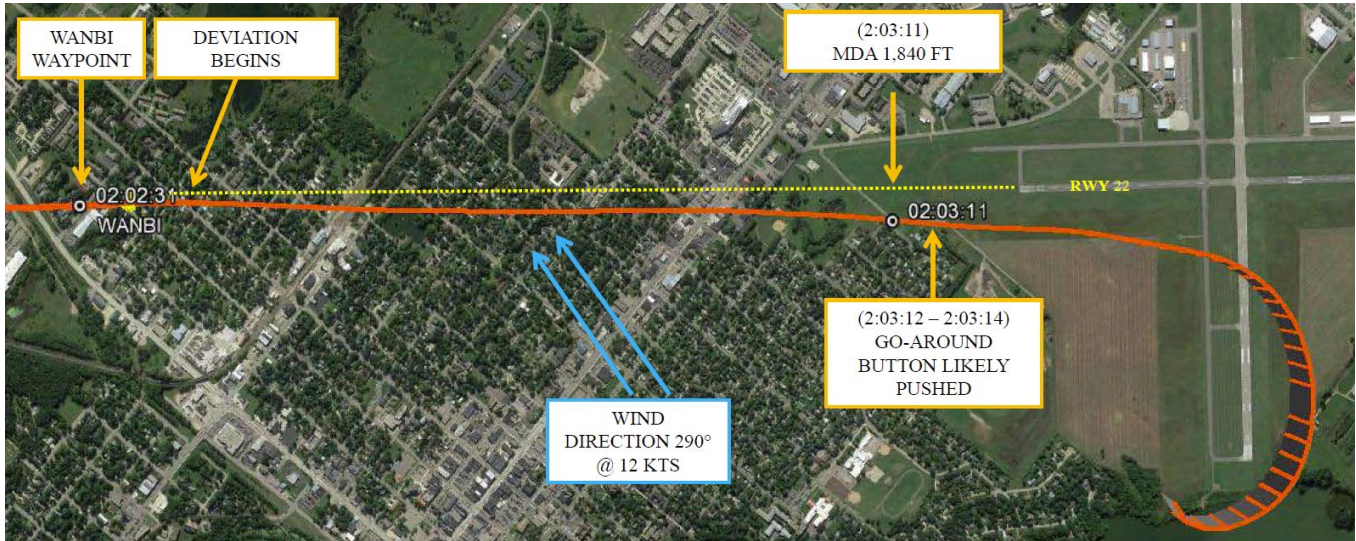
Figure 3 – Flight Path

A review of the recorded flight data revealed that the flight path was in line with the GPS approach course and followed the respective waypoints. The helicopter intercepted the approach's last waypoint, WANBI, at 02:02:31 then the flight path started to deviate right of course (figure 3). The flight path continued toward AXN while maintaining the slight right deviation until 02:03:11 when the helicopter reached 1,840 ft, which is the approach's minimum descent altitude. Between 02:03:12 and 02:03:14 the collective position percentage increases, which is consistent with the reported go-around maneuver (figure 4). The helicopter descends to 1,740 ft until a climb began at 02:03:17. The helicopter climbed and turned right with a maximum bank angle of 50°. The flight path continued right as the helicopter then descended and the collective position continued to increase.

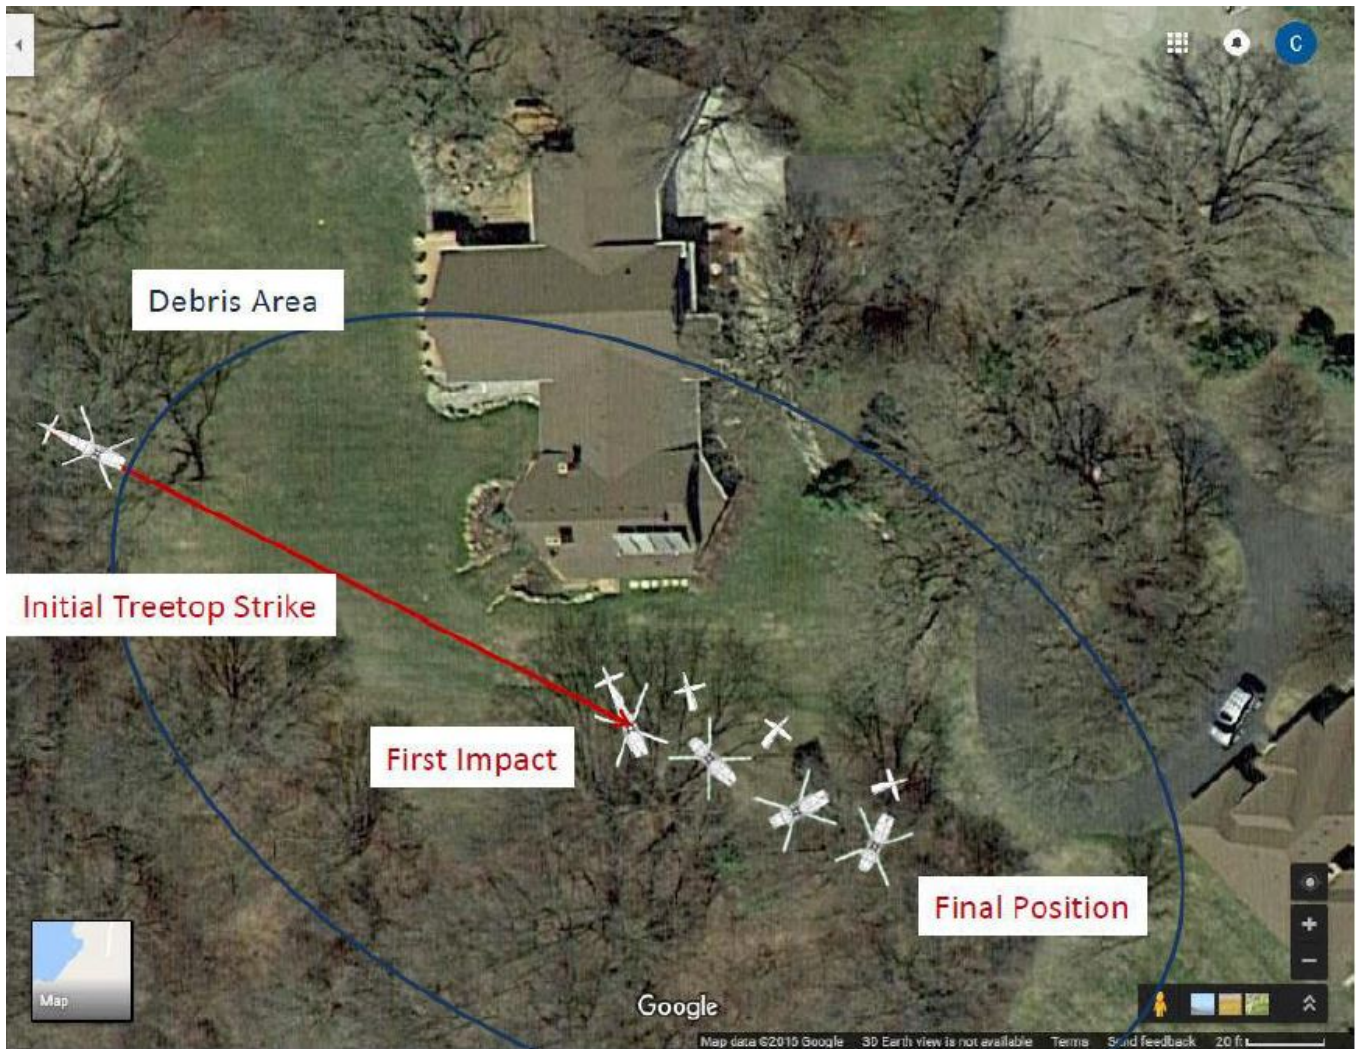
Figure 5 – Wreckage Diagram

The accident site was located in a residential area surrounded by trees about 1,000 yards northwest of the approach end of AXN's runway 22 (figure 5). The debris path was about 130 yards long and began with lopped tree tops (95 to 100 ft tall) and ended about 30 yards beyond the main wreckage. The middle of the debris path was in a back yard of a residence and consisted of lopped tree tranches, fragmented main rotor blades, and pieces of the helicopter. The initial impact marks were several parallel ground scars followed by the helicopter's tail skid in an impact crater. The debris path continued with a large ground impact area that contained helicopter pieces, followed by the main wreckage. The fuselage came to rest on its left side, was separated aft of the engines, and wrapped around two trees. The right side of the fuselage exhibited ground impact damage and mud smearing. The tail and aft portion of the rear fuselage were pointing in an opposite direction from the fuselage. The bottom of the tail contained mud smearing and splatter marks near the tail rotor. The right pilot seat and one passenger seat pan had separated from their respective mounts.
