Aviation Investigation Final Report

Location:	Broadus, Montana	Accident Number:	WPR16FA182
Date & Time:	September 17, 2016, 12:36 Local	Registration:	N413D
Aircraft:	Beech 95 B55 (T42A)	Aircraft Damage:	Substantial
Defining Event:	Unknown or undetermined	Injuries:	3 Fatal
Flight Conducted Under:	Part 91: General aviation - Personal

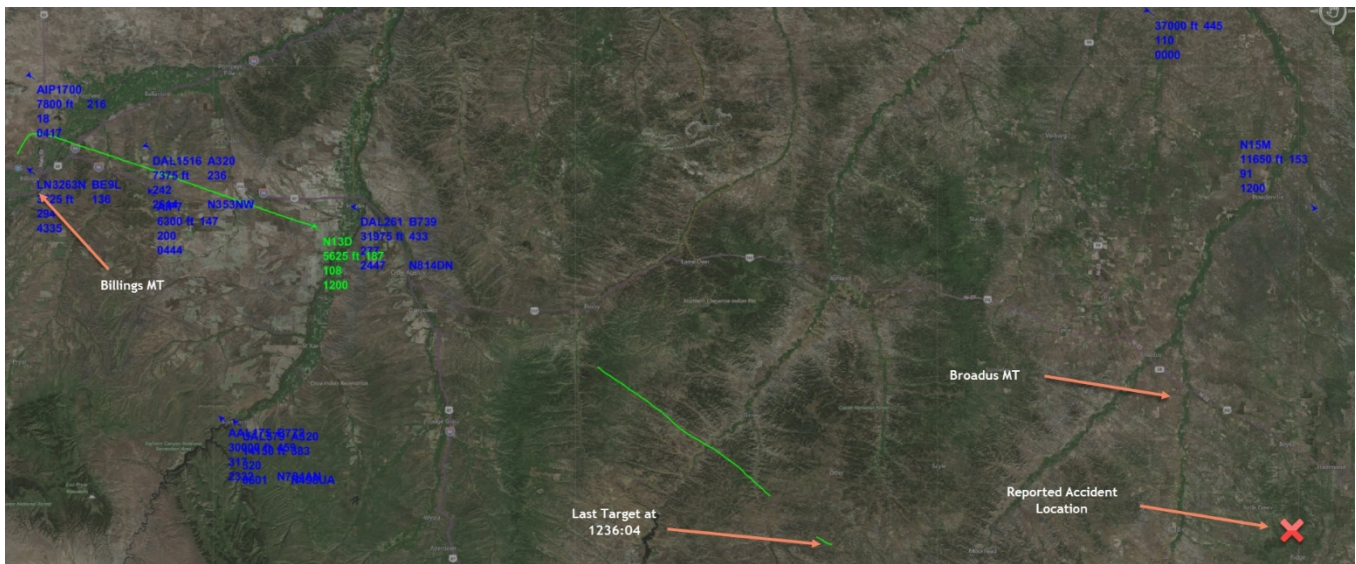
Figure 1 - OpsVue flight track of the accident airplane.

Track data for the flight was obtained from Harris OpsVue, which uses Federal Aviation Administration (FAA) radar data and applies an altimeter correction to estimate altitude. The altitude data may have an error of +/-300 ft.

The OpsVue data indicated the airplane departed BIL, about noon, squawking a transponder code of

0456, and made a right turn toward the southeast. About 6 minutes later, the airplane had climbed to an altitude of 5,500 to 5,600 ft. and began squawking a transponder code of 1200. Track data consistent with the accident airplane continued for about 13 minutes.

No data was available between 1213:13 and 1225:03; data consistent with the airplane's course then resumed at an altitude of about 5,800 ft and continued on the southeast course for about 36.5 nautical miles (nm). No data was available between 1233:04 and 1235:28; another track then began at an altitude of 5,800 ft, still heading southeast and about 7.3 nm from where the track stopped. At 1235: 57, the track started a left turn with data ending at 1236:04 at an altitude of 5,800 ft. The last data point was located about 43.35 nautical miles southwest of Broadus, Montana.
