# Aviation Investigation Final Report

<b>Location:</b>	Iola, Kansas	<b>Accident Number:</b>	CEN17LA009
<b>Date &amp; Time:</b>	October 1, 2016, 17:35 Local	<b>Registration:</b>	N38DM
<b>Aircraft:</b>	AERO SMART SOLUTIONS INC LANCAIR EVOLUTION	<b>Aircraft Damage:</b>	Substantial
<b>Defining Event:</b>	Fuel contamination	<b>Injuries:</b>	1 Minor, 1 None
<b>Flight Conducted Under:</b>	Part 91: General aviation - Personal

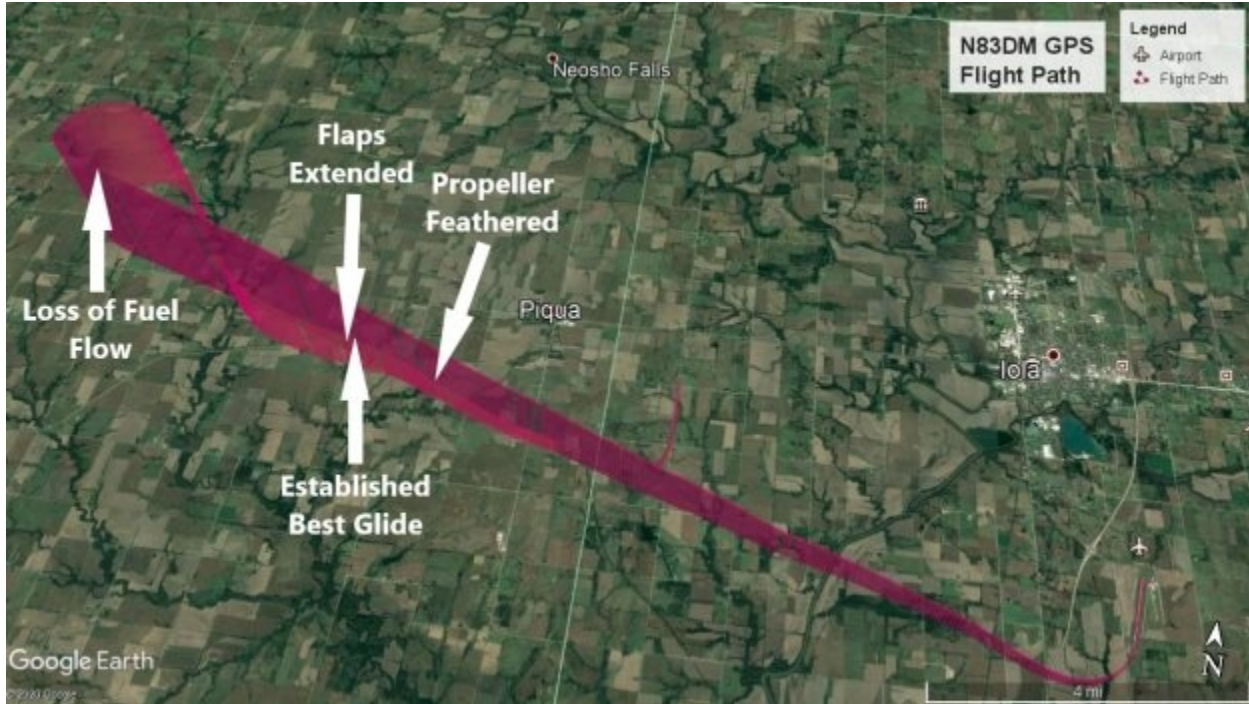
Figure 1: Plot of Flight Track with Control Inputs Depicted

The pilot's operating handbook (POH) recommended that the configuration for a forced landing is landing gear up, flaps up, propeller feathered, and airspeed at 110 knots to achieve maximum glide performance. This configuration provides a maximum glide performance of about 500 ft per minute (fpm) descent and about 3.5 nautical miles glide distance per 1,000 ft of altitude lost. Data from the engine monitoring system revealed that, about 3 minutes after the fuel flow stopped and about 2-3 minutes before the accident, the flaps were extended to takeoff position, the airplane achieved 110 kts, and the propeller was feathered. During this time, the rate of descent exceeded 1,000 fpm and was, at times, in excess of 4,000 fpm. The pilot did not mention of the use of an emergency engine-out checklist or consultation of the POH during the event. The pilot's failure to accomplish all of the steps in the emergency engine-out checklist promptly after the loss of engine power led to an accelerated loss of altitude and the subsequent inability to glide to the airport.

The raw, unsmoothed data from the engine monitoring system indicated normal flight parameters until 17:29:35 when the fuel flow abruptly dropped to zero. The flaps were extended at 17:32:33 to about 16°, or takeoff position, and remained at 16° until the end of the flight. The airplane achieved 110 knots, best glide speed, at 17:32:35. The propeller was feathered at 17:33:10. Figure 1 depicts these events during the flight. From 17:29:48 until 17:33:18 the rate of descent exceeded 1,000 ft per minute (fpm) and was, at times, in excess of 4,000 fpm. During that 3.5-minute period, the airplane descended from about 11,900 ft to about 3,560 ft, an average descent rate of nearly 2,300 ft per minute.

In multiple statements provided by the pilot, there was no mention of the use of an emergency engine out checklist or consultation of the pilot operating handbook (POH) during the event.
