Aviation Investigation Final Report

Location:	Hurt, Virginia	Accident Number:	ERA16LA333
Date & Time:	September 27, 2016, 17:45 Local	Registration:	N5327K
Aircraft:	Ryan Navion	Aircraft Damage:	Substantial
Defining Event:	Powerplant sys/comp malf/fail	Injuries:	1 None
Flight Conducted Under:	Part 91: General aviation - Personal

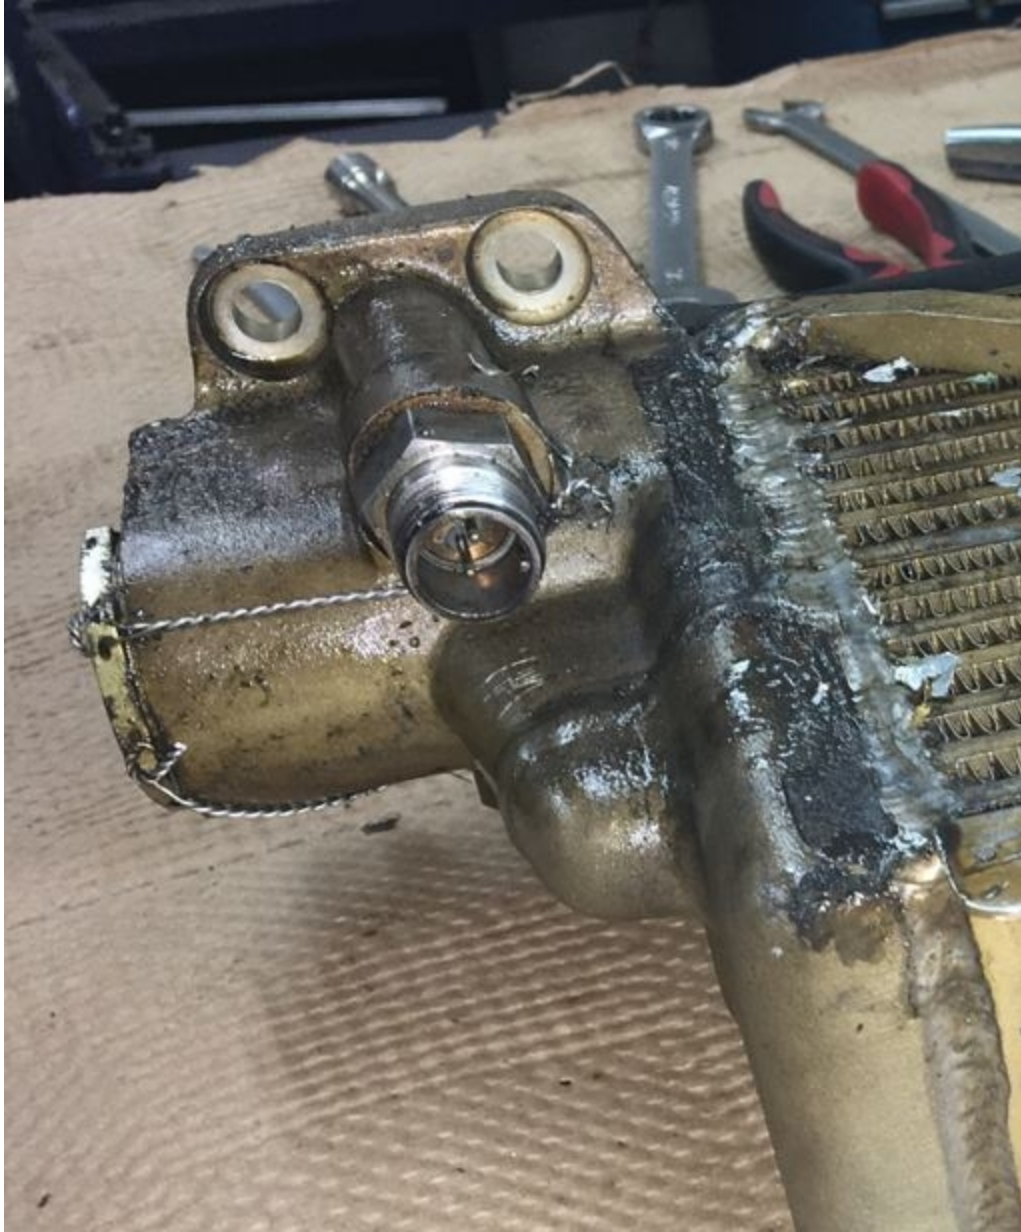
Figure 1. Oil Temperature Probe

Incorrect installation of the oil temperature probe and an inadequate annual inspection that failed to detect leaking oil around the loose probe, which resulted in a catastrophic engine failure due to oil starvation.

Examination of the airplane by a Federal Aviation Administration inspector revealed that the right wing leading edge sustained substantial damage, and fence wire was wrapped around the propeller flange. The top left side of the engine crankcase was damaged, and there were holes in the crankcase near cylinder Nos. 6, 4 and 2. A connecting rod protruded through the hole near cylinder No. 4. No oil was present in the crankcase. A teardown examination of the engine was subsequently performed at the manufacturer's facility, under the supervision of a National Transportation Safety Board investigator. The examination revealed that the internal engine components exhibited heat distress consistent with a lack of lubrication. Further examination revealed that the oil temperature probe was safety wired, however it could be moved by hand. An air pressure hose was attached to the oil cooler and when 30 psi was applied, bubbles were noted around the crush washer seal of the oil temperature probe. Oil residue was also noted all over the oil cooler and surrounding area of the engine. See Figure 1. The oil temperature probe was removed, and the crush washer was found installed backwards.

The temperature probe was considered an airframe item and was not installed by the engine manufacturer. The engine was delivered with a plug in the oil temperature probe port, and the installer could remove the plug and replace it with an oil temperature probe. A review of the 1951 Navion B Service Manual revealed no specific torque values for tightening the oil temperature probe. The maintenance manual for the accident engine provided a torque range for the oil temperature port plug (with crush washer), as 190 in/lbs to 210 in/lbs. The version of the manual in effect at the time of the accident did not specify the orientation of crush washers.
