# Aviation Investigation Final Report

<b>Location:</b>	Blackshear, Georgia	<b>Accident Number:</b>	ERA17FA027
<b>Date &amp; Time:</b>	October 21, 2016, 14:30 Local	<b>Registration:</b>	N10EB
<b>Aircraft:</b>	Nanchang CJ6	<b>Aircraft Damage:</b>	Substantial
<b>Defining Event:</b>	Midair collision	<b>Injuries:</b>	1 Fatal
<b>Flight Conducted Under:</b>	Part 91: General aviation - Personal

<b>Location:</b>	Blackshear, Georgia	<b>Accident Number:</b>	ERA17FA027
<b>Date &amp; Time:</b>	October 21, 2016, 14:30 Local	<b>Registration:</b>	N33CY
<b>Aircraft:</b>	Nanchang CJ6	<b>Aircraft Damage:</b>	Minor
<b>Defining Event:</b>	Midair collision	<b>Injuries:</b>	2 None
<b>Flight Conducted Under:</b>	Part 91: General aviation - Personal

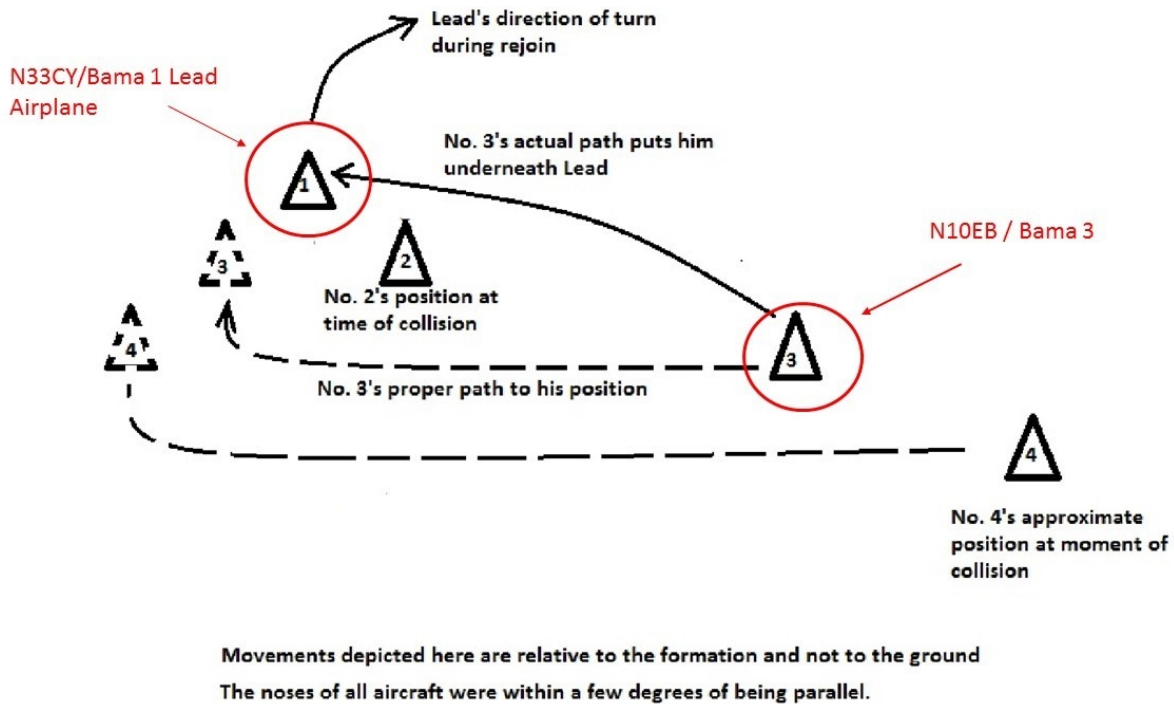
Bama 3 was expected to maneuver toward the left formation spot on the outside of the turn and off the left wing of Bama 1 (see figure 1). Bama 4 was following about 1,000 ft behind Bama 3 and had not yet performed his rejoin maneuver. The Bama 1 pilot reported that he saw Bama 3 approaching from the right at an acute angle (forward of the desired bearing line and at a high aspect angle), at a high rate of closure, and the pilot was not adjusting the airplane's flight path. The Bama 1 pilot announced on the radio, "Bama [3] you are overshooting. Take it to the outside!" The Bama 1 pilot further reported that Bama 3 had "disappeared under my [airplane's] right front." The Bama 1 pilot then looked to the left because he expected to see Bama 3 emerge from under his airplane and continue the lateral movement outside of the formation's turn, but instead the collision occurred.

Figure 1. Bama 1 pilot's depiction of the formation of airplanes before the accident. Red annotations added for clarity.

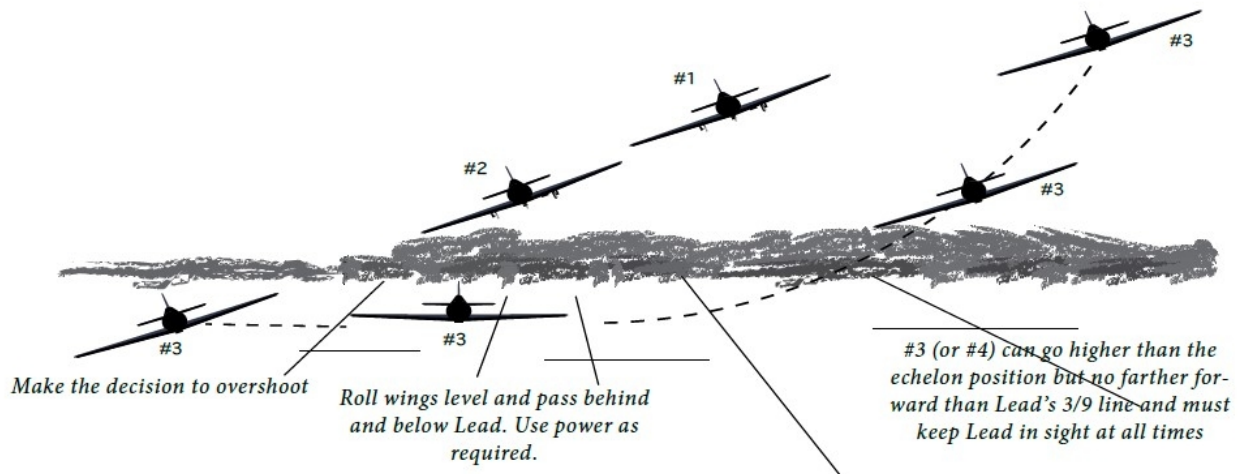
Figure 2. Overshoot maneuver depicted in Red Star Pilots Association formation manual. The figure represents a left-hand turn and does not represent the accident formation flight.

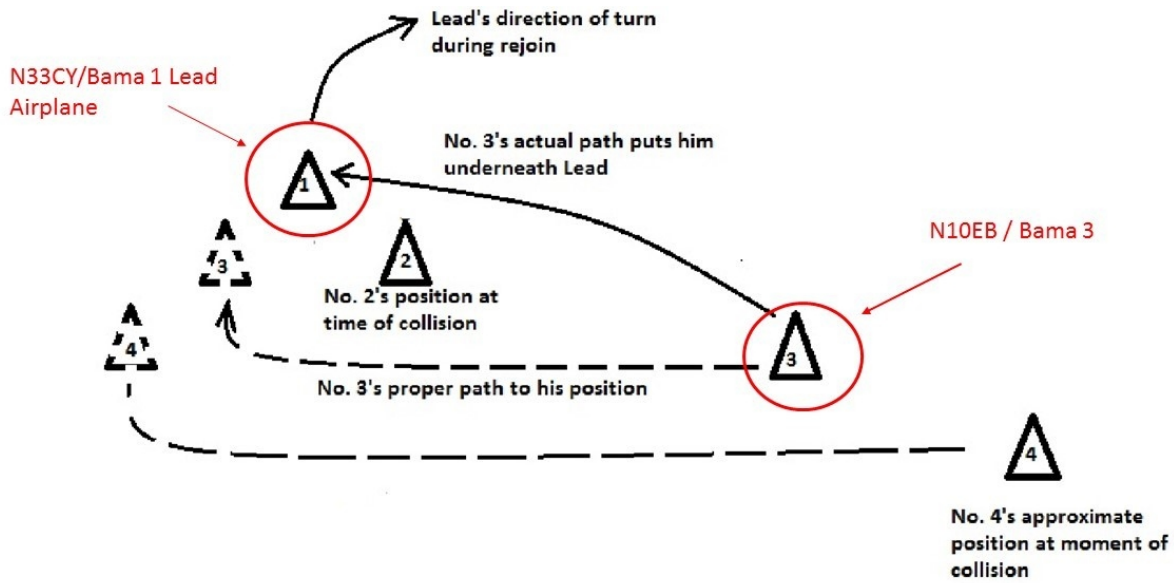
Movements depicted here are relative to the formation and not to the ground  
 The noses of all aircraft were within a few degrees of being parallel.

Figure 2. Overshoot maneuver depicted in Red Star Pilots Association formation manual. The figure represents a left-hand turn and does not represent the accident formation flight.
