Aviation Investigation Final Report

Location:	Seattle, Washington	Incident Number:	ENG171A003
Date & Time:	October 26, 2016, 15:50 Local	Registration:	N855NW
Aircraft:	Airbus A330 223	Aircraft Damage:	None
Defining Event:	Powerplant sys/comp malf/fail	Injuries:	120 None
Flight Conducted Under:	Part 121: Air carrier - Scheduled

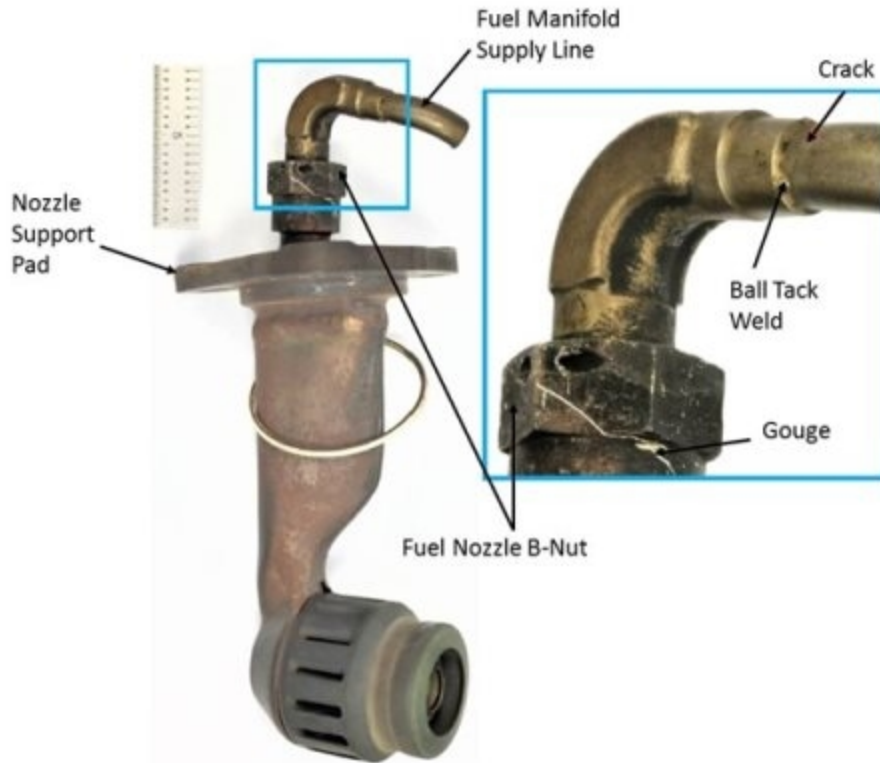
Figure 1- Fuel Nozzle No. 1 and Fuel Manifold Supply Line Section

The No. 1 engine fire was caused by a fuel leak that originated from a high cycle fatigue crack on the fuel nozzle No. 1 fuel manifold supply line. Fuel nozzle No. 1 is located at the 12 o'clock position on the engine, so the fuel that leaked from the crack ran down the diffuser case and ignited on the engine case surface. The diffuser case reaches high enough temperatures during engine operation to auto-ignite Jet A fuel. The greatest concentration of soot/discoloration was observed from the 6 to 9 o'clock positions between the forward flange of the HPT case to the aft flange of the diffuser case, consistent with fuel collecting at the bottom of the engine and in the lower half of the thrust reverser cowls and creating a rich fuel to air mixture.

fuel leak that subsequently ignited on hot engine case surfaces. The fatigue crack originated and progressed due to elevated fuel manifold assembly vibration levels. Engine vibration testing identified a combustor tone that excites a natural (resonant) frequency of the fuel manifolds at specific engine speeds on Pratt & Whitney PW4000-94 and -100 inch fan series engines that feature a TALON II combustor.

A visual and binocular examination identified a crack that originated from the run out of the braze fillet around the toe of a ball tack weld (**Figure 1**). Scanning electron microscopy was used to examine the crack surface features and they were consistent with high cycle fatigue (HCF). There were no defects or material damage on the manifold supply line near the crack origin. A test of the manifold supply line material confirmed the material met drawing specification. The braze joint where the manifold supply line joins the elbow fitting had sufficient coverage and no voids in the braze material were observed. A complete copy of the materials laboratory report is available in the docket under the title "Pratt & Whitney Materials & Processes Engineering Metallurgical Investigation of Fuel Triplet and Fuel Nozzle from PW4168 Engine P733619."

On November 8, 2017, P&W released SB PW4ENG-73-224 recommending the installation of fuel manifold brackets and clamps on PW4000-94 inch fan engines with TALON II combustors. The FAA issued AD 2019-06-02 on March 26, 2019 to mandate the SB. The AD has the same compliance requirements as those recommended in the SB and the AD effective date was April 30, 2019. Additional information about SB and AD scope and compliance is included in the NTSB powerplants group chairman's factual report in the docket.

On March 14, 2018, P&W released service bulletin (SB) PW4G-A73-48 recommending the installation of brackets and clamps on the fuel manifold assemblies to dampen the resonant vibratory response to a combustor tone on PW4000-100 inch fan engines with TALON II combustors. The FAA mandated the installation of the fuel manifold brackets and clamps with airworthiness directive (AD)-2019-06-07 on March 28, 2019.
