# Aviation Investigation Final Report

<b>Location:</b>	Fort Lauderdale, Florida	<b>Accident Number:</b>	DCA17MA022
<b>Date &amp; Time:</b>	October 28, 2016, 17:51 Local	<b>Registration:</b>	N370FE
<b>Aircraft:</b>	McDonnell Douglas MD 10-10F	<b>Aircraft Damage:</b>	Substantial
<b>Defining Event:</b>	Landing gear collapse	<b>Injuries:</b>	2 None
<b>Flight Conducted Under:</b>	Part 121: Air carrier - Non-scheduled

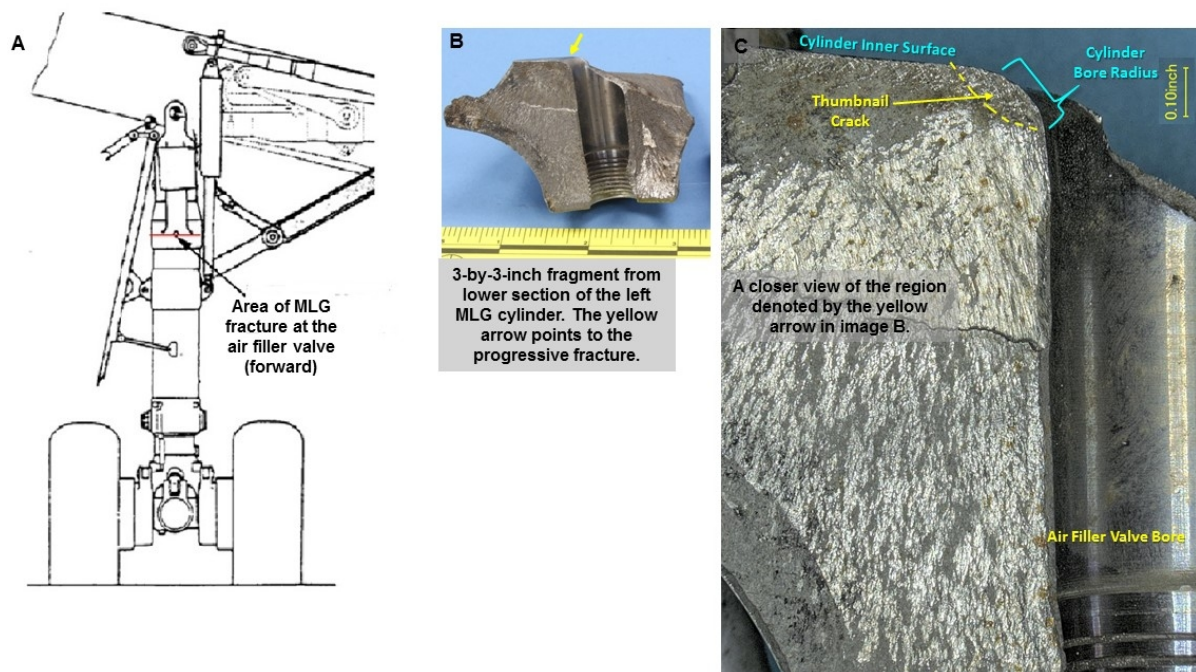
Metallurgical examination of a 3-by-3-inch fragment of the left MLG cylinder (see images B and C in figure 1) and the mating fracture region on the largest piece of the fractured left MLG (see figure 2) found indications consistent with overstress fracture having emanated from the air filler valve bore. The overstress features emanated from a small thumbnail crack, located at the radius between the cylinder inner diameter surface and the air filler valve bore surface. This thumbnail crack was observed on both mating fracture surfaces of the MLG and the 3-by-3-inch fragment, and it exhibited features (such as crack arrest marks) consistent with a pre-existing crack that progressed to fracture of the MLG. The observed features in the initiation region of the thumbnail crack were found to be consistent with fatigue cracking, as exhibited by the fatigue striations observed during microscopic examination. Later propagation regions of the thumbnail crack revealed features consistent with mixed mode fatigue, overstress, and intergranular fracture. These findings confirmed that once the crack progressed to a critical length, the left MLG cylinder fractured in overstress due to the loads imposed during landing.

Figure 1. A diagram of an MD-10-10F left MLG (A), photograph of the 3-by-3-inch fragment from the lower section of the accident left MLG cylinder (B), and closer view of the region pointed out in image B (C).

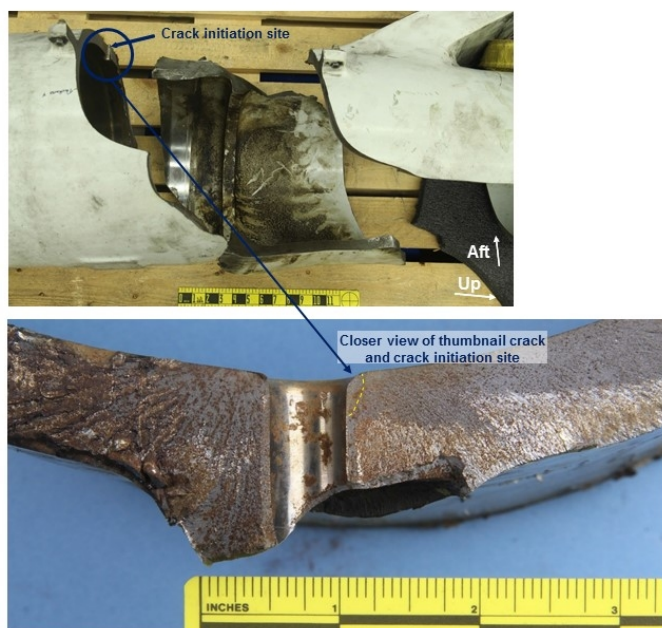
Figure 2. Photographs of largest piece of fractured left MLG pointing to the crack initiation site (top) and a closer view of the crack initiation site, with a yellow dashed line highlighting the mating thumbnail crack (bottom).

The most prominent quality of the crack initiation site was a feature consistent with a corrosion pit. No indications of nickel, chrome, or cadmium plating were found at the radius or along the smooth sections of the air filler valve bore, as stipulated by maintenance instructions. The absence of a protective coating, over time, could lead to corrosion pitting. Any corrosion pitting or mechanical damage to the protective coating incurred during maintenance can lead to fatigue cracking.

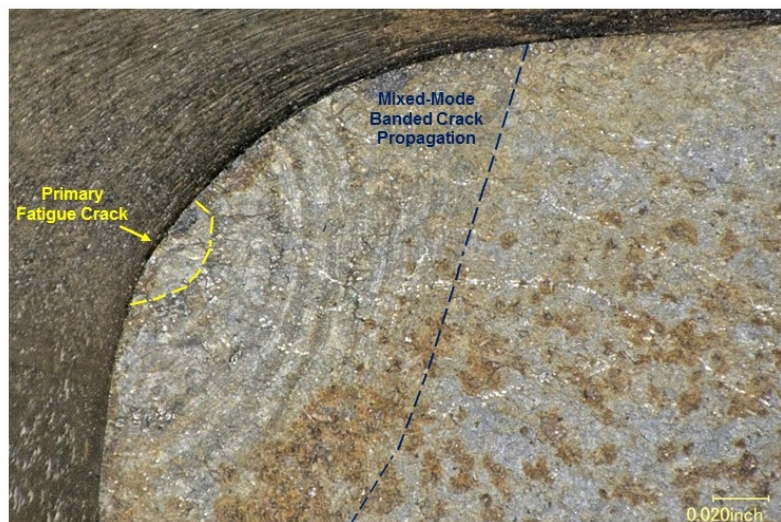
Figure 3. Closer view of the primary fatigue crack region (highlighted by the dashed yellow line) and the region of mixed-mode crack propagation (highlighted by the dashed blue line).

The examination also found that the thumbnail crack was not exclusively consistent with fatigue crack propagation, but rather contained bands of other failure modes. After the initial fatigue cracking from the crack initiation site, an intergranular fracture band surrounded the first 0.02 inch of fatigue, followed by a band of fatigue striations. After this, three overstress bands (exhibiting dimple rupture features) alternating with fatigue were observed, followed by a final mixed fatigue and overstress band (see Fatigue Analysis later in this section for more information). The distance from the fatigue crack to the intergranular region measured 0.019 inch. The measured width of the intergranular band was 0.013 inch.

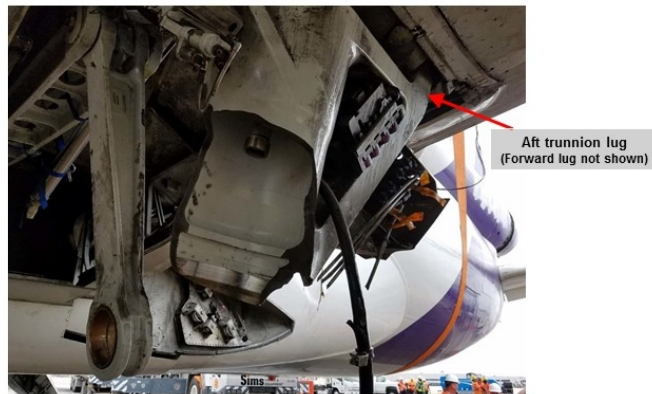
The airplane came to rest off the left side of runway 10L near the A4 taxiway. The outer cylinder of the left MLG was fractured midway through the air filler valve bore on the aft side. The outer cylinder of the left MLG shock strut fractured around its entire circumference; the upper portion of the cylinder remained intact and attached to the airplane at the forward and aft trunnion lugs (figure 1 shows a diagram of an MD-10-10F MLG and figure 2 shows the upper portion of the accident MLG). No anomalies were noted with the trunnion lugs or trunnion bolt attachment points.

Figure 2. Upper portion of the left MLG attached to the airplane.

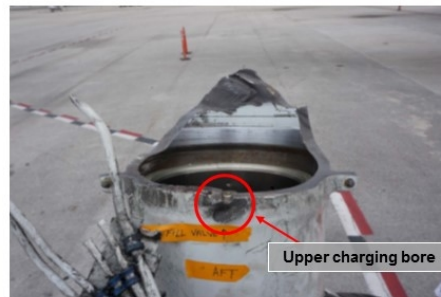
The inboard side lugs and bolt and nut for the retract actuator attach points and the fixed door attach points remained intact. On the aft side of the lower section of the fractured gear, about half of the upper charging bore was visible (see figure 3). On-scene examination identified features consistent with fatigue on the fracture surface of the outer cylinder in the area of the air filler valve bore (see Tests and Research for more information).

Figure 3. Aft side of the lower section of the left MLG cylinder and fill valve.

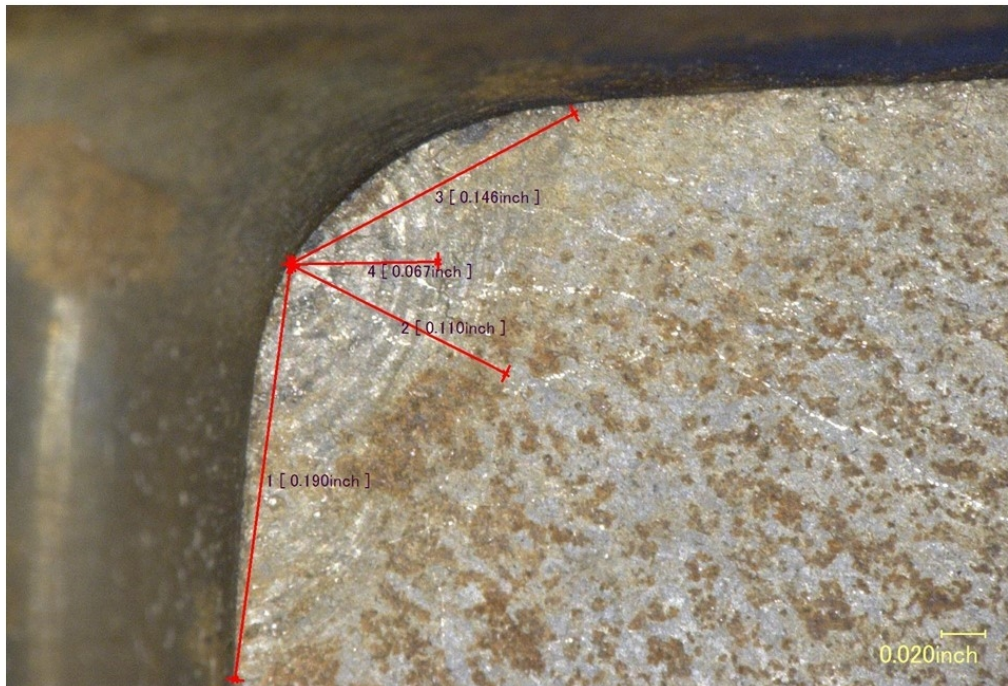
The estimated total number of cycles for each band are summarized below (figure 4 shows a closeup view of the fatigue striation region); the number in parentheses represents the total striation quantity summation to that point:

- Striation count in 1st fatigue thumbnail (origin to intergranular band): 526
- Striation count in 1st fatigue thumbnail (intergranular band to overstress band 1): 165 (691 total to this point)
- Striation count before overstress band 1: 691
- Striation count in 2nd band: 253 (944)
- Striation count in 3rd band: 242 (1186)
- Striation count in 4th band: 218 (1404)

Figure 4. A closeup view of the fatigue striation region.
