Aviation Investigation Final Report

Location:	Fort Lauderdale, Florida	Accident Number:	DCA17MA022
Date & Time:	October 28, 2016, 17:51 Local	Registration:	N370FE
Aircraft:	McDonnell Douglas MD 10-10F	Aircraft Damage:	Substantial
Defining Event:	Landing gear collapse	Injuries:	2 None
Flight Conducted Under:	Part 121: Air carrier - Non-scheduled

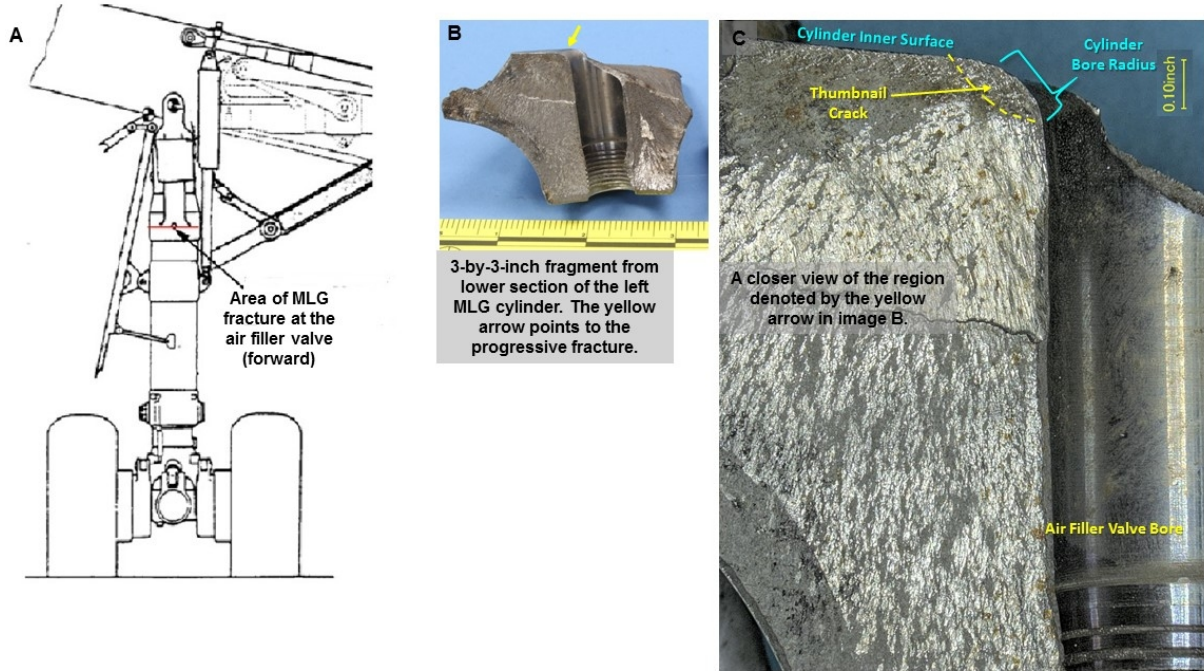
Metallurgical examination of a 3-by-3-inch fragment of the left MLG cylinder (see images B and C in figure 1) and the mating fracture region on the largest piece of the fractured left MLG (see figure 2) found indications consistent with overstress fracture having emanated from the air filler valve bore. The overstress features emanated from a small thumbnail crack, located at the radius between the cylinder inner diameter surface and the air filler valve bore surface. This thumbnail crack was observed on both mating fracture surfaces of the MLG and the 3-by-3-inch fragment, and it exhibited features (such as crack arrest marks) consistent with a pre-existing crack that progressed to fracture of the MLG. The observed features in the initiation region of the thumbnail crack were found to be consistent with fatigue cracking, as exhibited by the fatigue striations observed during microscopic examination. Later propagation regions of the thumbnail crack revealed features consistent with mixed mode fatigue, overstress, and intergranular fracture. These findings confirmed that once the crack progressed to a critical length, the left MLG cylinder fractured in overstress due to the loads imposed during landing.

Figure 1. A diagram of an MD-10-10F left MLG (A), photograph of the 3-by-3-inch fragment from the lower section of the accident left MLG cylinder (B), and closer view of the region pointed out in image B (C).

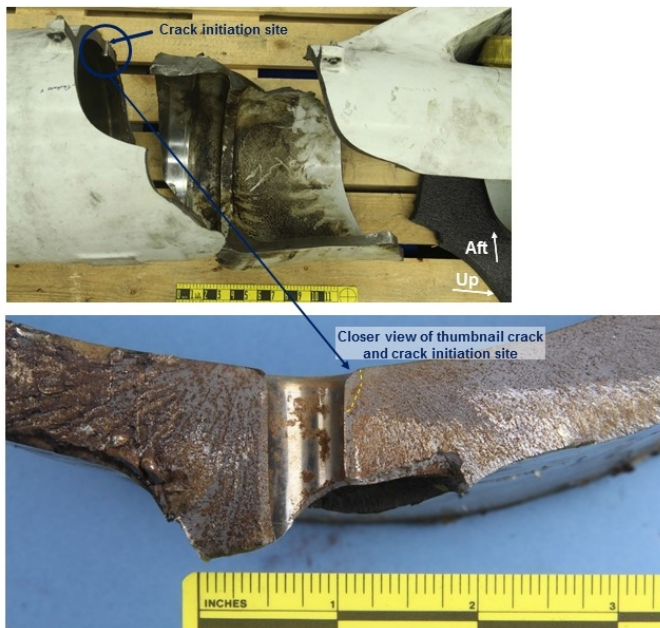
Figure 2. Photographs of largest piece of fractured left MLG pointing to the crack initiation site (top) and a closer view of the crack initiation site, with a yellow dashed line highlighting the mating thumbnail crack (bottom).

The most prominent quality of the crack initiation site was a feature consistent with a corrosion pit. No indications of nickel, chrome, or cadmium plating were found at the radius or along the smooth sections of the air filler valve bore, as stipulated by maintenance instructions. The absence of a protective coating, over time, could lead to corrosion pitting. Any corrosion pitting or mechanical damage to the protective coating incurred during maintenance can lead to fatigue cracking.

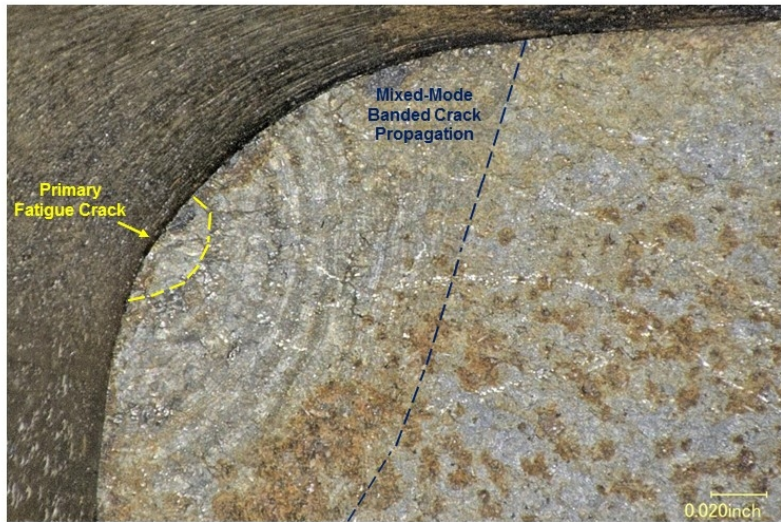
Figure 3. Closer view of the primary fatigue crack region (highlighted by the dashed yellow line) and the region of mixed-mode crack propagation (highlighted by the dashed blue line).

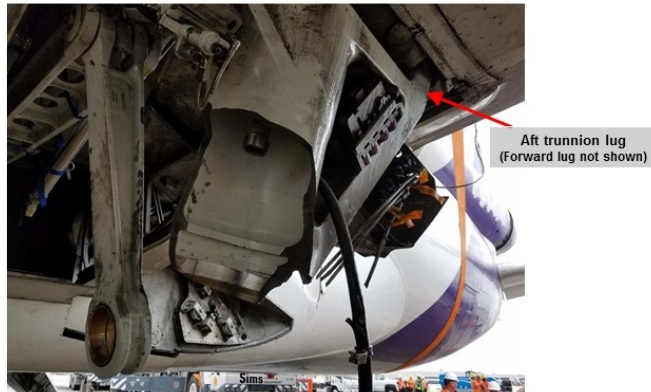
The airplane came to rest off the left side of runway 10L near the A4 taxiway. The outer cylinder of the left MLG was fractured midway through the air filler valve bore on the aft side. The outer cylinder of the left MLG shock strut fractured around its entire circumference; the upper portion of the cylinder remained intact and attached to the airplane at the forward and aft trunnion lugs (figure 1 shows a diagram of an MD-10-10F MLG and figure 2 shows the upper portion of the accident MLG). No anomalies were noted with the trunnion lugs or trunnion bolt attachment points.

Figure 2. Upper portion of the left MLG attached to the airplane.

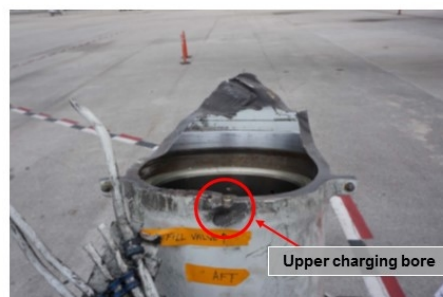
The inboard side lugs and bolt and nut for the retract actuator attach points and the fixed door attach points remained intact. On the aft side of the lower section of the fractured gear, about half of the upper charging bore was visible (see figure 3). On-scene examination identified features consistent with fatigue on the fracture surface of the outer cylinder in the area of the air filler valve bore (see Tests and Research for more information).

Figure 3. Aft side of the lower section of the left MLG cylinder and fill valve.
