# Aviation Investigation Final Report

<b>Location:</b>	Camilla, Georgia	<b>Accident Number:</b>	ERA17FA066
<b>Date &amp; Time:</b>	December 5, 2016, 22:22 Local	<b>Registration:</b>	N765FA
<b>Aircraft:</b>	Fairchild SA227	<b>Aircraft Damage:</b>	Destroyed
<b>Defining Event:</b>	Loss of control in flight	<b>Injuries:</b>	1 Fatal
<b>Flight Conducted Under:</b>	Part 135: Air taxi & commuter - Non-scheduled

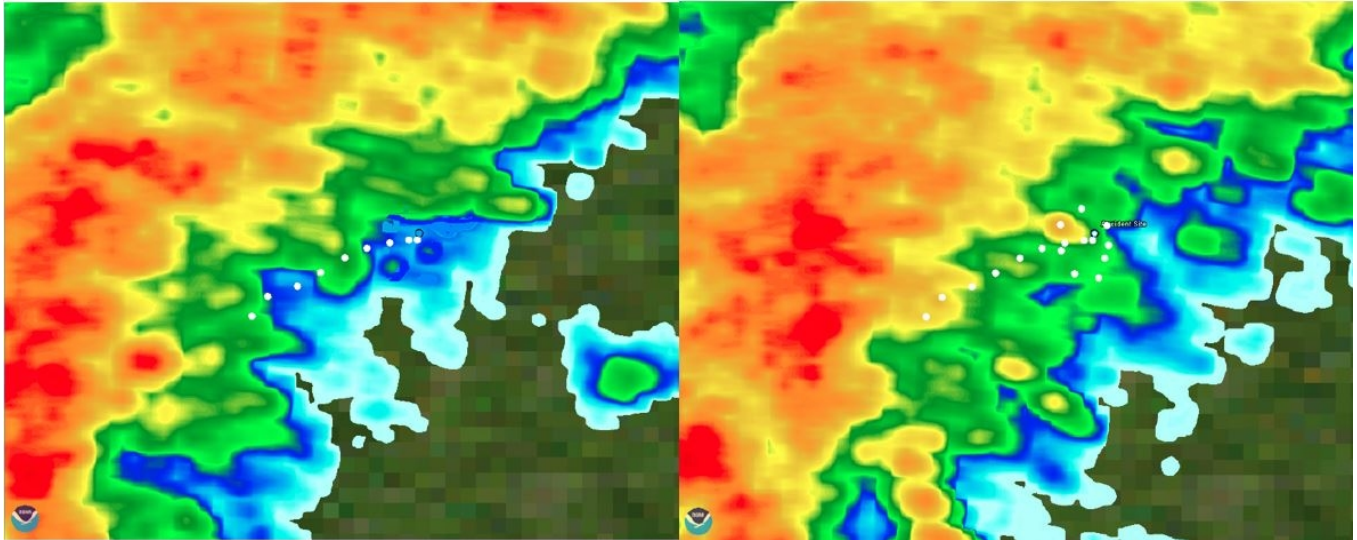
The KTLH WSR-88D base reflectivity image for the 0.5° elevation scan at 2221:47 (see Figure 1) showed the accident flight as it tracked along the leading edge of a line of heavy-intensity echoes, and operating in echoes of 5 to 20 dBZ, or light intensity precipitation. The next base reflectivity image for the 0.5° elevation scan at 2228:12 showed rapidly-developing echoes over the preceding flight track (which ended at 2222:24 in the vicinity of the accident site), with intensities of up to 43.5 dBZ or heavy-intensity precipitation.

Figure 1 - WSR-88D 0.5° base reflectivity image at 2221:47 (left) and 2228:12 (right) with radar-derived flight track overlaid (white dots).
