# Aviation Investigation Final Report

<b>Location:</b>	Port Orange, Florida	<b>Accident Number:</b>	ERA17FA074
<b>Date &amp; Time:</b>	December 27, 2016, 17:56 Local	<b>Registration:</b>	N669WR
<b>Aircraft:</b>	INDEPENDENT TECHNOLOGIES INC EPIC LT	<b>Aircraft Damage:</b>	Substantial
<b>Defining Event:</b>	Loss of control in flight	<b>Injuries:</b>	2 Fatal
<b>Flight Conducted Under:</b>	Part 91: General aviation - Personal

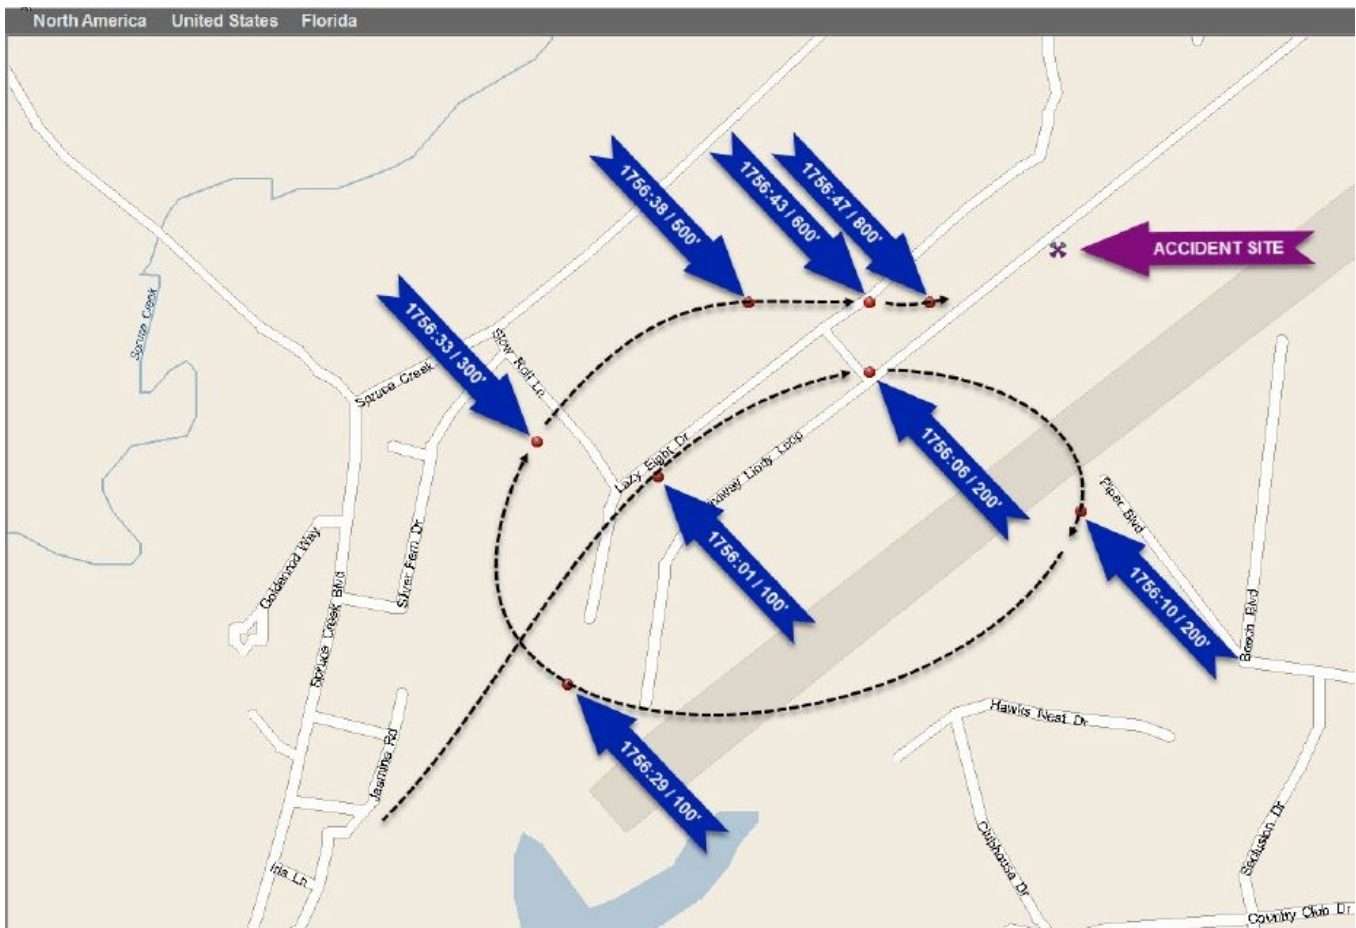
Figure 1. Radar Flight Track of Attempted Landing at 7FL6.

Based on radar information and statements from witnesses, the pilot's approach to the airport was unstabilized. He descended below the minimum descent altitude of 440 ft, and, after breaking through the fog about 100 ft agl, the airplane reentered the fog and completed a 360° right turn near the approach end of the runway, during which its altitude varied from 100 ft to 300 ft. The airplane then climbed to an altitude about 800 ft before radar contact was lost near the accident site. The airplane came to rest inverted, consistent with one witness's statement that it descended through the clouds in a spin before impact; postaccident examination revealed no preimpact anomalies with the airplane or engine that would have precluded normal operation. Although the pilot was instrument rated, his recent instrument experience could not be established.

A review of radar data revealed that, during the final 46 seconds of flight, the airplane approached the airport on a northeasterly heading just north of the final approach course. At 1756:01, the airplane was abeam the runway numbers at an altitude of 100 ft mean sea level (msl) (76 ft above ground level) before it initiated a climbing right turn. During the turn, the airplane initially climbed to 200 ft msl then descended to 100 ft msl before climbing up to 300 ft. After completing a 360° turn, the airplane began to climb on a northeasterly heading. Over the next 14 seconds, the airplane climbed to 800 ft, while making a shallow turn to the right followed by a turn to the left before the data ended at 1756:47. The last radar return was near-coincident with the location of the accident site (See figure 1).
