Aviation Investigation Final Report

Location:	Mt. Wilson, California	Incident Number:	OPS171A010
Date & Time:	December 16, 2016, 01:25 Local	Registration:	B-16726
Aircraft:	Boeing 777	Aircraft Damage:	None
Defining Event:	Air traffic event	Injuries:	N/A
Flight Conducted Under:	Part 129: Foreign

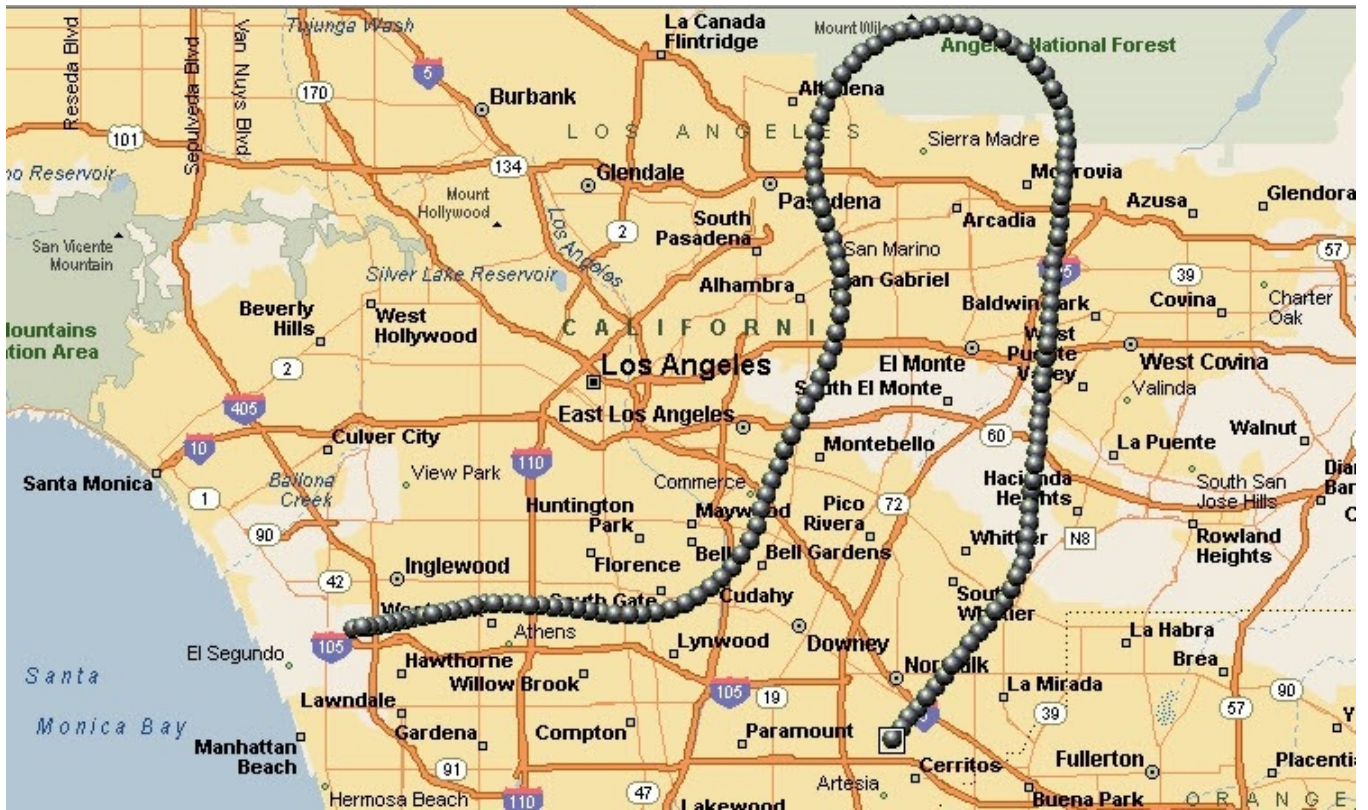
At 0121:16, the SCT Manhattan controller instructed the pilot of EVA015 "turn left heading of 180, climb and maintain 7,000." The pilot of EVA015 read back the heading and altitude and requested a "high speed climb." The SCT Manhattan controller approved the request. Radar data indicated EVA015 began to make a left turn.

Figure 2 - Radar data showing EVA015 departing LAX and being turned northbound toward Mount Wilson.

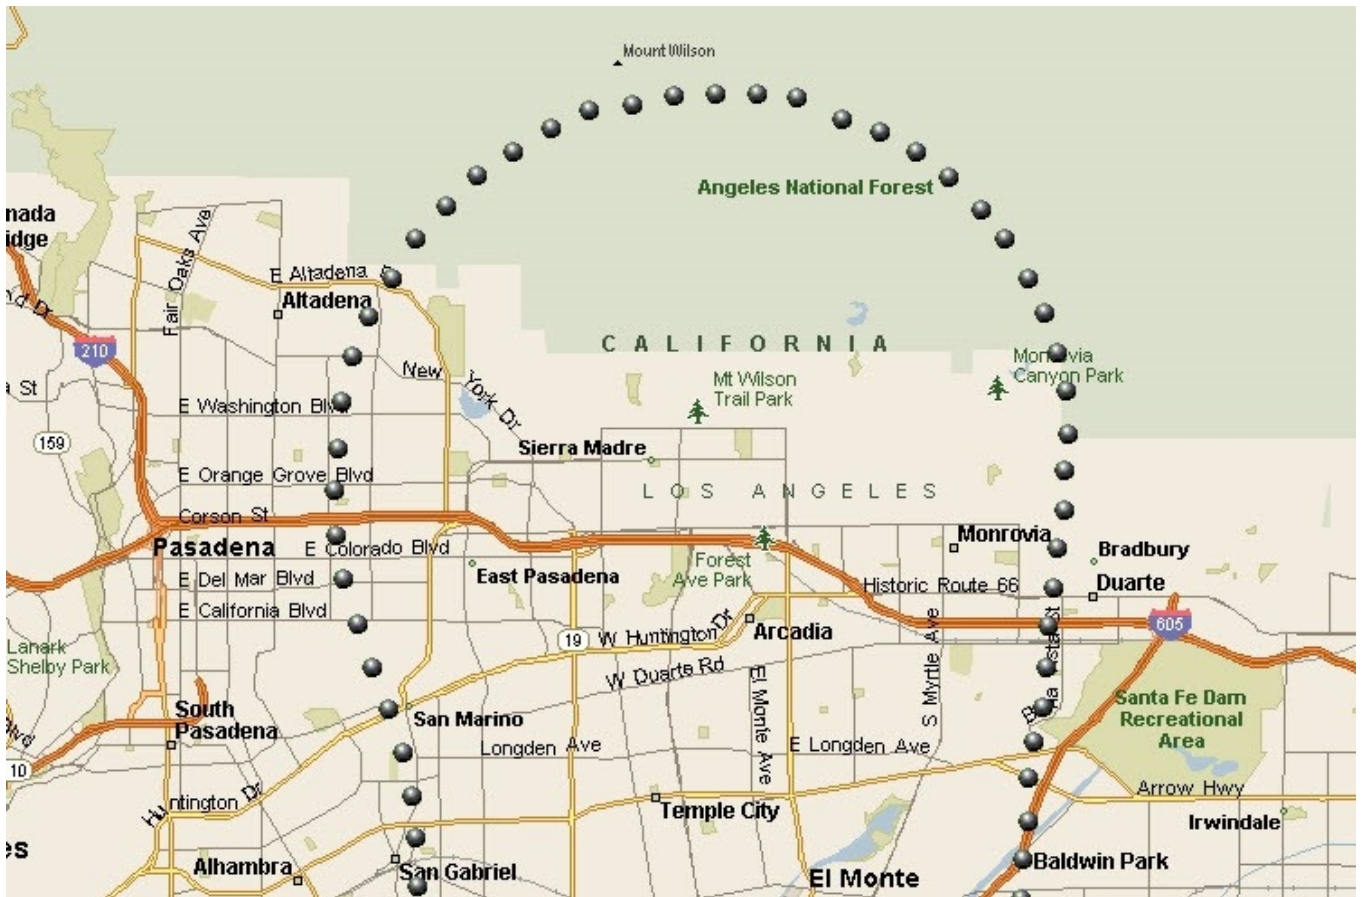
"[unintelligible] right turn to southbound, continue climb seven thousand." The pilot of EVA015 reiterated "continue right turn, and ah climb to seven thousand to a heading one eight zero."

Figure 3 - Radar data showing EVA015 making a right turn just south of Mount Wilson.

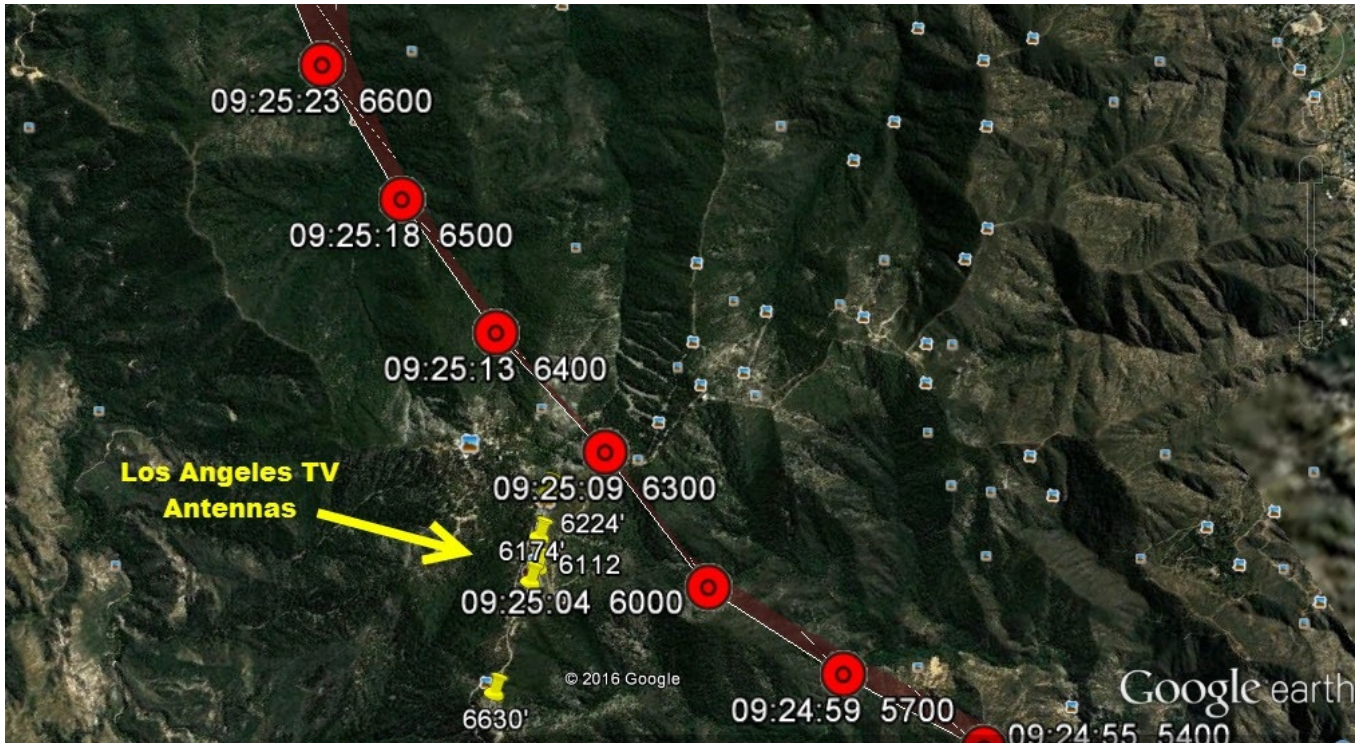
Radar data for this report was obtained from the FAA at SCT and were derived from ASR sensors. The SCT plot playback (.PPB) data was of good quality and was part of the STARS (Standard Terminal Automation Replacement) utilized by air traffic control. Figure 2 illustrates the radar flight track of EVA015 as it departed LAX runway 07R until the aircraft was clear of any obstructions and had resumed the departure procedure. Figure 3 illustrates the radar flight track of EVA015 as it traveled near Mt. Wilson CA at an altitude of 6,200 feet, the MVA for that segment was 7,800 feet. Figure 4 is a Google Earth image illustrating the plotted radar flight track of EVA015 and the locations and heights (msl) for the antennae on top of Mt. Wilson.

Figure 4 - Radar data overlaid on a Google Earth image with the TV antennas and the associated heights plotted.
