Aviation Investigation Final Report

Location:	Port Orford, Oregon	Accident Number:	WPR17FA052
Date & Time:	January 13, 2017, 11:25 Local	Registration:	N81839
Aircraft:	Piper PA 28-236	Aircraft Damage:	Substantial
Defining Event:	Loss of control in flight	Injuries:	1 Fatal
Flight Conducted Under:	Part 91: General aviation - Personal

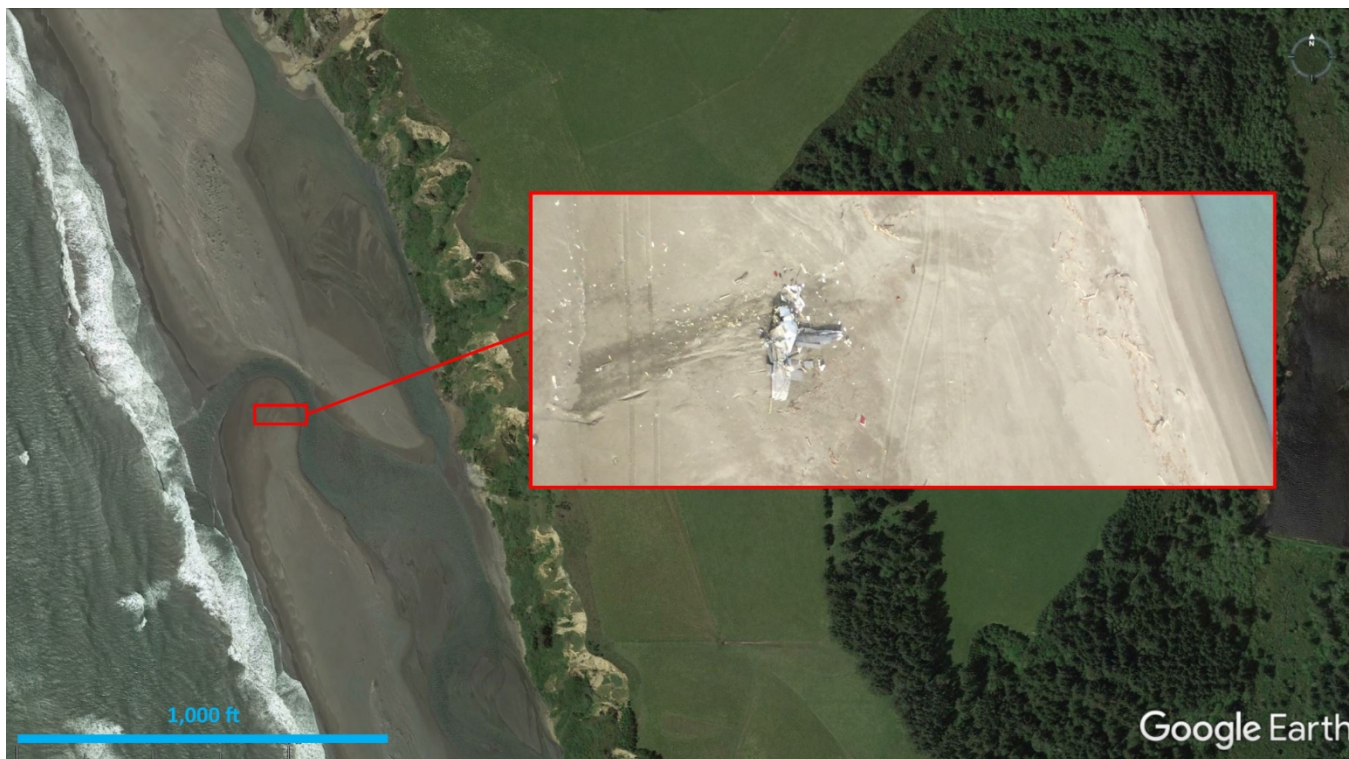
The airplane came to rest surrounded by water in the middle of the northern tip of a sandspit, about 50 ft from the ocean and 600 ft from the beach cliffs to the east (Photo 1). A debris field consisting of the nose landing gear and small composite fragments led from the ocean swash to the main wreckage. Beyond the wreckage, sand and cabin contents had been ejected about 50 ft east.

Photo 1 – Location of Wreckage on the Sandpit

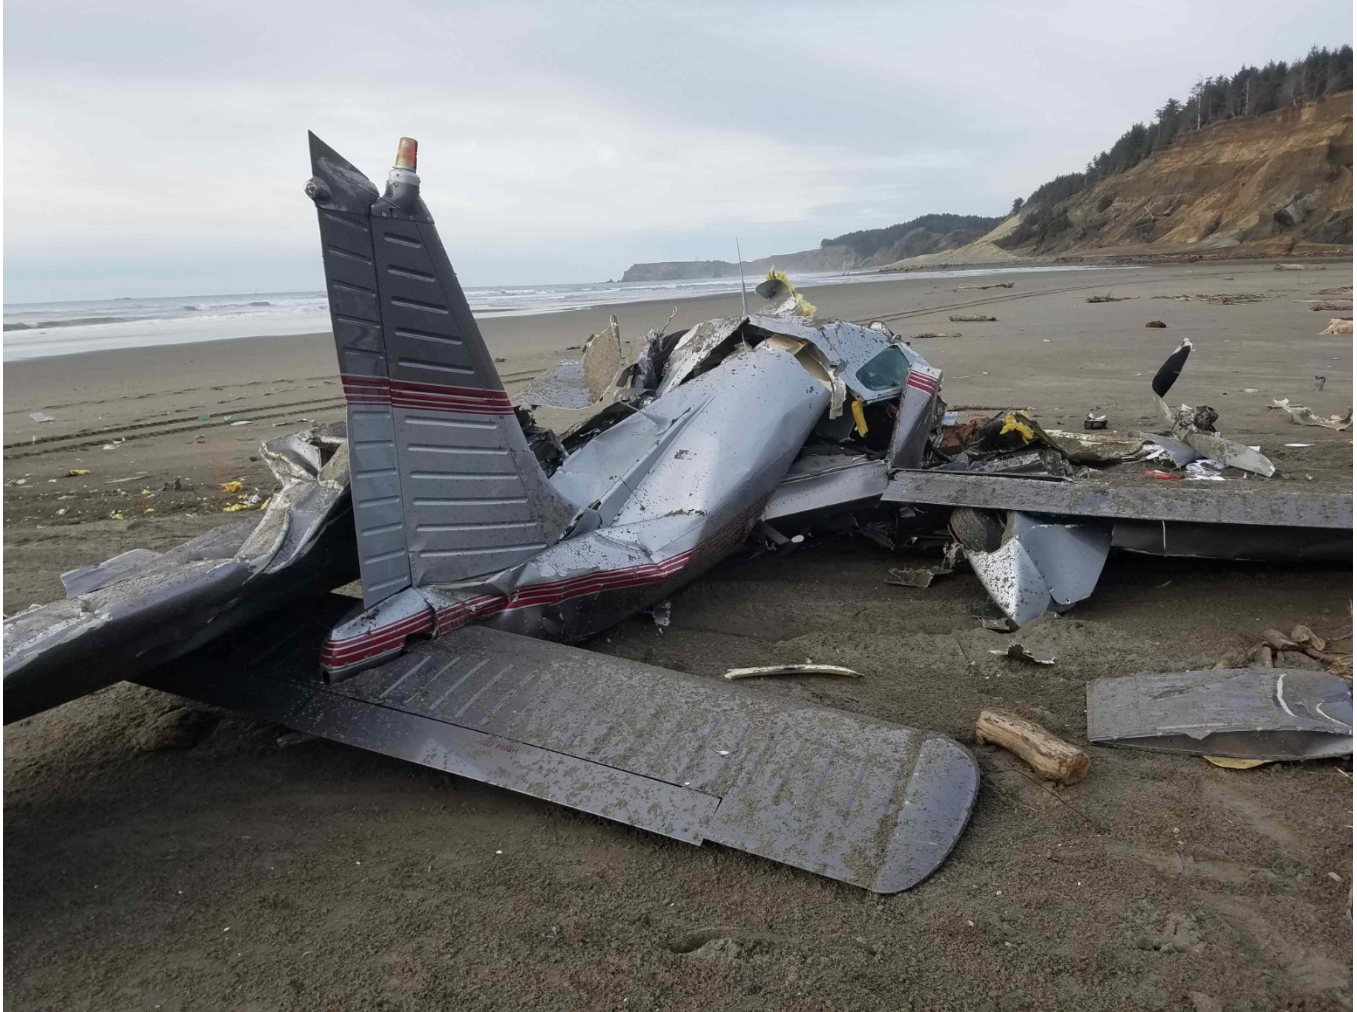
The cabin was on a north heading and had sustained crush damage from the firewall through to the leading edge of the vertical stabilizer. The left wing had folded back parallel to the tailcone and was resting on top of the left horizontal stabilizer. The left wing had sustained leading edge crush damage through to the main spar along its entire length with the damage deeper and more pronounced at the tip. The right wing remained attached to the cabin and had sustained leading edge crush damage through to the main spar along its entire length (Photo 2). All flight control surfaces remained attached to their respective attach points.

Photo 2 – Accident Site Facing North
