Aviation Investigation Final Report

Location:	San Francisco, California	Incident Number:	OPS171A014
Date & Time:	February 15, 2017, 20:00 Local	Registration:	N214NN (A1); N627VA (A2)
Aircraft:	EMBRAER S A ERJ 170-200 LR (A1); Airbus A320 (A2)	Aircraft Damage:	None (A1); None (A2)
Defining Event:	Air traffic event	Injuries:	N/A (A1); N/A (A2)
Flight Conducted Under:	Part 121: Air carrier - Scheduled (A1); Part 121: Air carrier - Scheduled (A2)

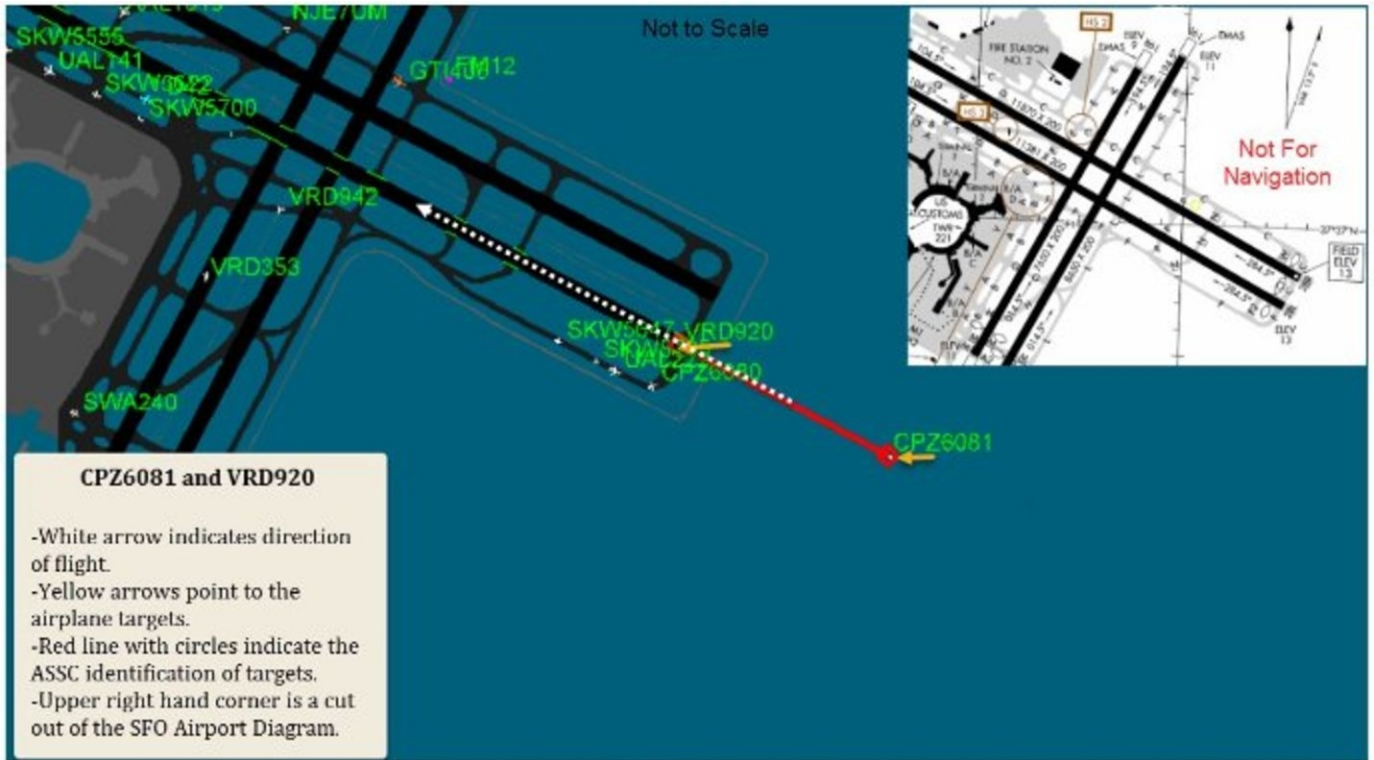
At 2000:13, the airport surface surveillance capability (ASSC) system display in SFO ATCT generated an aural and visual alert indicating a conflict between CPZ6081 and VRD920. FAA radar and ASSC data indicated that CPZ6081 was about .85 mile from the runway 28L threshold and at 500 feet, and VRD920 was in LUAW runway 28L.

Six seconds after the ASSC alert was generated the local controller instructed the pilot of CPZ6081 to "go around." The pilot acknowledged, "go around, go around." ASSC data indicated CPZ6081 was approximately .56 mile from the runway threshold and at 300 feet at the time the local controller issued

Figure 1. ASSC display screenshot illustrating the position of VRD920 and CPZ6081 when the SFO local controller issued go around instructions.
