# Aviation Investigation Final Report

<b>Location:</b>	Riverside, California	<b>Accident Number:</b>	WPR17FA066
<b>Date &amp; Time:</b>	February 27, 2017, 16:41 Local	<b>Registration:</b>	N1246G
<b>Aircraft:</b>	Cessna T310Q	<b>Aircraft Damage:</b>	Destroyed
<b>Defining Event:</b>	Aerodynamic stall/spin	<b>Injuries:</b>	4 Fatal, 1 Serious
<b>Flight Conducted Under:</b>	Part 91: General aviation - Personal

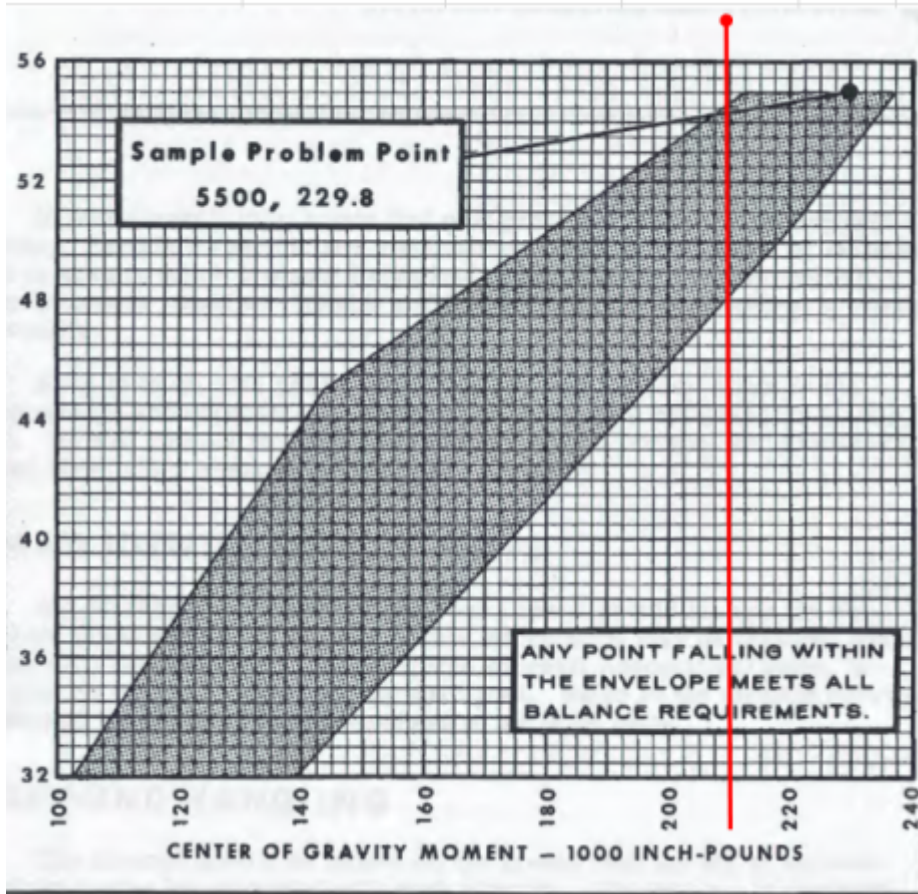
Figure 1 - Airplane Center of Gravity Moment Envelope Plotted with Main & Auxiliary Tanks at Full Capacity

Calculations indicated that the airplane was loaded over its maximum gross takeoff weight by about 300 pounds. Additionally, the airplane's center of gravity (CG) was forward of the forward limit for its maximum gross weight. Although CGs that are forward but within the approved envelope generally result in more favorable stall characteristics, the airplane was loaded outside of published limits, and its performance under these conditions was unpredictable.

An airplane weight and balance estimate was computed using occupant weights from the autopsy reports and from the surviving passenger. The baggage weight was determined by weighing an assortment of personal effects and baggage recovered from the accident site. The computed total weight was 5,812 pounds (lbs), which was 312 lbs over the airplane's maximum allowable gross weight of 5,500 lbs. The manufacturer does not provide center of gravity (CG) limits for weights above gross weight; the computed CG of 36.82 inches was forward of the forward limit of 38.67 inches at gross weight. Figure 1 shows the airplane weight and balance estimate plotted on the manufacturer's published CG moment envelope diagram from the pilot's operating handbook (POH).

According to the FAA Airplane Flying Handbook (FAA-H-8083-3B), the flight characteristics of a multi-engine airplane will vary significantly with shifts of the CG within the approved envelope. At forward CGs within the envelope, the airplane will be more stable, with a slightly higher stalling speed, a slightly lower cruising speed, and favorable stall characteristics. However, the airplane's performance outside the performance envelope cannot be predicted.
