Aviation Investigation Final Report

Location:	Chalmers, Indiana	Accident Number:	CEN17FA127
Date & Time:	March 14, 2017, 15:46 Local	Registration:	N530KD
Aircraft:	MCDONNELL DOUGLAS HELI CO 369FF	Aircraft Damage:	Destroyed
Defining Event:	External load event (Rotorcraft)	Injuries:	1 Fatal
Flight Conducted Under:	Part 133: Rotorcraft ext. load

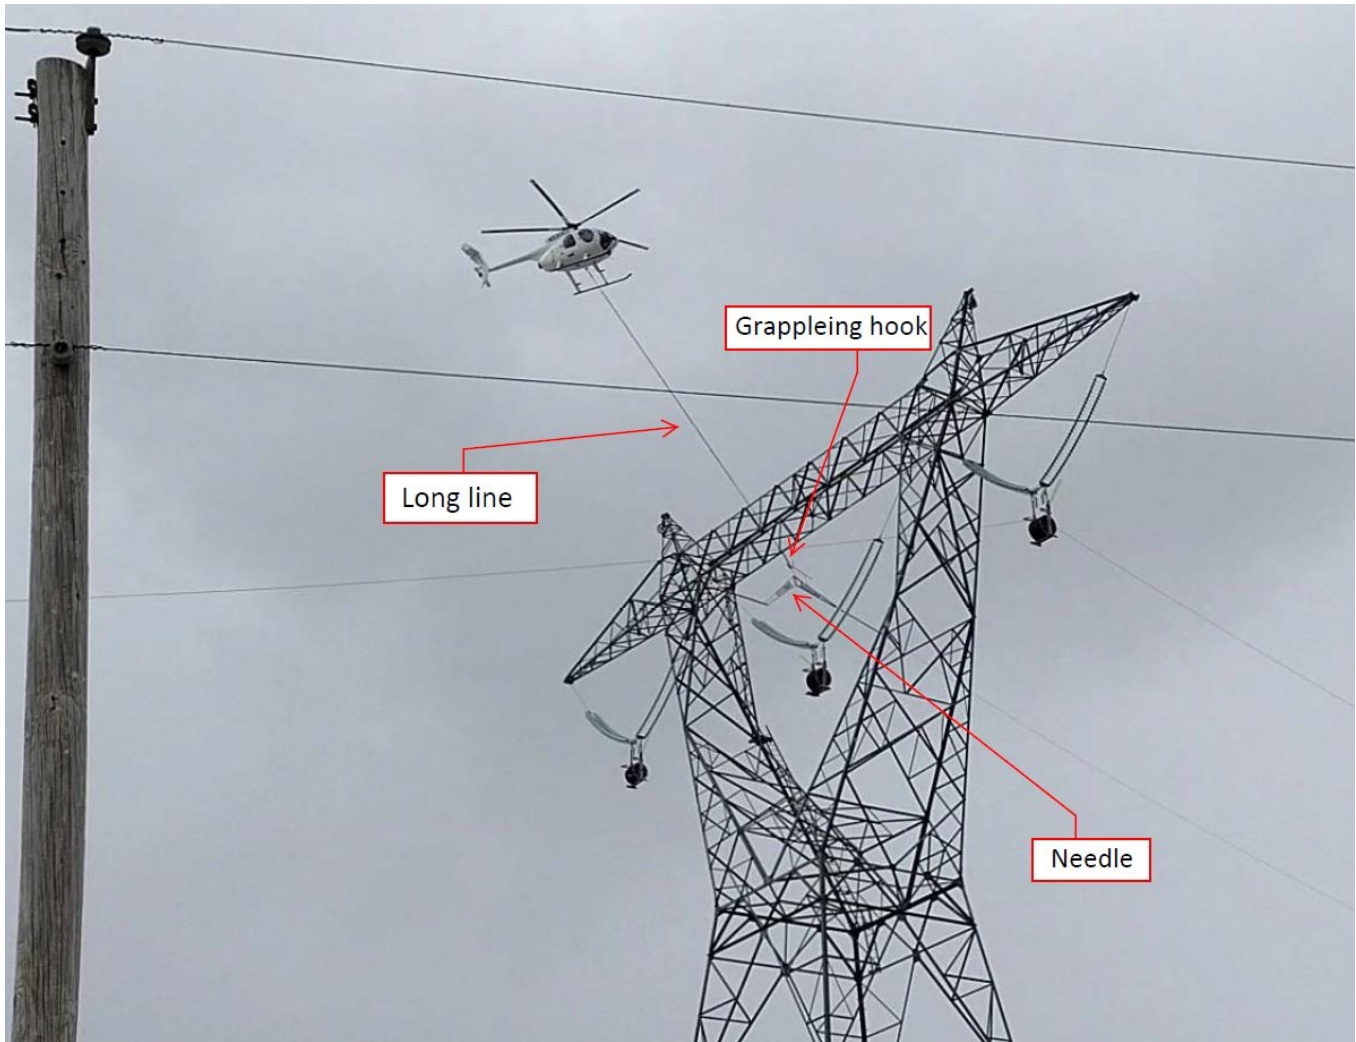
Figure 1 – Image from Accident Video with Notations

A witness provided a 3-minute cell phone video of the events leading to the accident and the entire accident sequence. The video revealed that the pilot was attempting to attach the needle's forward hook to the tower structure (figure 1) when the accident occurred.

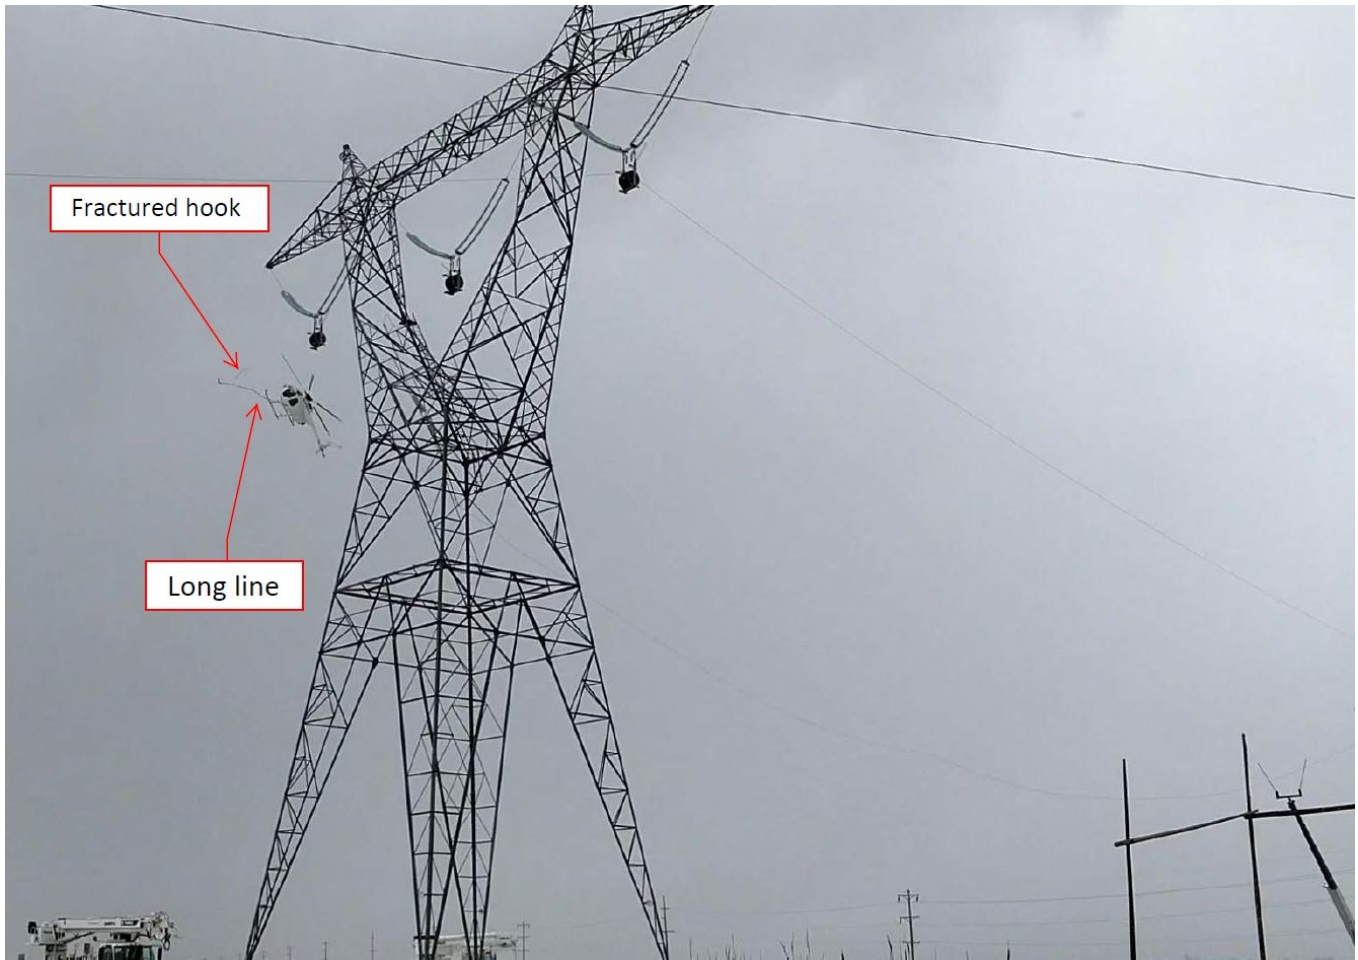
Figure 2 – Image from Accident Video with Notations

Review of the video showed that the pilot attempted twice to hook the needle to the tower and was unsuccessful each time. Before the third attempt, the helicopter wobbled several times. On the third attempt, the helicopter flew backward until the needle impacted the tower. The helicopter continued a backward motion, pitched up, then descended with the tailboom pointed at the ground (figure 2). The needle's aft loop, which the grapple hook was attached to, separated from the needle and was thrown to the south. While still airborne, the helicopter made a descending 180° clockwise rotation, as viewed from above, with the long line still attached. The rotation stopped as the helicopter faced north then rolled left about 80°. The long line became entangled with the main rotor blades, and then the blades impacted the top of the cabin and the tailboom. The tailboom separated about mid span, and both the tailboom and the rest of the helicopter descended and impacted the ground. There was no evidence of a post-crash fire.

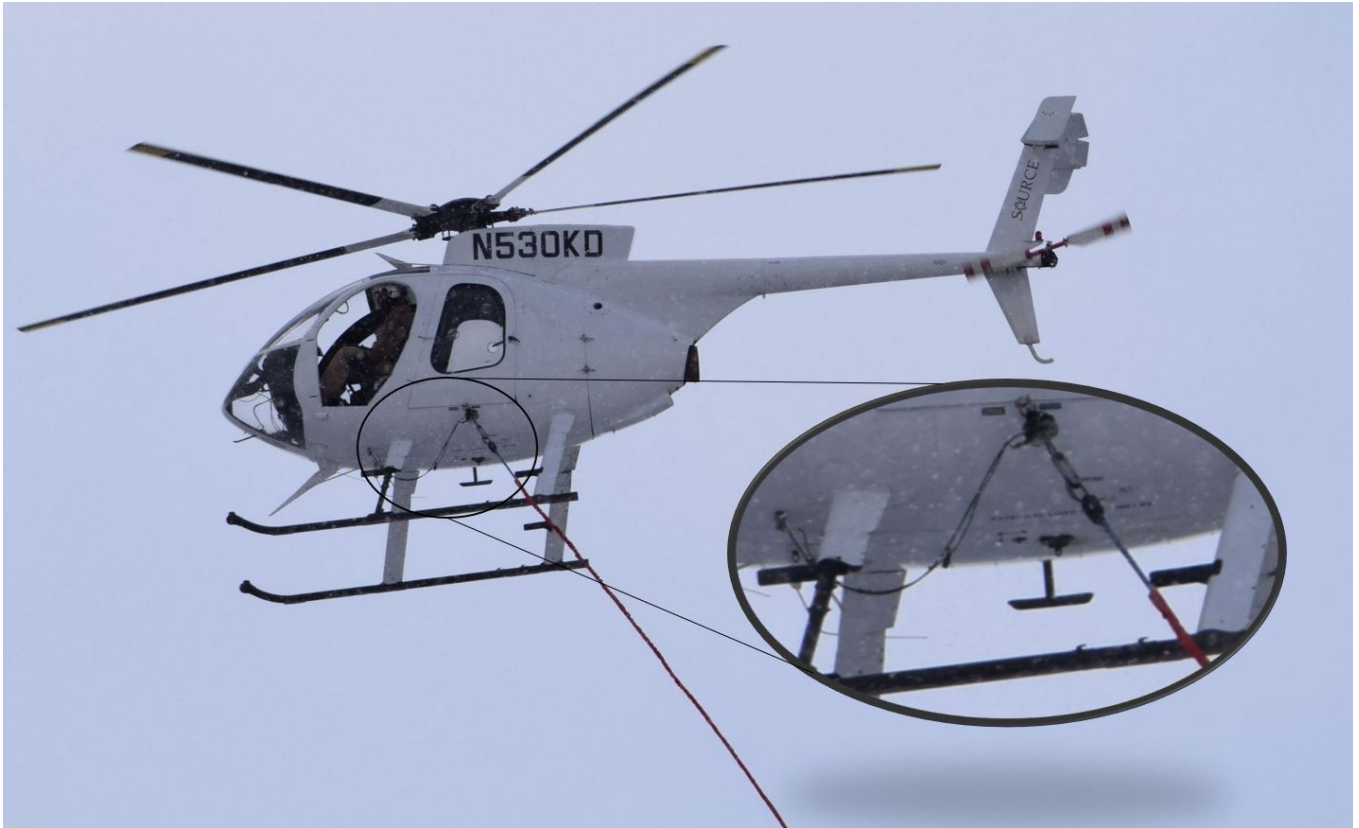
Figure 3 – Side Pull Hook Assembly

The helicopter was equipped with a Colorado Helicopters, Inc., Side Pull Hook Assembly (figure 3) per supplemental type certificate (STC) SH5230NM. According to the STC holder, the purpose of the assembly is to quickly rig a helicopter for pulling a sock line on power line construction projects. The assembly featured mechanical and electric cargo hook release mechanisms. The system is certified for a maximum side pull load of 1,900 lbs., which is safeguarded by a breakaway swivel; the two-piece breakaway swivel is held together with a calibrated shear pin. The STC holder noted that if the airframe is about to be overloaded, the shear pin is designed to break and allow for the long line to fall away from the helicopter; no unusual attitudes will result, and the helicopter should easily come to a hover.

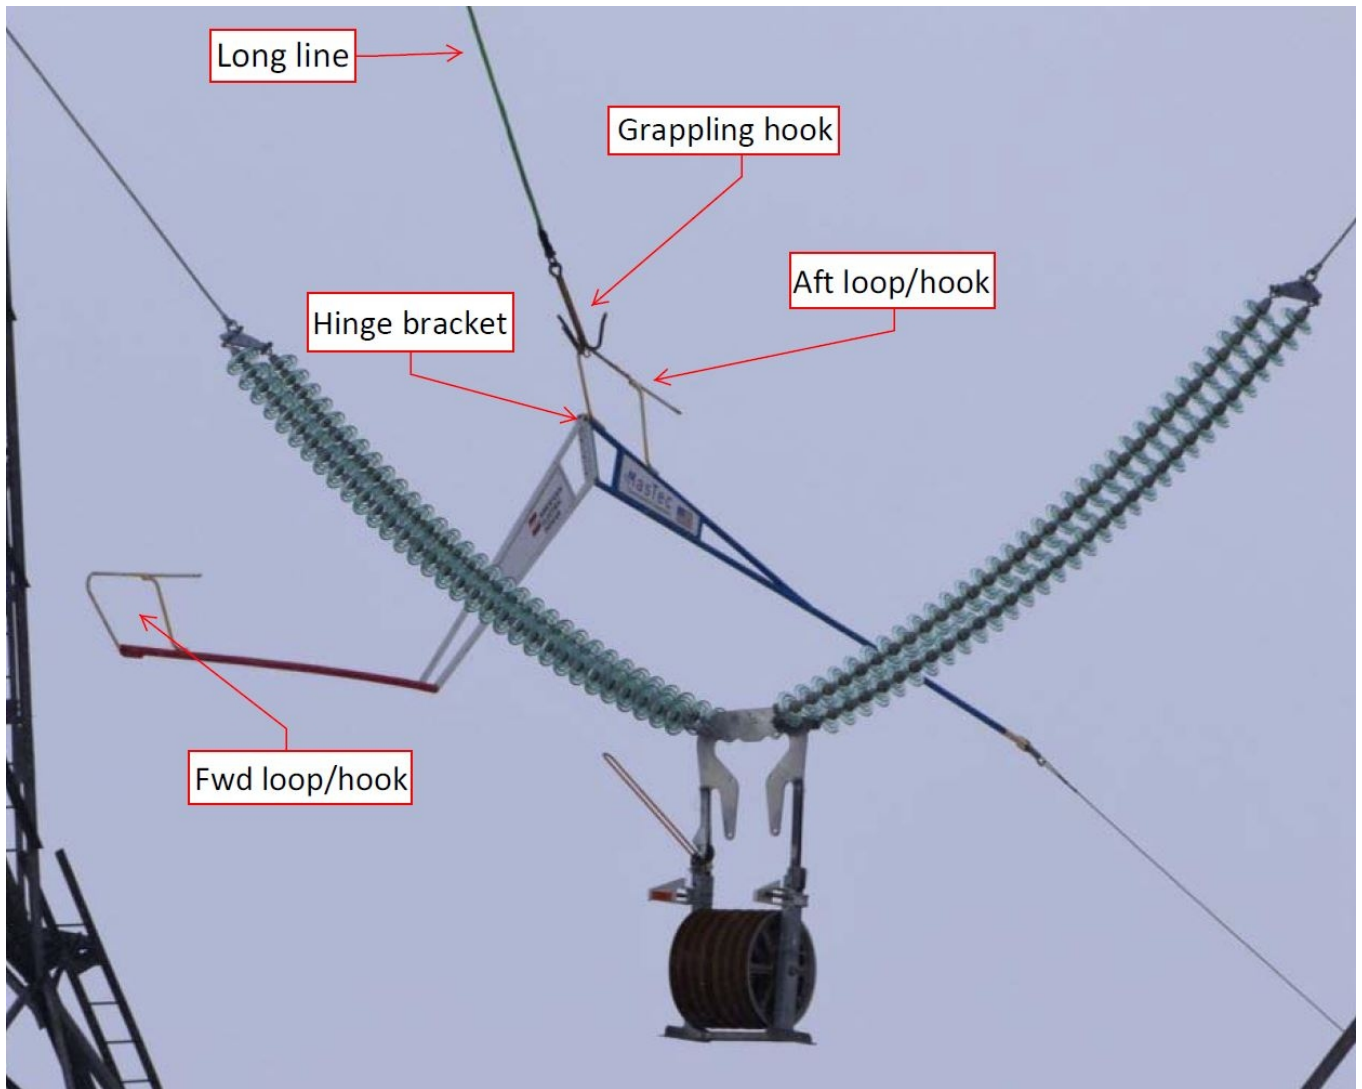
Figure 4 – Needle with Notations

The frame of the needle was made of steel tubing; the forward and aft sections of the needle were connected in the middle by a hinge bracket. Each section of the needle featured a closed loop with a straight open hook extending aft; the straight hooks (see figure 4) allowed the pilot to temporarily attach the needle to a horizontal cross-member of the tower and then reposition the helicopter. The aft end of the needle was connected to the metal sock line via metal carabiners and a non-breakaway swivel. The weight of the needle was about 200 lbs. Figure 4 shows the multicolored needle connected to the long line via the grappling hook. The photo depicted in figure 4 was captured a few minutes before the accident and is indicative of the exact configuration during the accident sequence.

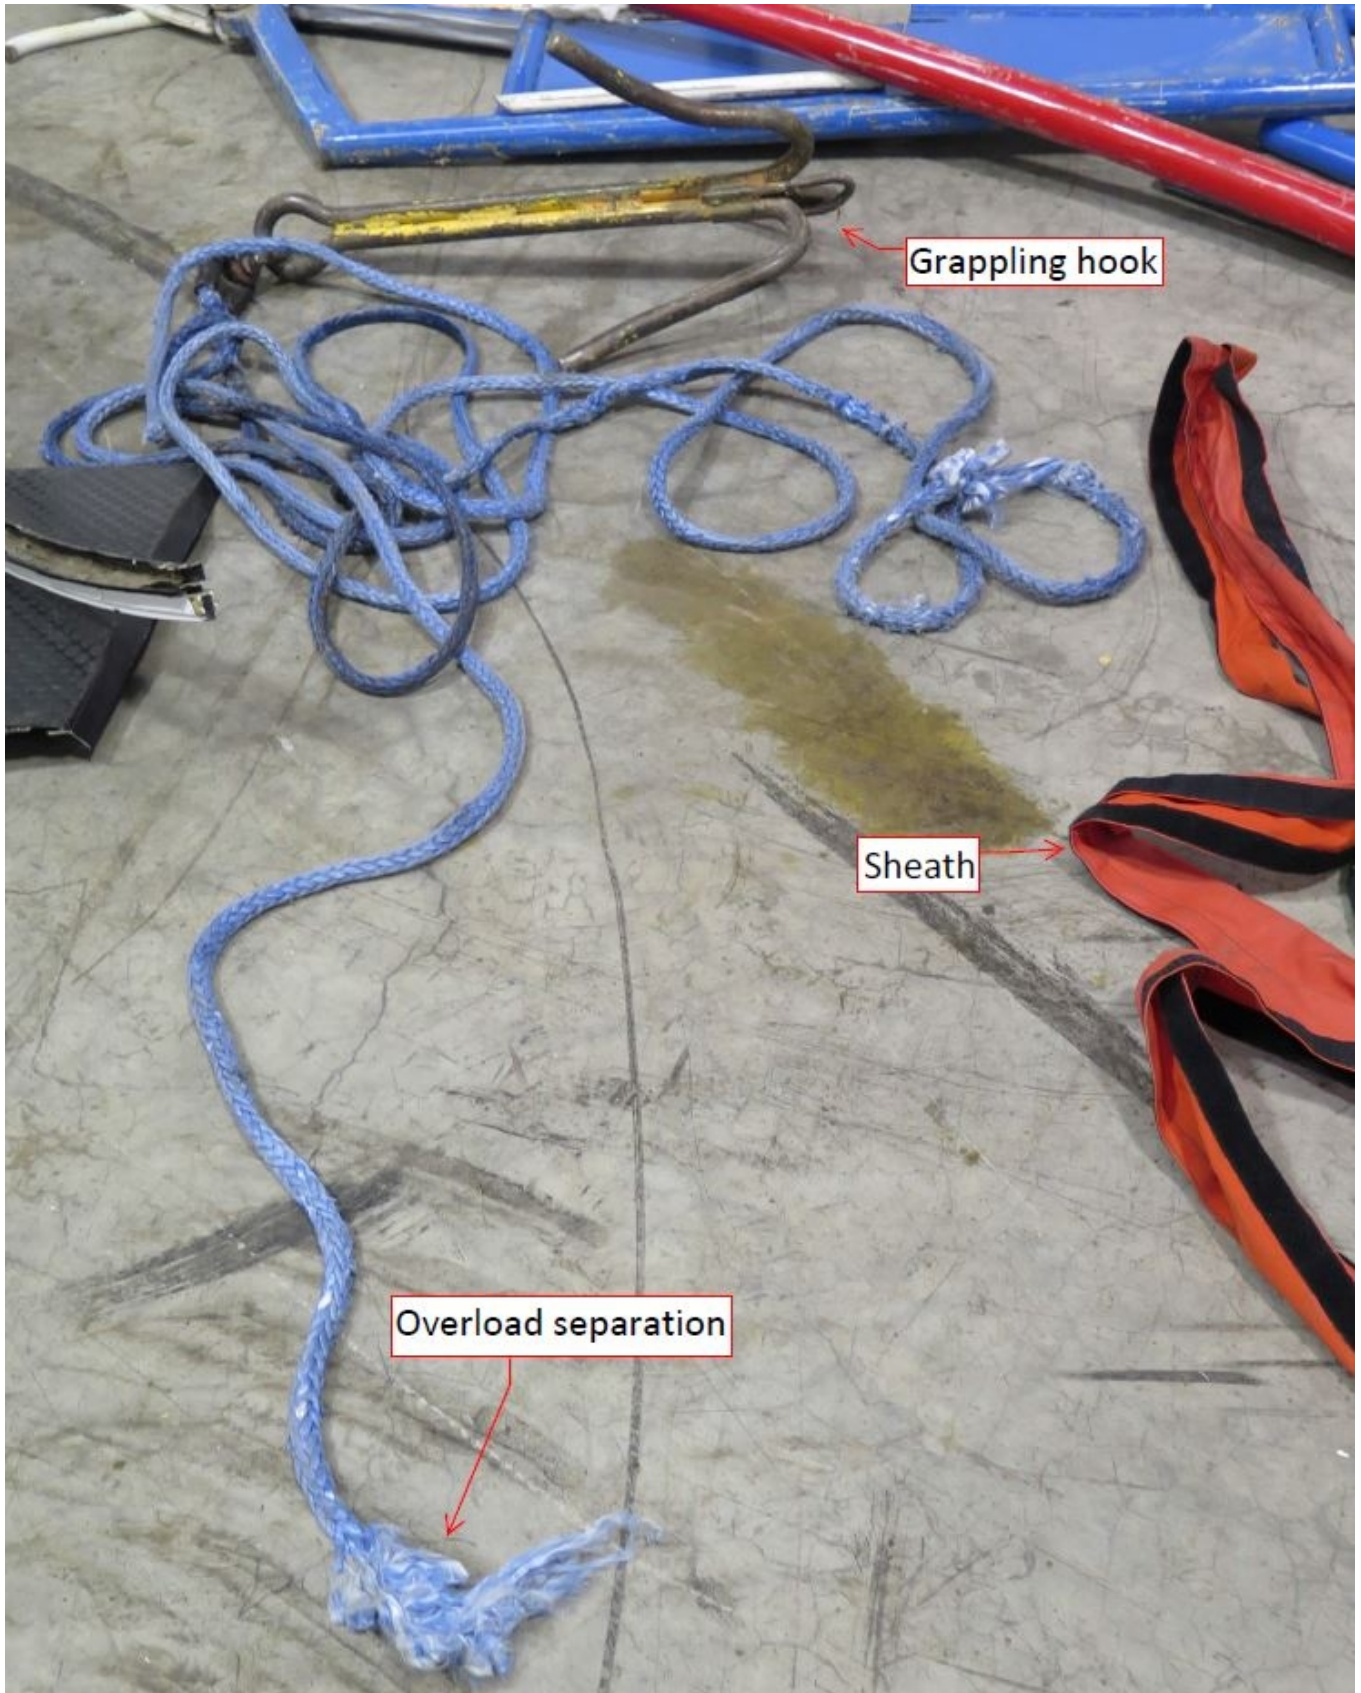
Figure 6 – Long line, Sheath, and Grappling Hook

The long line was separated in tension overload near the top of the line, a few feet from the cargo hook. Figure 3 shows the top portion of the long line still attached to the helicopter before the accident and figure 6 shows the postaccident condition of the long line. The cargo hook was found open at the accident site. The breakaway swivel, its shear pin, the two carabiners that hooked to either side of the swivel, and the upper portion of the long line were not found during the investigation. The aft end of the needle remained connected to the sock line via a non-breakaway swivel. The needle's fractured aft loop was found about 50 yards south of the accident site. Except for the fracture after loop, the rest of the needle remained intact with ground impact damage.

Overload separation

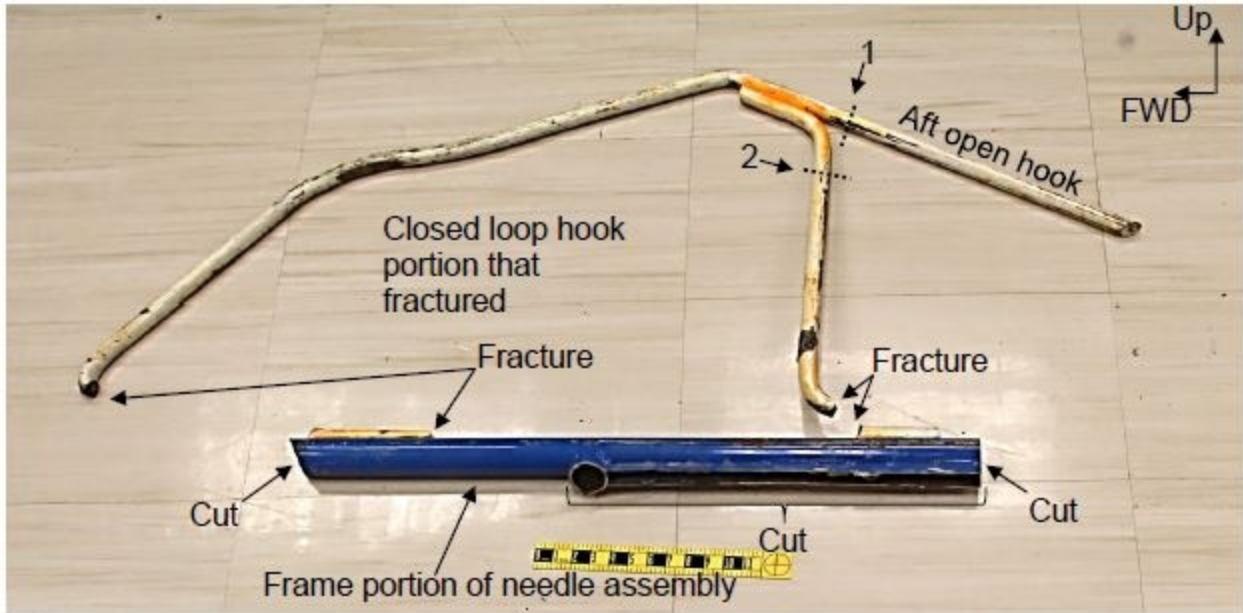
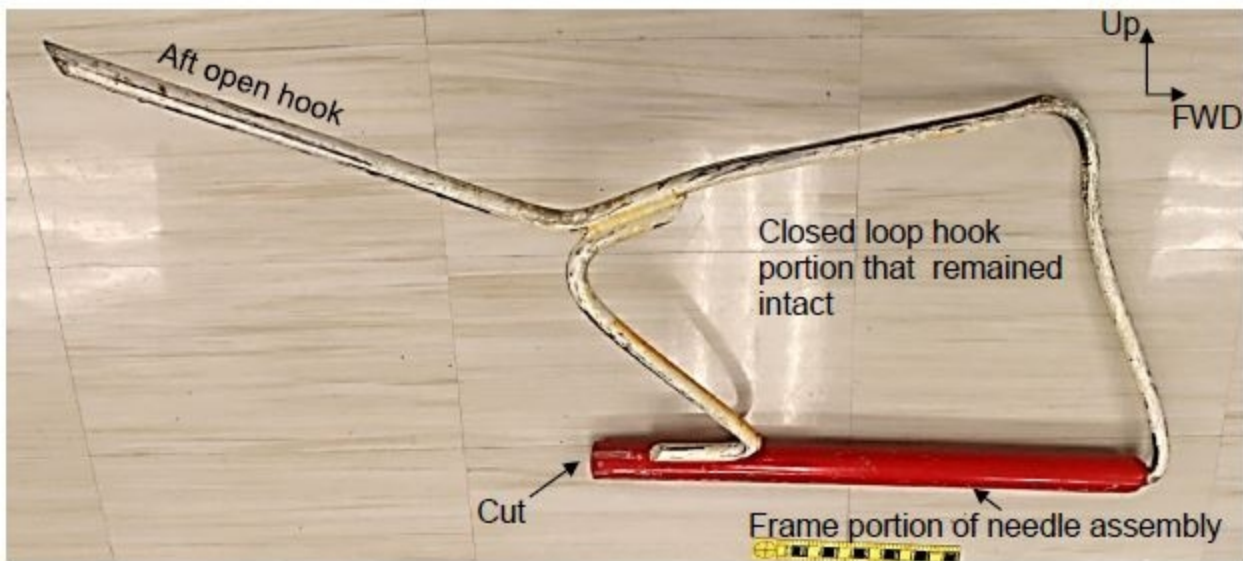
Figure 7 – Needle Damage

Portions of the damaged needle assembly were sent to the NTSB Materials Laboratory for examination and testing; photos of the as-received portions are shown in figure 7.

The needle assembly contained closed loops at the center and the forward end. The top portion of each closed loop also contained an open hook portion that faced aft. A visual examination of the needle assembly revealed that the aft closed loop (the point of attachment of the grappling hook) fractured at two locations. The fractures were through the round solid bar portion and intersected a portion of the weld at the frame portion. A bench binocular microscope examination of the fracture faces revealed rough texture features on slant planes consistent with ductile-bending overstress separation, with no evidence of a preexisting crack, such as fatigue crack. The welds at the fracture face showed no evidence of defects such as porosity.

A metallurgical section was made through the loop portions in the areas indicated by arrows 1 and 2 in figure 7 to obtain a 0.3-inch-thick disc portion from the 1-inch diameter solid round bar. Rockwell hardness (HRB) testing of the flat cut faces, perpendicular to the length of the solid round bar, produced average hardness values of 93 HRB, which converted to a tensile strength of about 94,000 lbs. per square inch. The load required to fracture the 1-inch solid round bar from the needle assembly was calculated by multiplying the approximate tensile strength by the cross-sectional area of the solid round bar. The load required to fracture the 1-inch solid round bar under constant tensile load was calculated to be 73,790 lbs., which is nearly 40 times greater than the load required to break the side hook's breakaway swivel shear pin.
