Aviation Investigation Final Report

| Location: | Chalmers, Indiana | Accident Number: | CEN17FA127 |
| Date & Time: | March 14, 2017, 15:46 Local | Registration: | N530KD |
| Aircraft: | MCDONNELL DOUGLAS HELI CO 369FF | Aircraft Damage: | Destroyed |

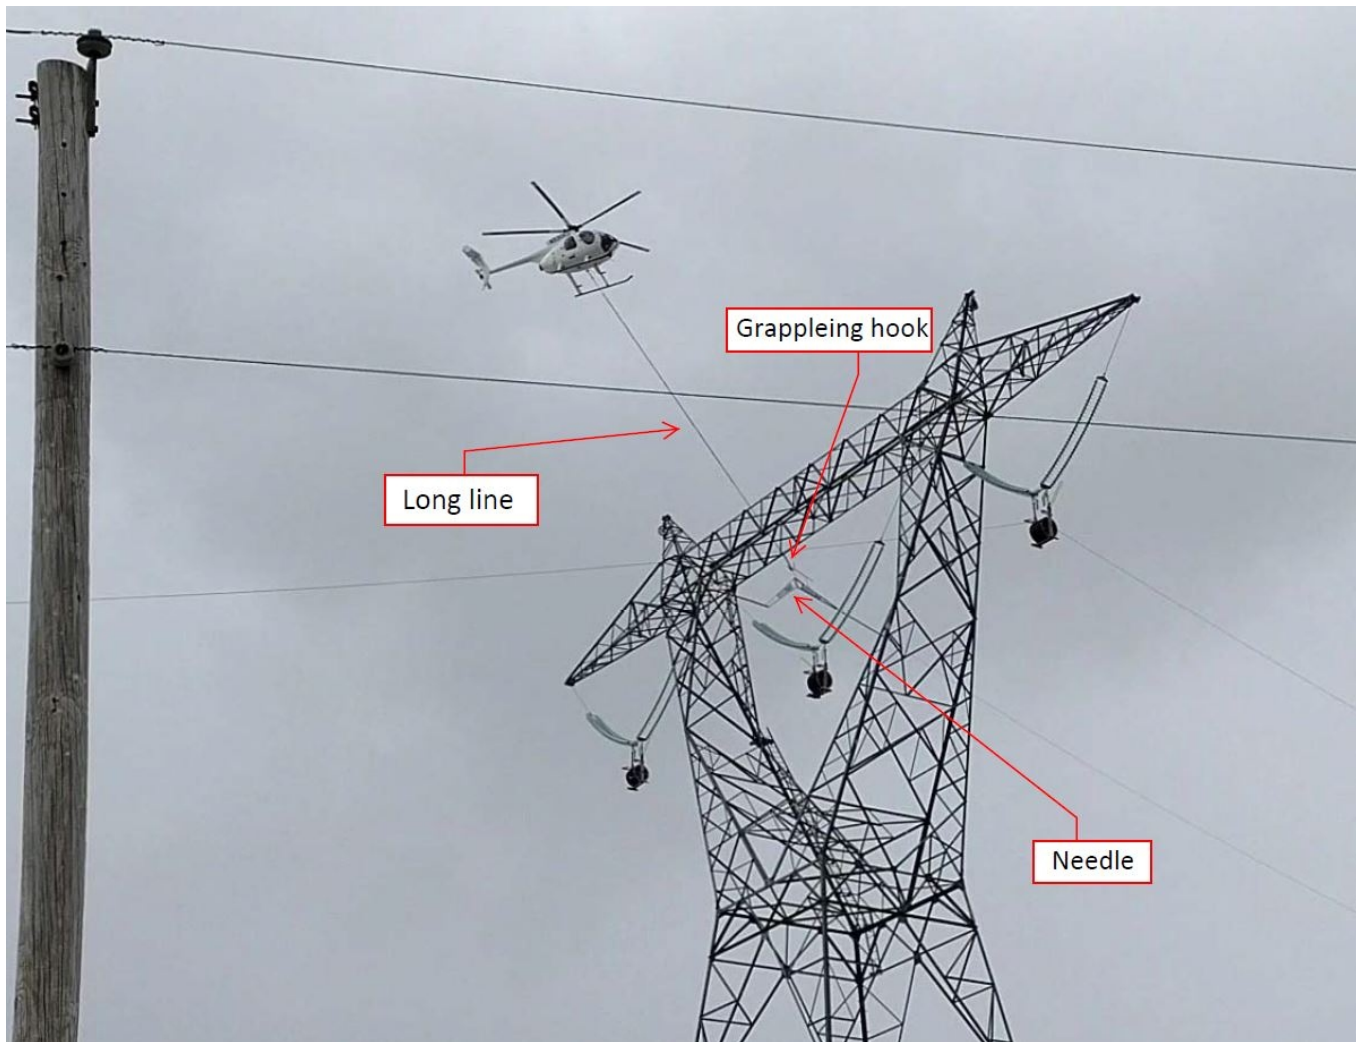
Figure 1 – Image from Accident Video with Notations

The tension on the sock line was controlled by a triple drum puller located about 2 miles (and 10 towers) north. Each of the three drums contained sock line for one of the three phases of the tower as seen in figure 1. The puller featured a manual brake that was operated by a power line construction employee. The employee and the pilot communicated via radio as the pilot would announce his operational intentions. The employee stated that the pilot had threaded the sock line through nine towers. The pilot announced over the radio that he was slowing and approaching the tenth tower. The employee later heard yelling over the radio and then silence. The amount of brake applied on the sock line at the time of the accident was not determined.

A witness provided a 3-minute cell phone video of the events leading to the accident and the entire accident sequence. The video revealed that the pilot was attempting to attach the needle's forward hook to the tower structure (figure 1) when the accident occurred.

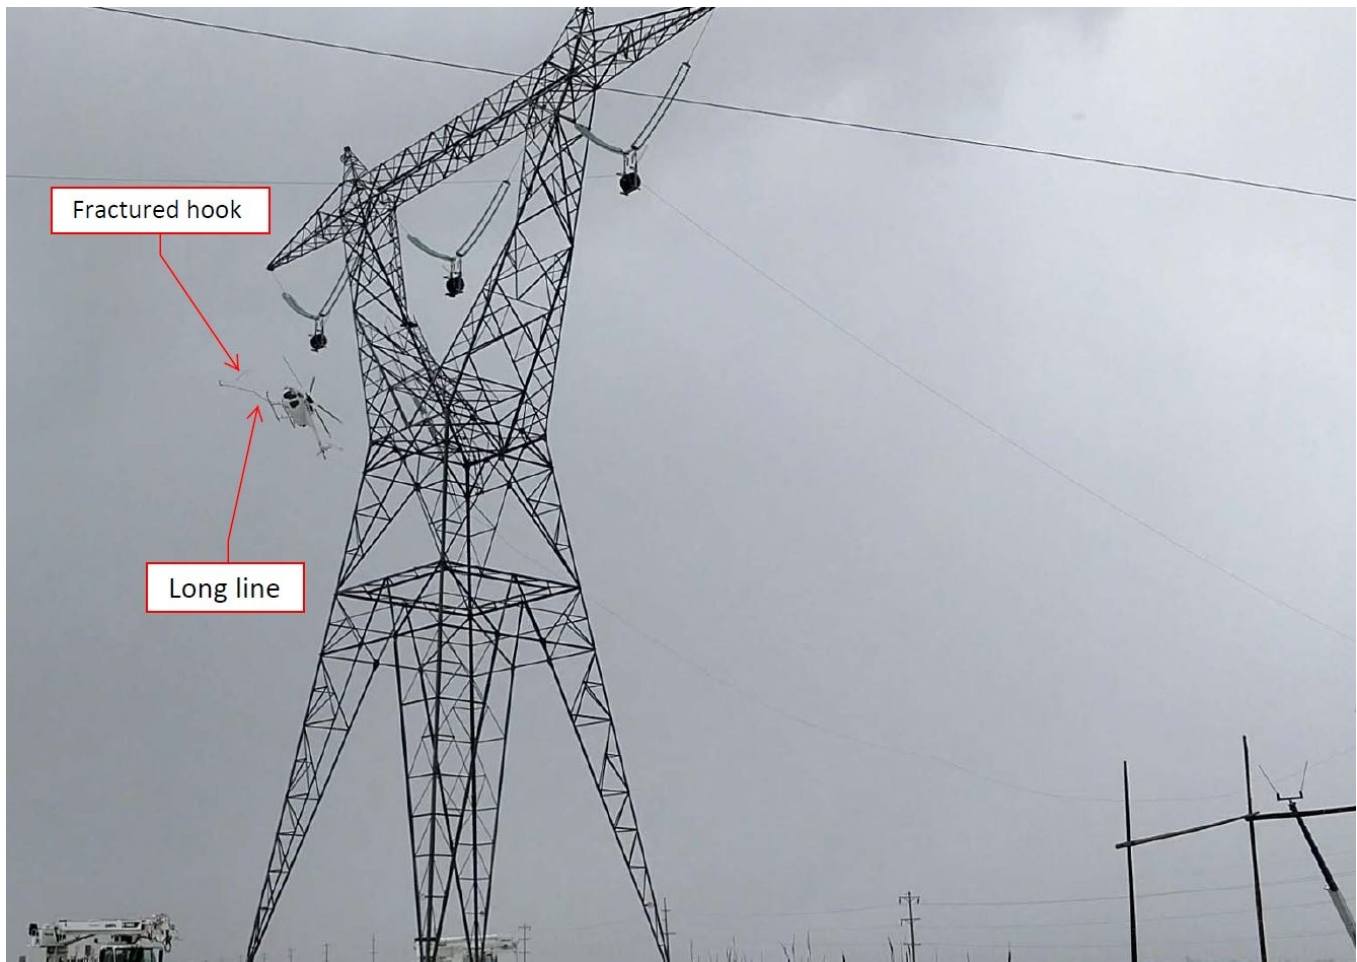
Figure 2 – Image from Accident Video with Notations

Review of the video showed that the pilot attempted twice to hook the needle to the tower and was unsuccessful each time. Before the third attempt, the helicopter wobbled several times. On the third attempt, the helicopter flew backward until the needle impacted the tower. The helicopter continued a backward motion, pitched up, then descended with the tailboom pointed at the ground (figure 2). The needle's aft loop, which the grapple hook was attached to, separated from the needle and was thrown to the south. While still airborne, the helicopter made a descending 180° clockwise rotation, as viewed from above, with the long line still attached. The rotation stopped as the helicopter faced north then rolled left about 80°. The long line became entangled with the main rotor blades, and then the blades impacted the top of the cabin and the tailboom. The tailboom separated about mid span, and both the tailboom and the rest of the helicopter descended and impacted the ground. There was no evidence of a post-crash fire.

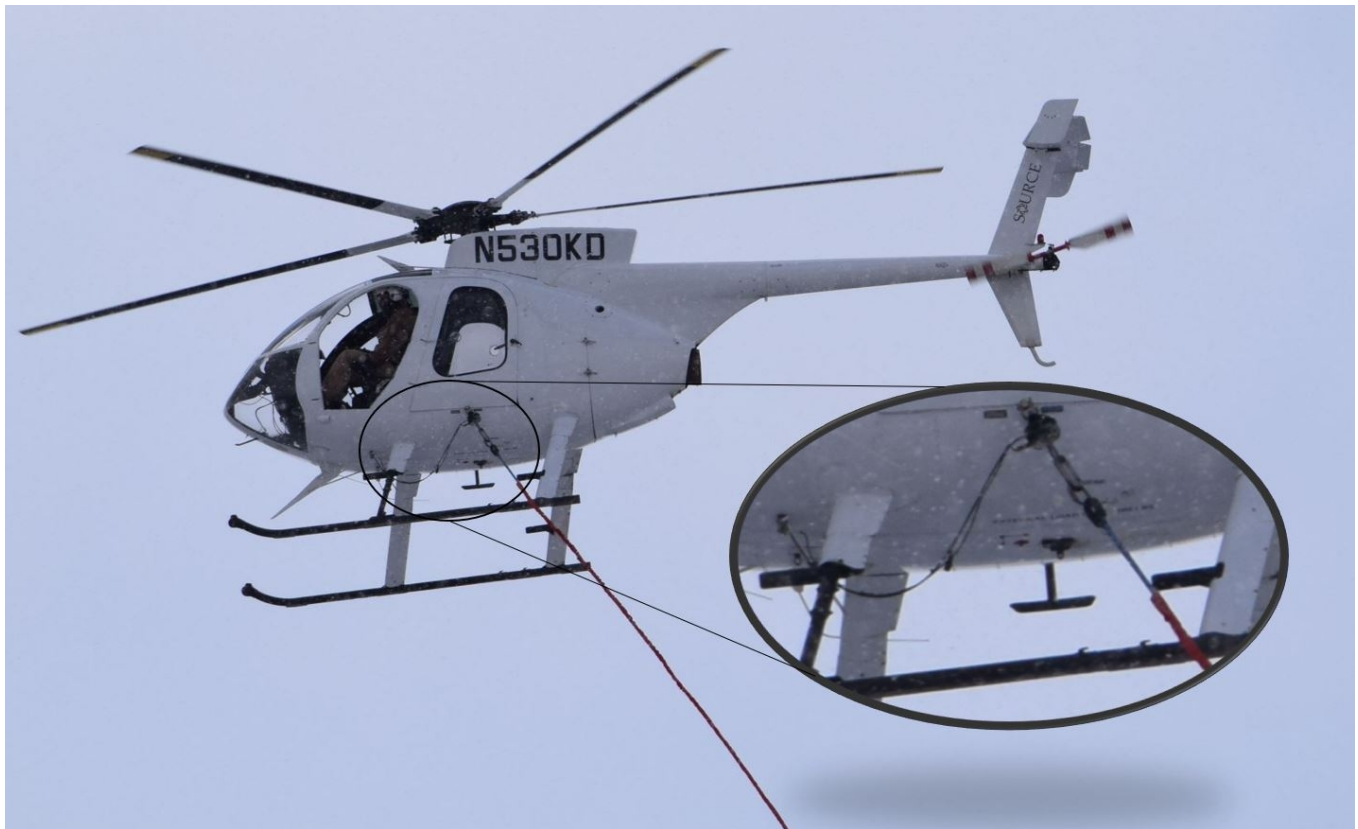
Figure 3 – Side Pull Hook Assembly

The helicopter was equipped with a Colorado Helicopters, Inc., Side Pull Hook Assembly (figure 3) per supplemental type certificate (STC) SH5230NM. According to the STC holder, the purpose of the assembly is to quickly rig a helicopter for pulling a sock line on power line construction projects. The assembly featured mechanical and electric cargo hook release mechanisms. The system is certified for a maximum side pull load of 1,900 lbs., which is safeguarded by a breakaway swivel; the two-piece breakaway swivel is held together with a calibrated shear pin. The STC holder noted that if the airframe is about to be overloaded, the shear pin is designed to break and allow for the long line to fall away from the helicopter; no unusual attitudes will result, and the helicopter should easily come to a hover.

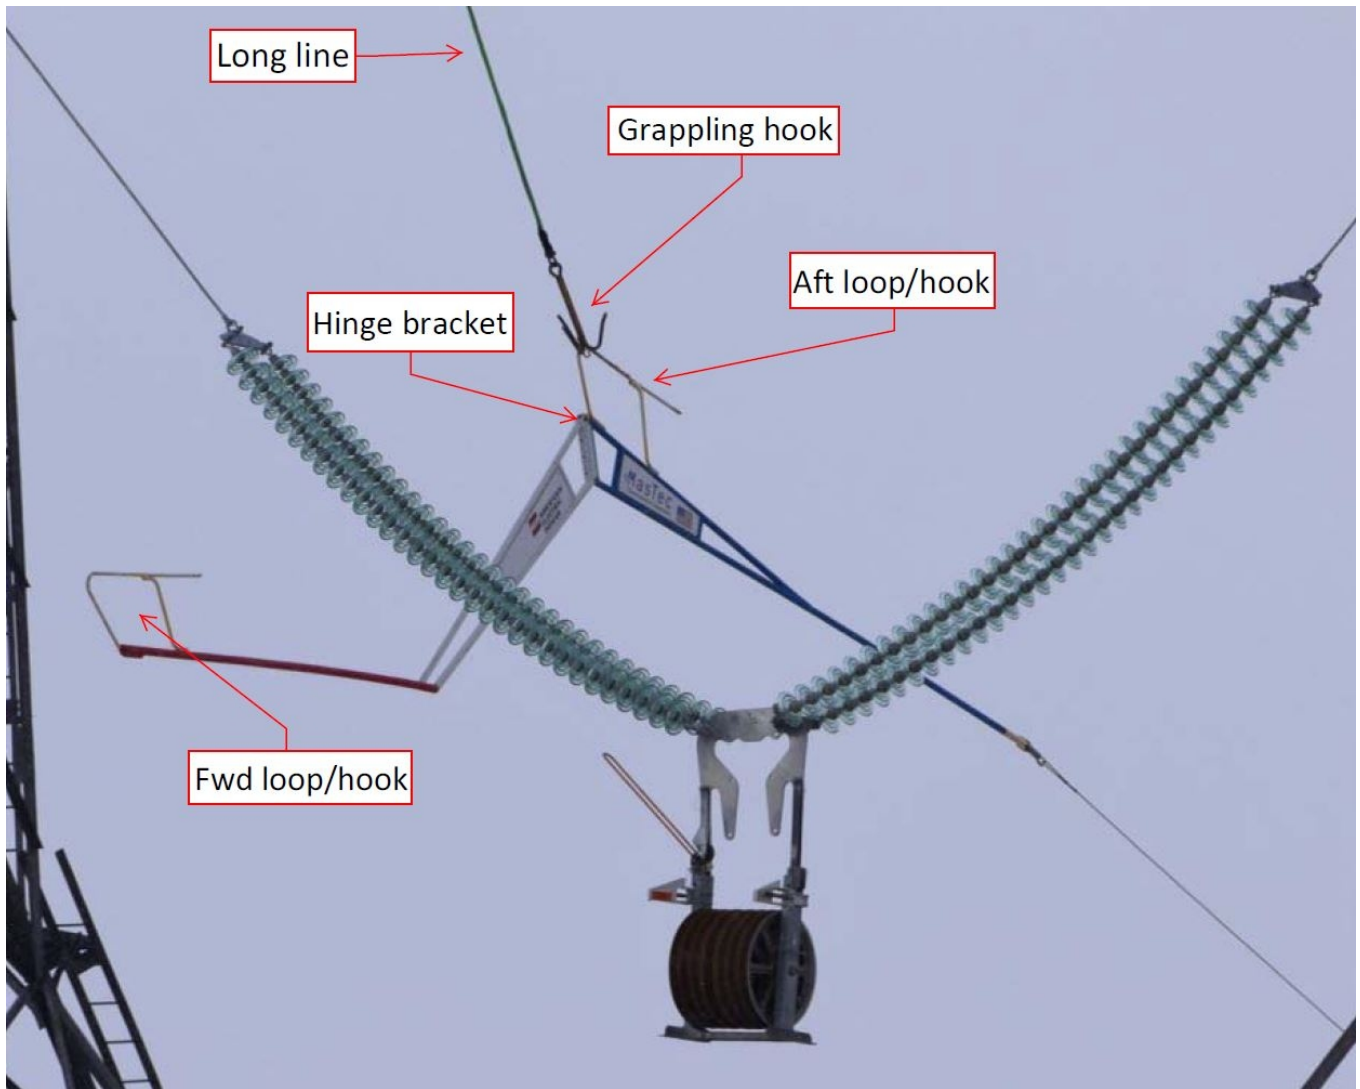
Figure 4 – Needle with Notations

The frame of the needle was made of steel tubing; the forward and aft sections of the needle were connected in the middle by a hinge bracket. Each section of the needle featured a closed loop with a straight open hook extending aft; the straight hooks (see figure 4) allowed the pilot to temporarily attach the needle to a horizontal cross-member of the tower and then reposition the helicopter. The aft end of the needle was connected to the metal sock line via metal carabiners and a non-breakaway swivel. The weight of the needle was about 200 lbs. Figure 4 shows the multicolored needle connected to the long line via the grappling hook. The photo depicted in figure 4 was captured a few minutes before the accident and is indicative of the exact configuration during the accident sequence.

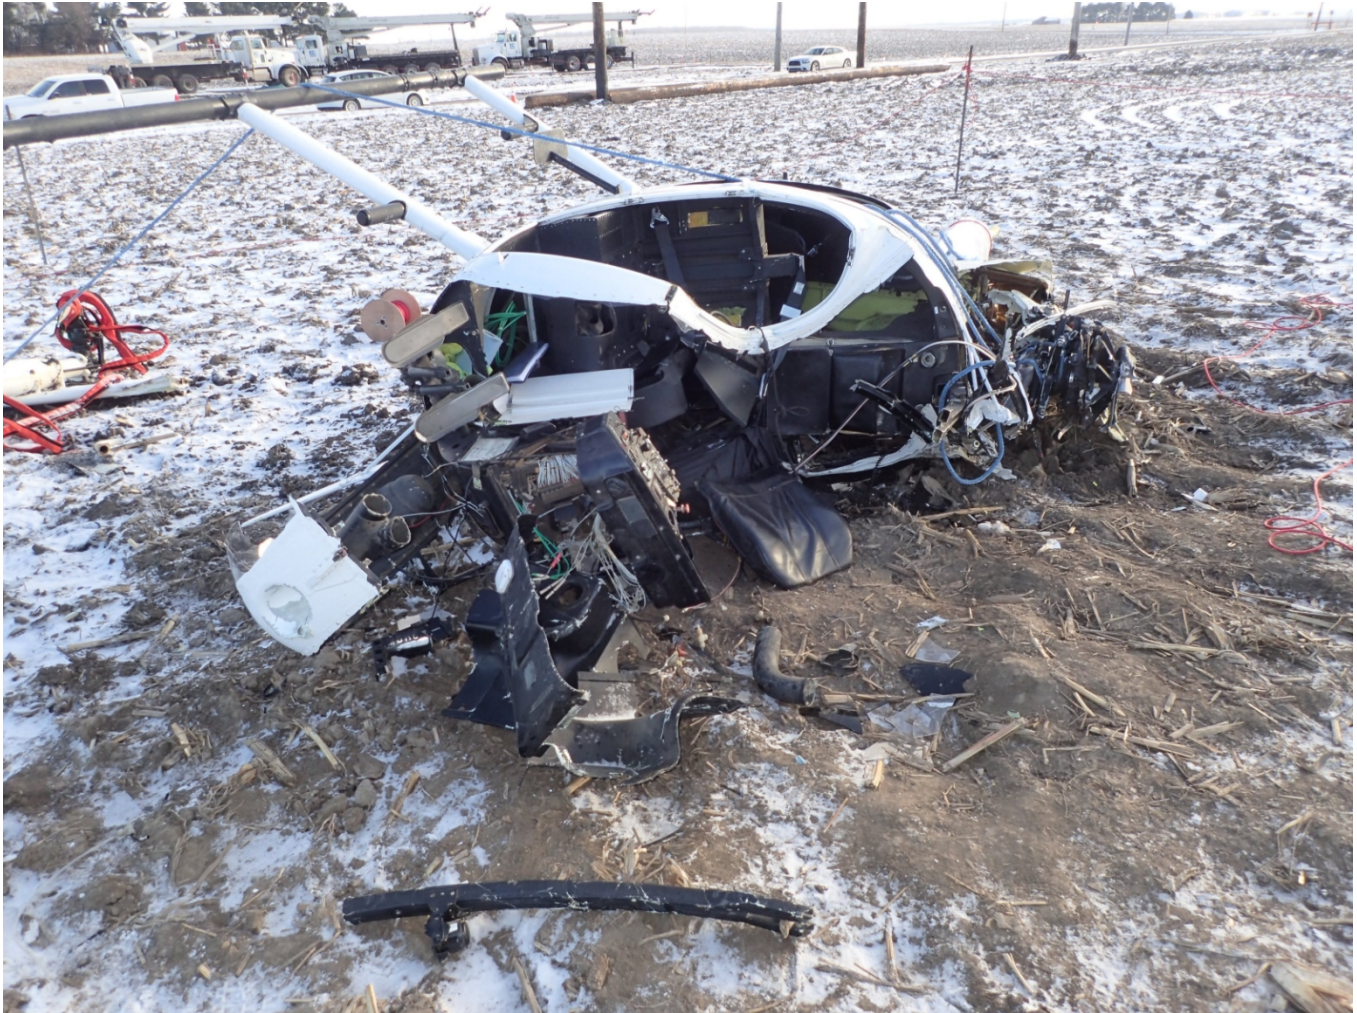
Figure 5 – Main Wreckage

The helicopter's fuselage came to rest on its left side (figure 5), the same side as the pilot's seat. The aft section of the tailboom came to rest about 5 ft to the north of the fuselage. The main rotor blades separated from the rotor hub and came to rest to the south of the fuselage. The tailboom exhibited blue transfer marks, and the long line sheath was entangled in the tail rotor assembly. The horizontal and vertical stabilizers separated from the end of the tailboom. The lower portion of the blue long line was entangled in the main rotor hub and extended over the right side of the fuselage and right skid toward the tailboom. The grappling hook remained attached to the long line and was partially embedded in the soil.

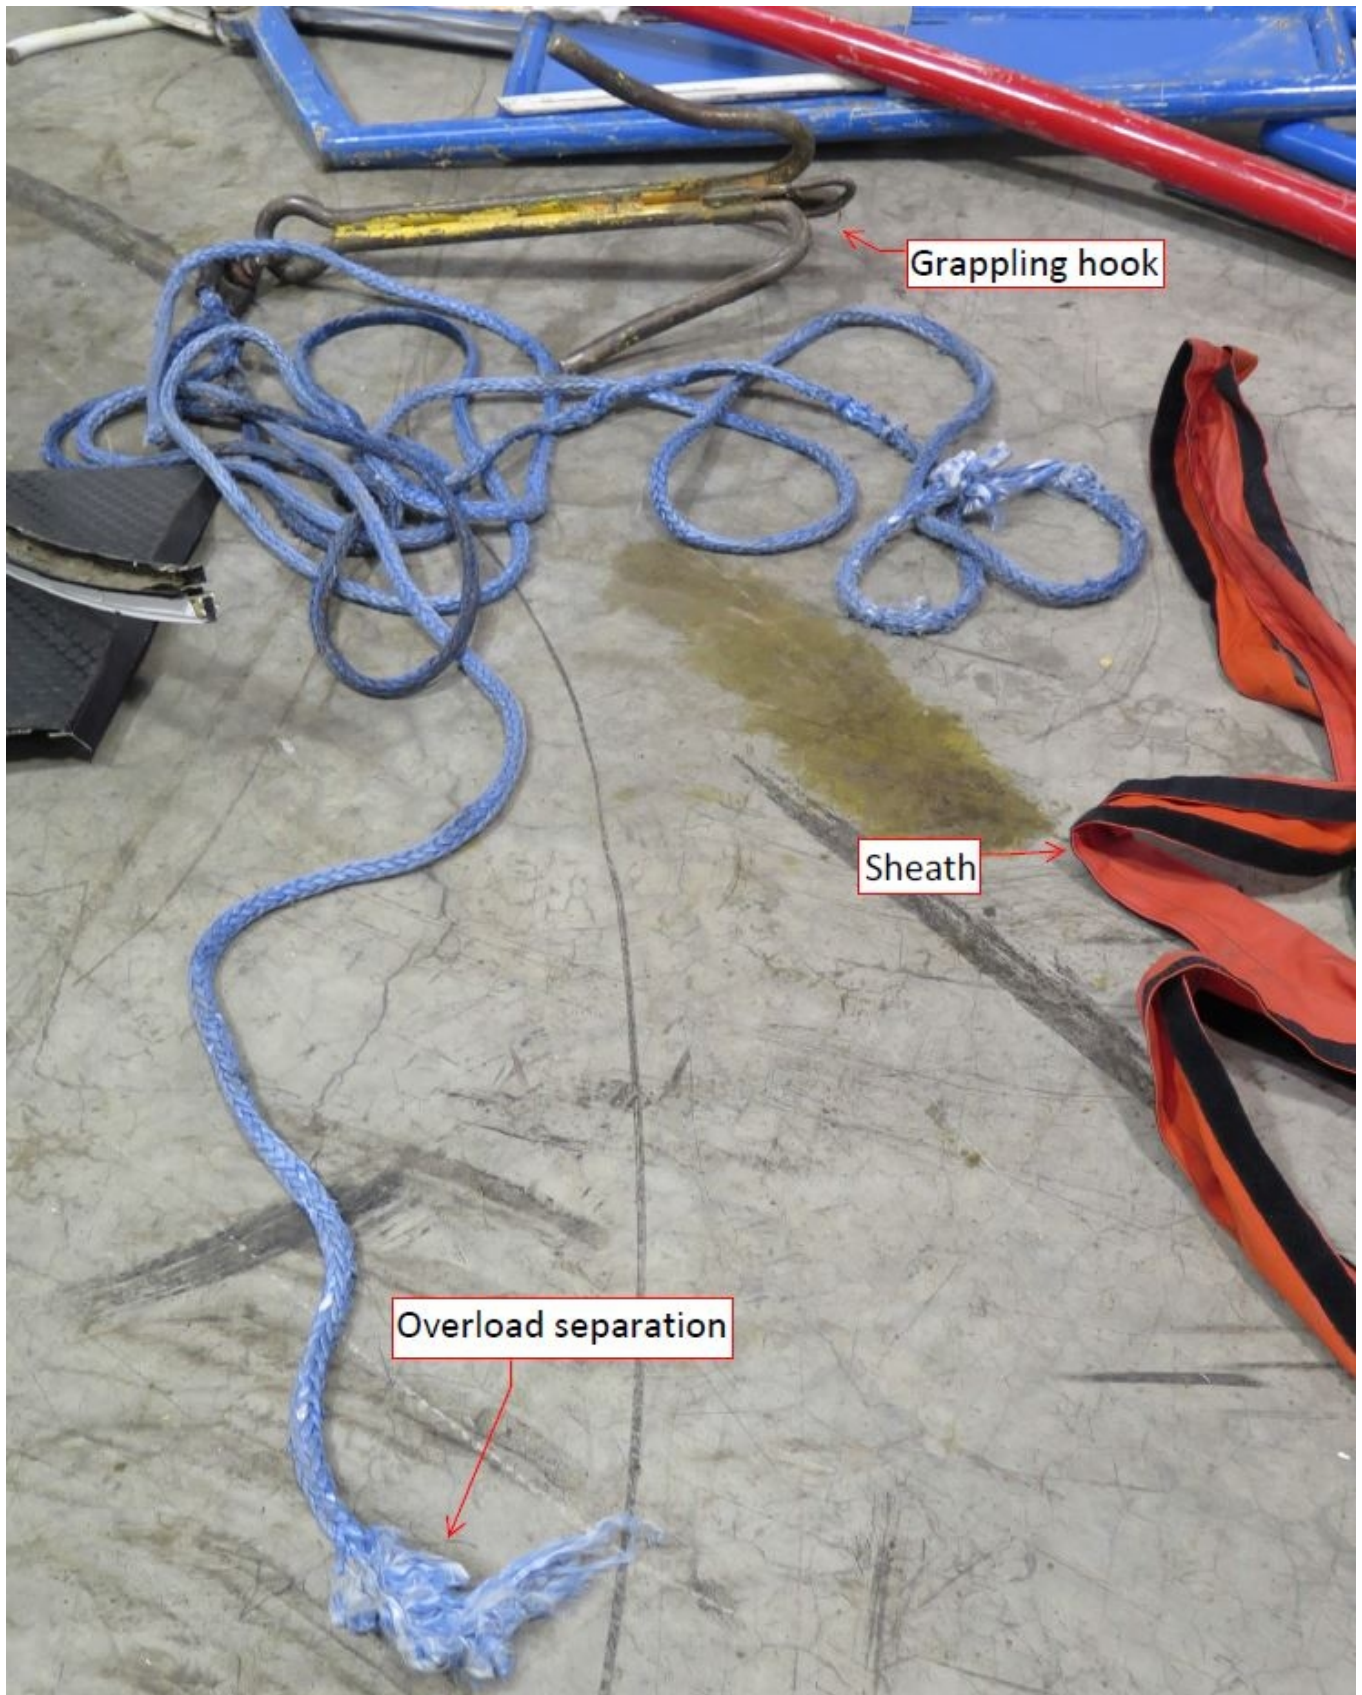
Figure 6 – Long line, Sheath, and Grappling Hook

The long line was separated in tension overload near the top of the line, a few feet from the cargo hook. Figure 3 shows the top portion of the long line still attached to the helicopter before the accident and figure 6 shows the postaccident condition of the long line. The cargo hook was found open at the accident site. The breakaway swivel, its shear pin, the two carabiners that hooked to either side of the swivel, and the upper portion of the long line were not found during the investigation. The aft end of the needle remained connected to the sock line via a non-breakaway swivel. The needle's fractured aft loop was found about 50 yards south of the accident site. Except for the fracture after loop, the rest of the needle remained intact with ground impact damage.

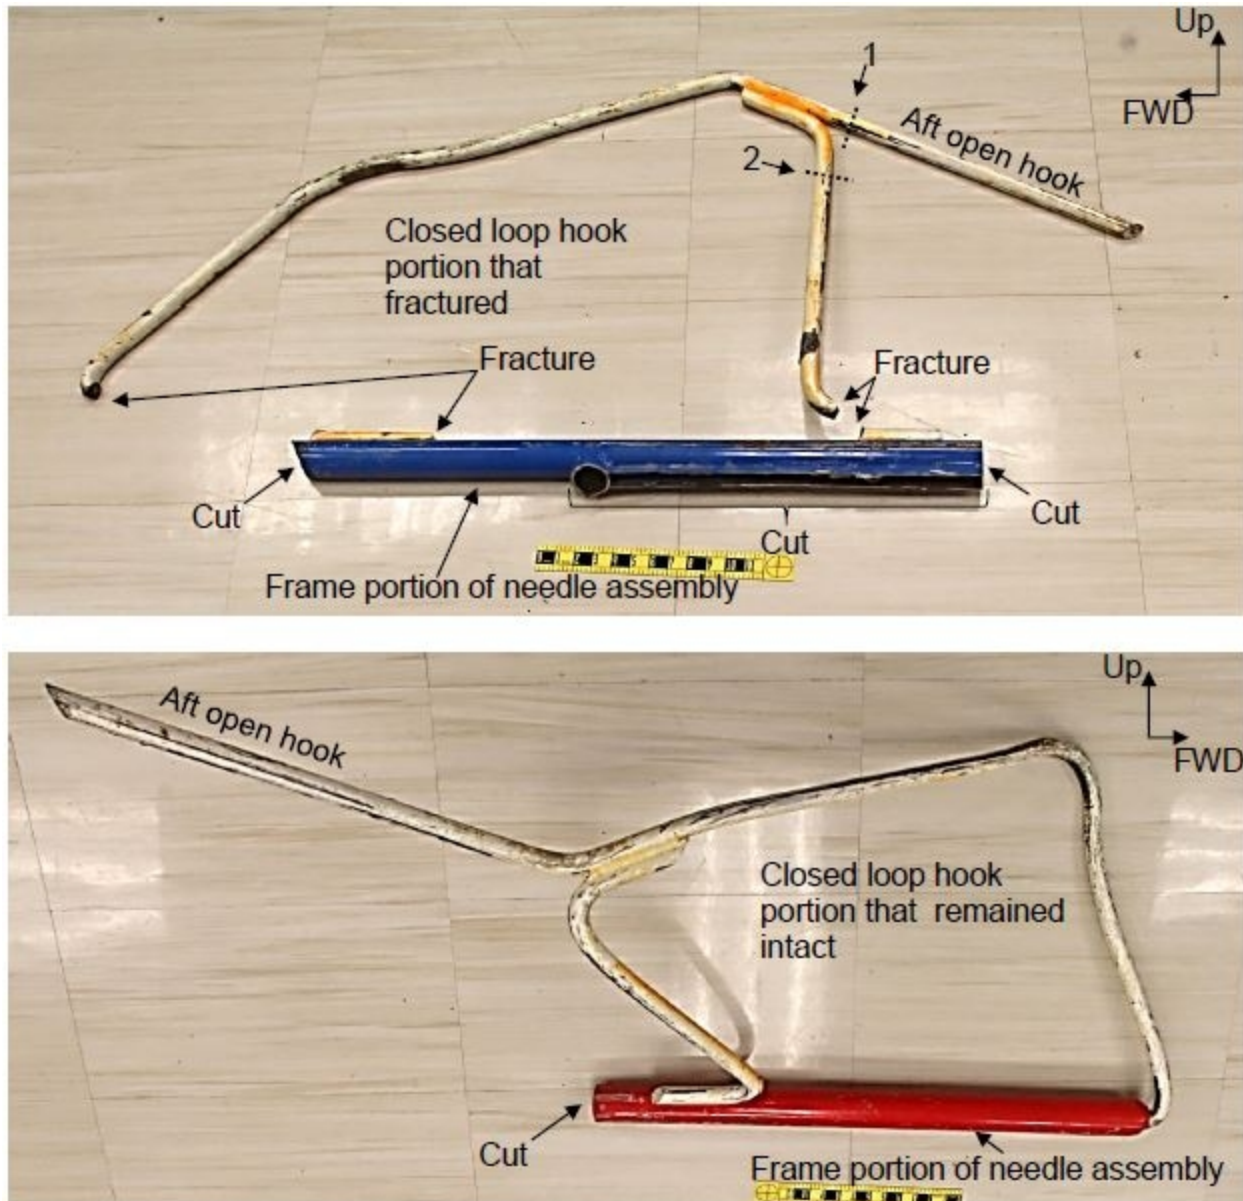
Figure 7 – Needle Damage

Examination of the fracture surfaces of the needle showed evidence of ductile overstress separation. There was no evidence of a preexisting fracture or crack in the needle. The fracture of the needle was most likely the result of the needle impacting the tower.

Portions of the damaged needle assembly were sent to the NTSB Materials Laboratory for examination and testing; photos of the as-received portions are shown in figure 7.

The needle assembly contained closed loops at the center and the forward end. The top portion of each closed loop also contained an open hook portion that faced aft. A visual examination of the needle assembly revealed that the aft closed loop (the point of attachment of the grappling hook) fractured at two locations. The fractures were through the round solid bar portion and intersected a portion of the weld at the frame portion. A bench binocular microscope examination of the fracture faces revealed rough texture features on slant planes consistent with ductile-bending overstress separation, with no evidence of a preexisting crack, such as fatigue crack. The welds at the fracture face showed no evidence of defects such as porosity.

A metallurgical section was made through the loop portions in the areas indicated by arrows 1 and 2 in figure 7 to obtain a 0.3-inch-thick disc portion from the 1-inch diameter solid round bar. Rockwell hardness (HRB) testing of the flat cut faces, perpendicular to the length of the solid round bar, produced average hardness values of 93 HRB, which converted to a tensile strength of about 94,000 lbs. per square inch. The load required to fracture the 1-inch solid round bar from the needle assembly was calculated by multiplying the approximate tensile strength by the cross-sectional area of the solid round bar. The load required to fracture the 1-inch solid round bar under constant tensile load was calculated to be 73,790 lbs., which is nearly 40 times greater than the load required to break the side hook's breakaway swivel shear pin.
