Aviation Investigation Final Report

Location:	Micanopy, Florida	Accident Number:	ERA17FA145
Date & Time:	April 4, 2017, 09:08 Local	Registration:	N155CL
Aircraft:	Pipistrel Virus SW	Aircraft Damage:	Destroyed
Defining Event:	Windshear or thunderstorm	Injuries:	1 Fatal
Flight Conducted Under:	Part 91: General aviation - Personal

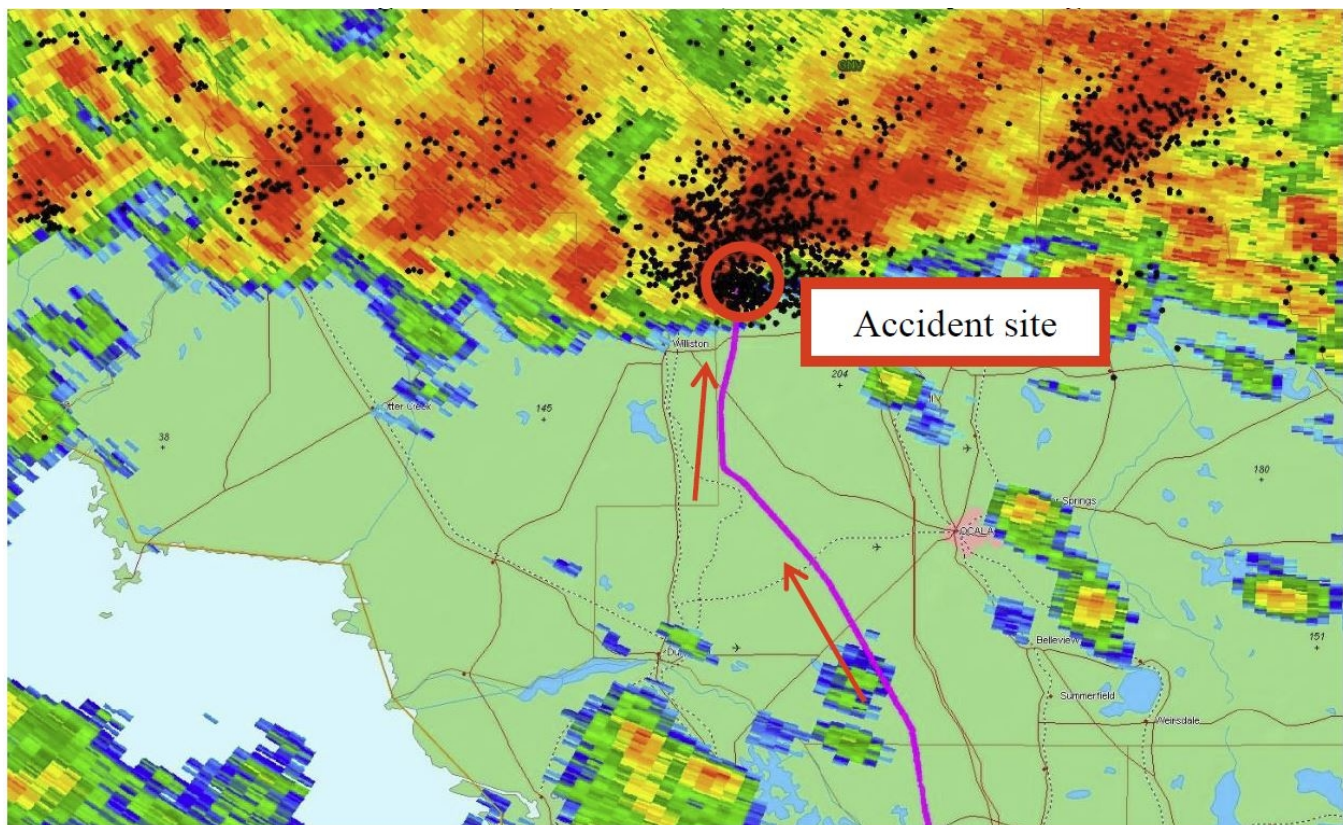
Radar returns from the motorglider ended at the edge of an east-west oriented line of severe thunderstorms, rain showers, and lightning that extended about 100 nautical miles to either side of the motorglider's radar flight track, according to National Weather Service (NWS) weather radar data. (See figure 1.)

Figure 1 - KJAX WSR-88D reflectivity for the 0.5° elevation scan initiated at 0911 EDT

Weather radar imagery and lightning data depicted heavy to extreme echoes (precipitation) at the accident location with convective cells and lightning. The echoes were consistent with the possibility of hail, extreme turbulence, and strong surface wind gusts. Radar velocity data indicated winds conducive to rotation above the accident site at the time of the accident, with the potential for tornadic activity at the surface. The area of heavy to extreme precipitation stretched across the entire width of northern Florida between 0845 and 0915.
