Aviation Investigation Final Report

Location:	Spanaway, Washington	Accident Number:	WPR17LA087
Date & Time:	April 13, 2017, 09:40 Local	Registration:	N5131H
Aircraft:	Titan TORNADO I	Aircraft Damage:	Substantial
Defining Event:	Flight control sys malf/fail	Injuries:	1 Serious
Flight Conducted Under:	Part 91: General aviation - Personal

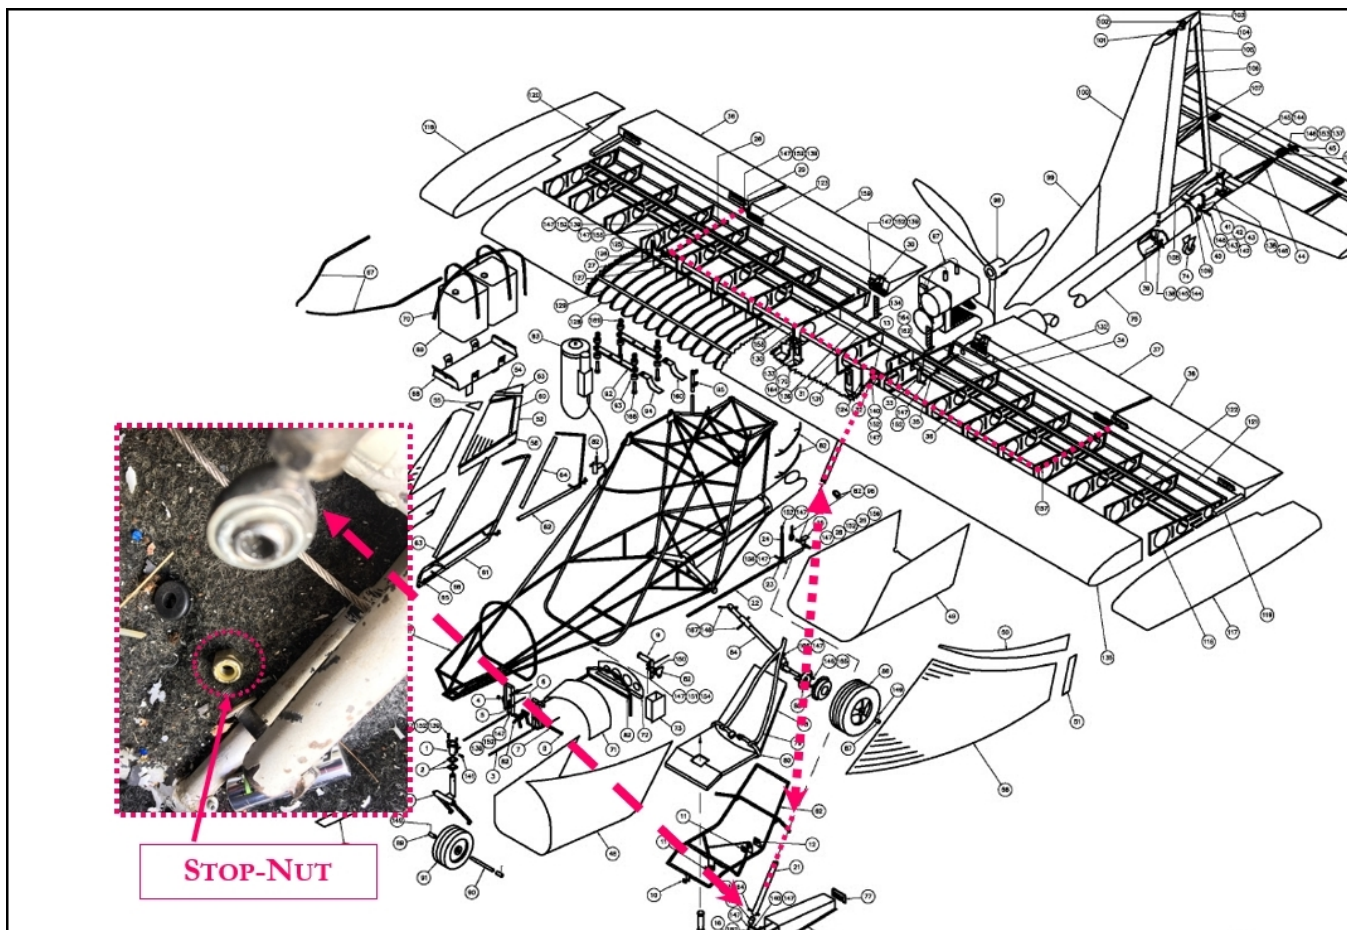
Picture 1: Aileron System

The examination of the aileron system revealed that the control tube was disconnected from the control mixer weldment. The stop nut that normally is affixed to the bolt connecting the aileron control tube to the control yoke tube was found on the cabin floor. The bolt end had a hole for a cotter pin, but no cotter pin was located. There were no markings on the nylon insert of the stop nut, which is consistent with the nut not being adequately attached during assembly.

During the last condition inspection, about 4 months and 24 flight hours before the accident, an airframe and powerplant mechanic had adjusted the aileron control mixer. It is likely that during that maintenance activity, the nylon hardware was not properly attached to the aileron control tube.

During the post-accident examination, control continuity for the rudder and elevator systems was established. An examination of the aileron system revealed that there was control continuity from the aileron control surfaces to the control tube in the cockpit. The upper attach point of the control tube (near wings) remained intact and the lower end (in cockpit) was found disconnected from the control mixer weldment. The stop-nut that normally is affixed to the bolt connecting the aileron control tube to the control yoke tube was found on the cabin floor about 5 inches from the ball joint (see picture 1). The bolt end had a hole for a cotter pin, but no cotter pin was located. There was no markings on the nylon insert of the stop nut consistent with it not being adequately tightened during the last maintenance.
