Aviation Investigation Final Report

Location:	Charleston, West Virginia	Accident Number:	DCA17FA109
Date & Time:	May 5, 2017, 06:51 Local	Registration:	N334AC
Aircraft:	SHORT BROS. & HARLAND SD3 30	Aircraft Damage:	Substantial
Defining Event:	Abnormal runway contact	Injuries:	2 Fatal
Flight Conducted Under:	Part 135: Air taxi & commuter - Non-scheduled

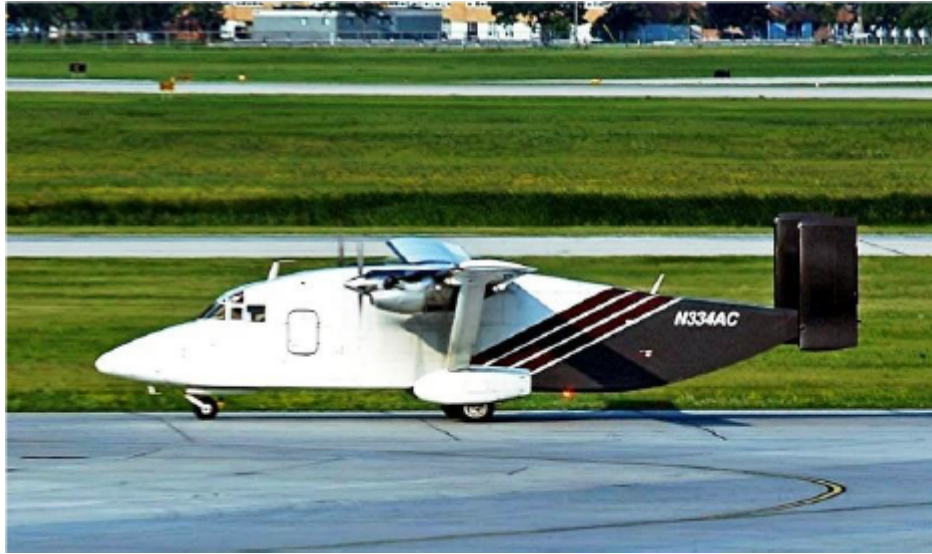
Figure 1. Photograph of accident airplane (N334AC).

The accident airplane was a Short Brothers SD3-30 Variant 200, serial number SH-3029 (see figure 1). An all-aluminum, high-wing, twin turboprop airplane, it was built in 1979 as a passenger airplane capable of transporting up to 30 people. ACC purchased and converted the airplane to a cargo configuration in December 1998 through the installation of several supplemental type certificates. Following completion of this work, the FAA issued a standard airworthiness certificate in the transport category on December 17, 1998. According to ACC, the cockpit voice recorder (CVR) was removed from the airplane during the conversion to the cargo configuration.

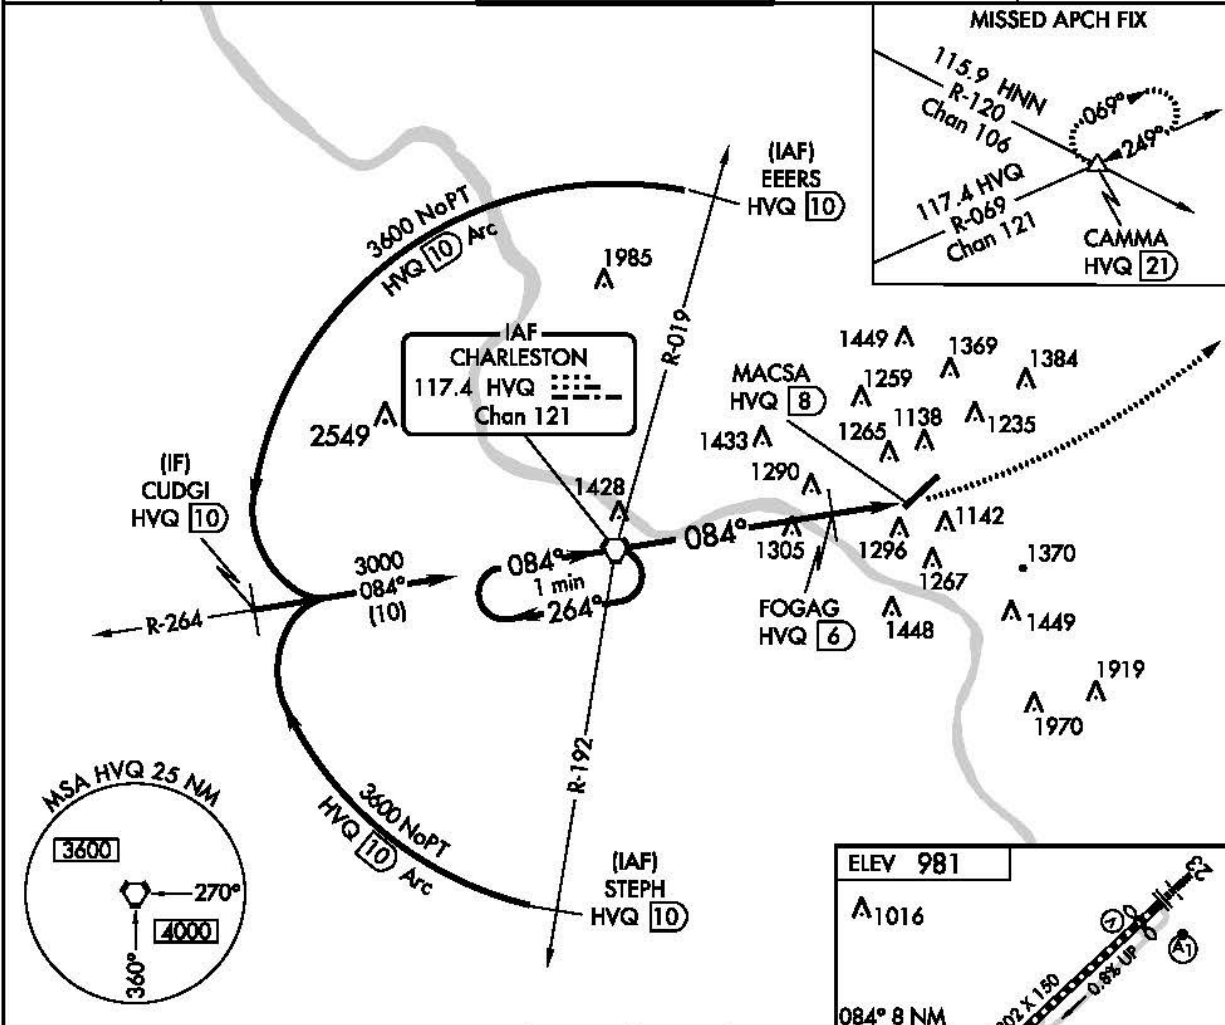
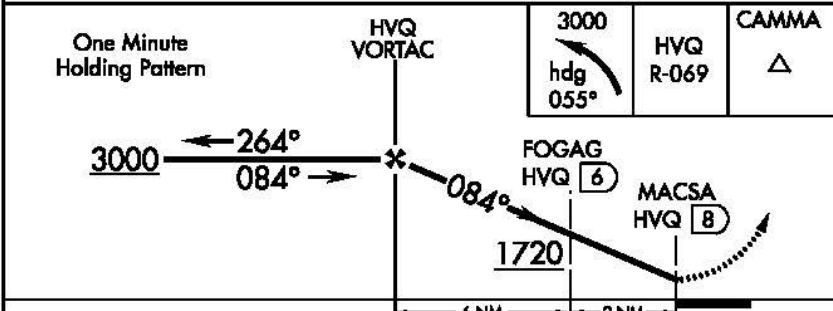
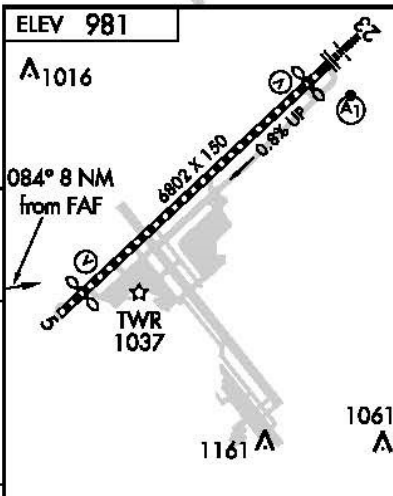
Figure 2. CRW VOR-A approach chart.

The VOR-A circling instrument approach was designated a circling approach because its final approach segment is more than 30° different from the alignment of runway 5 (the intermediate and final approach course for the VOR-A approach is on an 84° radial). The accident airplane was equipped with DME that allowed the flight crew to use the FOGAG fix minimums as indicated on the CRW VOR-A approach chart (see figure 2) These minimums indicated an MDA of 1,600 ft and 1-mile visibility after crossing FOGAG, which is 2 DME from the missed approach point (MAP). If visual contact with the runway is not established by the MAP, according to the approach chart, a missed approach should be performed by initiating a climbing left turn to 3,000 ft mean sea level (msl) via a heading of 55° and HVQ radial 069° to CAMMA intersection at 21 DME (see the Additional Information section for information about ACC's missed approach guidance). A postaccident flight check by the FAA found no problems with the navigation system.
