# Aviation Investigation Final Report

<b>Location:</b>	Charleston, West Virginia	<b>Accident Number:</b>	DCA17FA109
<b>Date &amp; Time:</b>	May 5, 2017, 06:51 Local	<b>Registration:</b>	N334AC
<b>Aircraft:</b>	SHORT BROS. & HARLAND SD3 30	<b>Aircraft Damage:</b>	Substantial
<b>Defining Event:</b>	Abnormal runway contact	<b>Injuries:</b>	2 Fatal
<b>Flight Conducted Under:</b>	Part 135: Air taxi & commuter - Non-scheduled

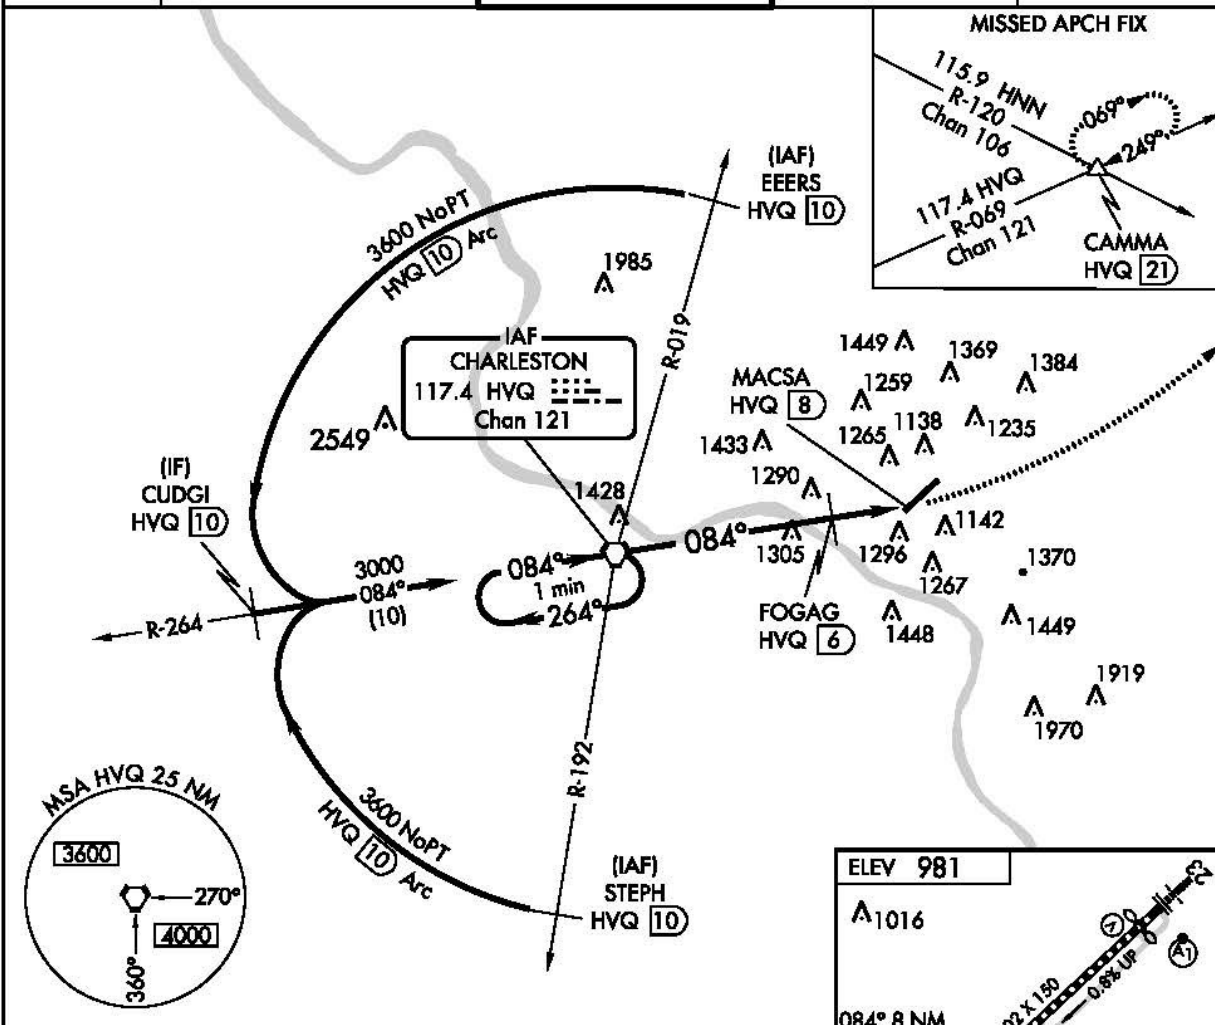
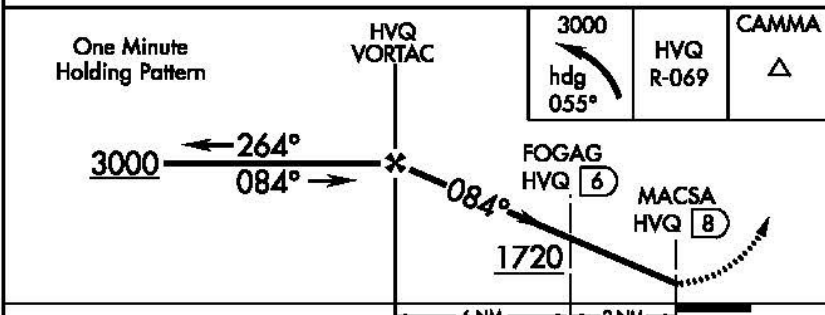
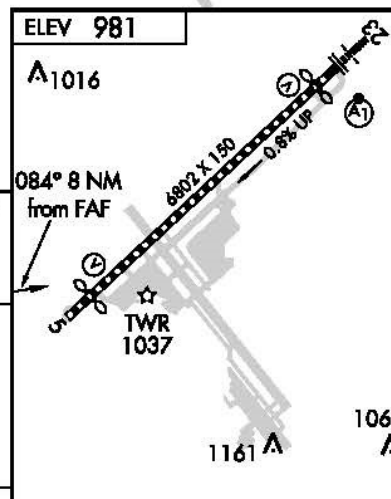
Figure 2. CRW VOR-A approach chart.

The VOR-A circling instrument approach was designated a circling approach because its final approach segment is more than 30° different from the alignment of runway 5 (the intermediate and final approach course for the VOR-A approach is on an 84° radial). The accident airplane was equipped with DME that allowed the flight crew to use the FOGAG fix minimums as indicated on the CRW VOR-A approach chart (see figure 2) These minimums indicated an MDA of 1,600 ft and 1-mile visibility after crossing FOGAG, which is 2 DME from the missed approach point (MAP). If visual contact with the runway is not established by the MAP, according to the approach chart, a missed approach should be performed by initiating a climbing left turn to 3,000 ft mean sea level (msl) via a heading of 55° and HVQ radial 069° to CAMMA intersection at 21 DME (see the Additional Information section for information about ACC's missed approach guidance). A postaccident flight check by the FAA found no problems with the navigation system.

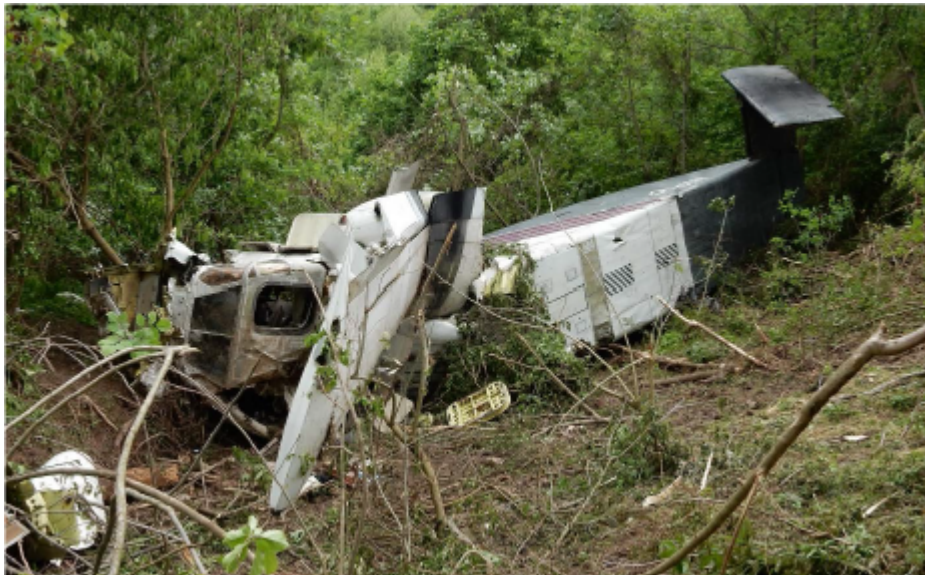
Figure 3. Photograph of the main wreckage.

The fuselage was resting on its left side with significant crushing damage and deformation observed forward of the location of the main landing gear. There was no evidence of fire. The cockpit area was crushed and damaged on the left side.

The right wing was fractured at the wing root and deformed forward and leading edge down. The right wing was intact, partially attached to the fuselage, and mostly undamaged. The right engine remained attached to the right wing. The right vertical stabilizer and rudder, right horizontal stabilizer and elevator, and center elevator remained attached to the empennage.
