Aviation Investigation Final Report

Location:	Firebaugh, California	Accident Number:	WPR17LA104
Date & Time:	May 15, 2017, 16:44 Local	Registration:	N846PM
Aircraft:	EVOLUTION AIR LLC LANCAIR EVOLUTION	Aircraft Damage:	Substantial
Defining Event:	Miscellaneous/other	Injuries:	3 Minor, 2 None
Flight Conducted Under:	Part 91: General aviation - Personal

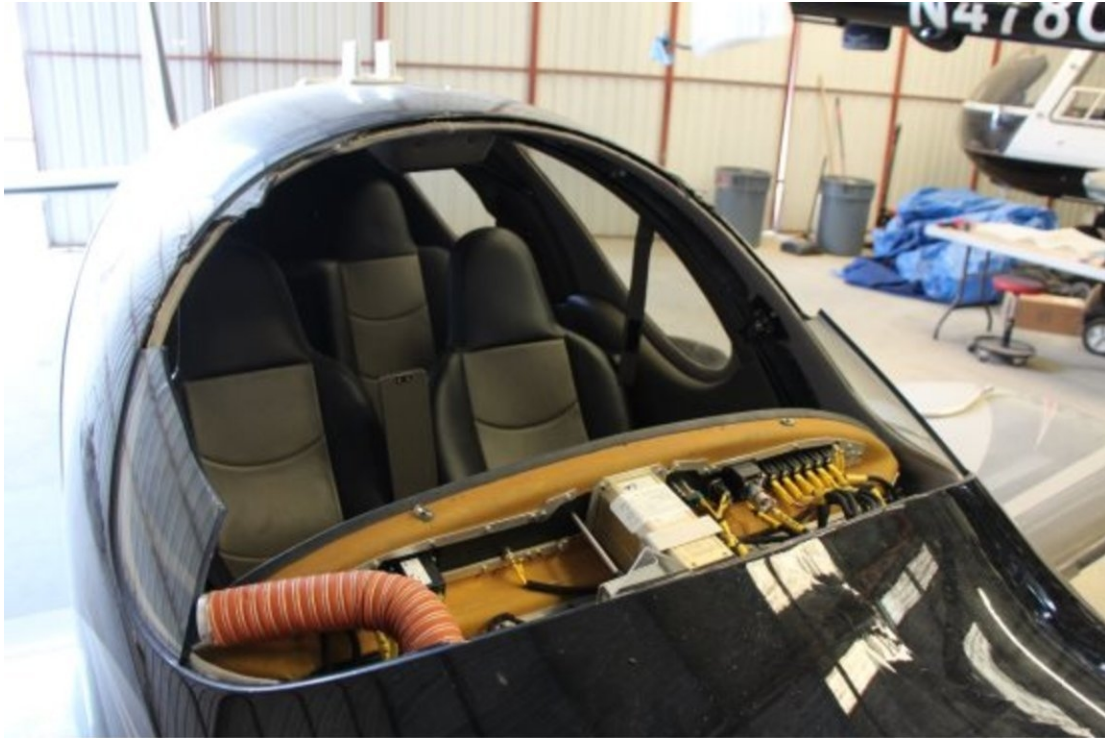
Figure 1. Forward Face of Windshield

A portion of the windshield that remained attached to the frame exhibited a fracture consistent with pure tension loading, likely from internal pressurization. Due to the curvature at that location, the fracture area was likely one of high stress on the windshield. Examination of the windshield fragments and frame did not show any evidence of impact from a foreign object, but showed significant structural flexing of the fuselage due to delaminated wet-layup plies during construction, as evidenced by extensive cracking at the aft engine cowling. However, the absence of an airplane structural analysis from the manufacturer precluded further review of the structural flexing of the fuselage. A material and bond evaluation showed that the windshield frame material did not exceed its glass transition temperature, indicating that the acrylic windshield was likely intact at the time of the failure; however, further analysis of the bond between the windshield and window frame could not be performed, as the manufacturer did not provide bond strength design values for either section.

The windshield was cast acrylic and the frame was a carbon fiber reinforced polymer (CFRP) with layers of carbon-fiber fabric and epoxy. Most of the windshield was fragmented and departed the airframe in-flight, but portions remained encased in the window frame. (See figure 1) Three pieces along the lower edge of the windshield were easily removed from the window frame. Large portions of the windshield extended beyond the edge of the integral window frame from about the 4 to 6 o'clock and about 6 to 8 o'clock positions. Additional sections of the windshield remained attached to the windshield frame but did not extend beyond the edge of the window frame cutout in the fuselage. The window frame had visible signs of damage to the composite airframe structure at the 2, 6, and 10 o'clock positions.

The windshield remnant at the left side of the frame included a longitudinal fracture (fracture A), and a crack in the lower left side of the windshield was adjacent to the frame (fracture B). Three other adjacent fractures were secondary.

The forward lower end of fracture A was flat and perpendicular to the interior and exterior surfaces across the thickness of the windshield and along the length of the fracture consistent with fracture under mostly tension loading.

Ratchet marks were observed from the interior surface at the origin area of fracture B, indicating a fracture initiation on multiple slightly offset planes from the interior surface. The overall subsequent progression of the fracture from the interior to exterior along the length of the crack was consistent with higher tension stress at the interior surface, indicative of a combination of tension and bending loads during fracture.

An examination of the windshield edge near fracture B showed gouges inconsistent with a rounded edge from a DA sander with 40-grit sandpaper. Further, the Hysol adhesive near the forward ends of fractures A and B showed impressions of parallel, curving grinding marks about 2 inches of the forward end of fracture B, also inconsistent with a DA sander with 40-grit sandpaper.

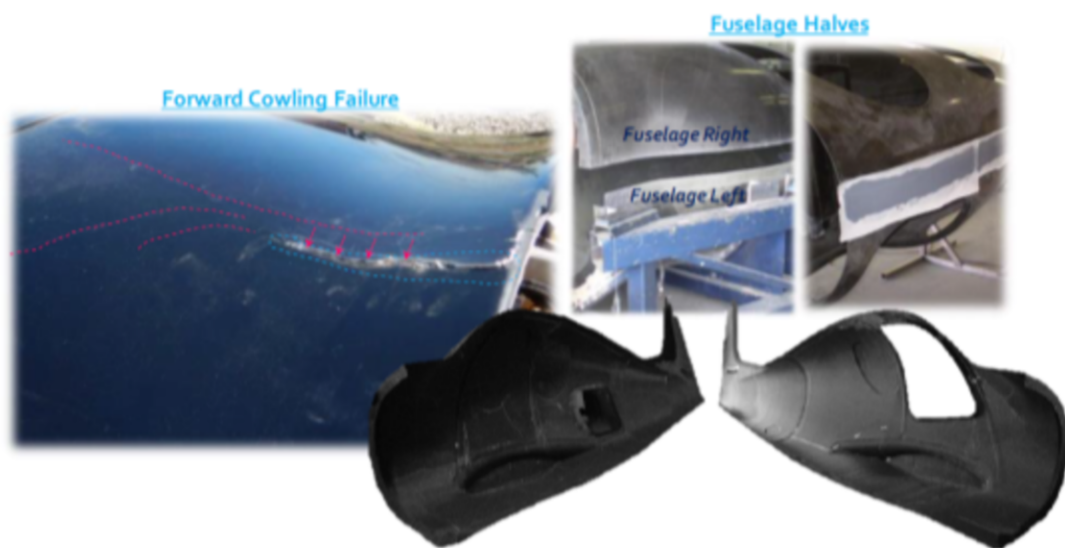
Figure 2: Excerpt of Forward Cowling Failure and Fuselage Halves from NIAR Report

Extensive cracking was found directly in front of the windshield, consistent with delaminated wet-layup plies that were applied to the fuselage after the two fuselage halves were joined together. (See figure 2) These findings indicated significant structural flexing in the fuselage.
