# Aviation Investigation Final Report

<b>Location:</b>	New Castle, Delaware	<b>Accident Number:</b>	ERA17FA190
<b>Date &amp; Time:</b>	May 25, 2017, 11:53 Local	<b>Registration:</b>	N62UP
<b>Aircraft:</b>	EUROCOPTER DEUTSCHLAND GMBH EC 135	<b>Aircraft Damage:</b>	Destroyed
<b>Defining Event:</b>	Loss of control in flight	<b>Injuries:</b>	1 Fatal
<b>Flight Conducted Under:</b>	Part 91: General aviation - Personal

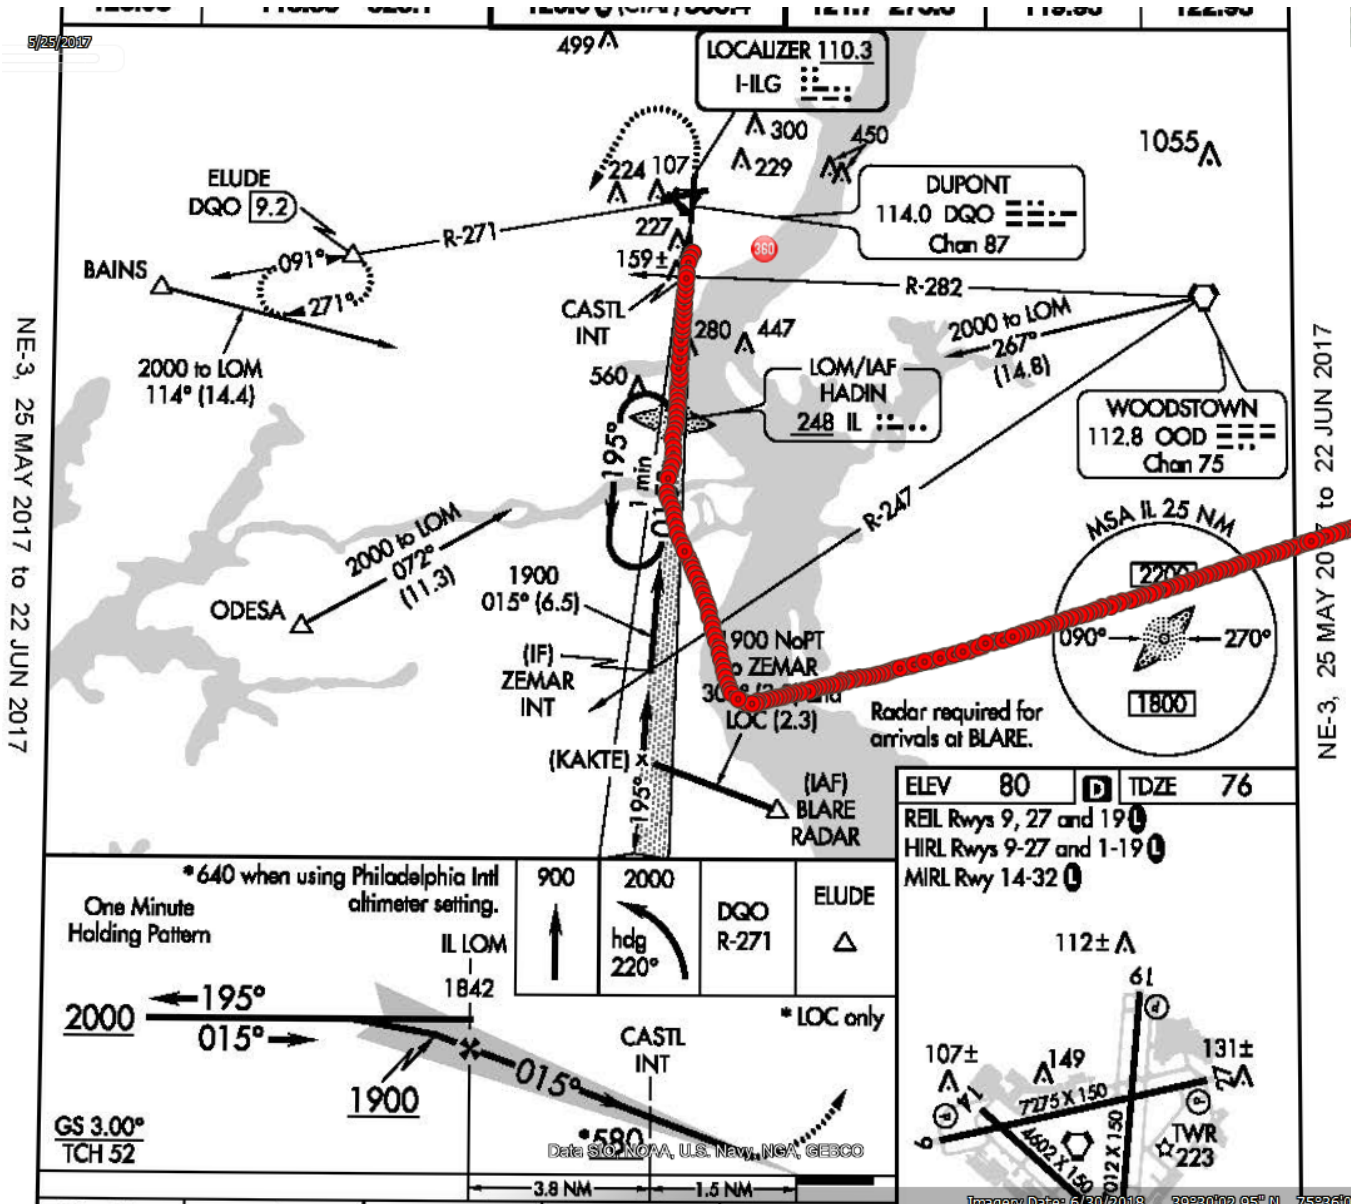
Figure 1. Overhead view of helicopter's radar ground track (red) overlaid onto the ILS Rwy 1 instrument approach procedure plan view.

The helicopter continued on course toward the runway; when it was about 3 miles, and about 2 minutes and 15 seconds beyond HADIN and still at an altitude of 2,000 ft msl, the pilot declared a missed approach. The controller advised the pilot to fly the published missed approach procedure. (The published procedure was a straight ahead climb to 900 ft, then left climbing turn to 2,000 ft to a heading of 220° to the ELUDE fix). Following the instruction, the helicopter climbed on course to 2,525 ft msl before it turned right and started a descent to 2,225 ft msl 4 seconds later. Subsequently, radar contact was lost when the helicopter was at 1,625 ft msl, and no additional communications were received from the pilot.

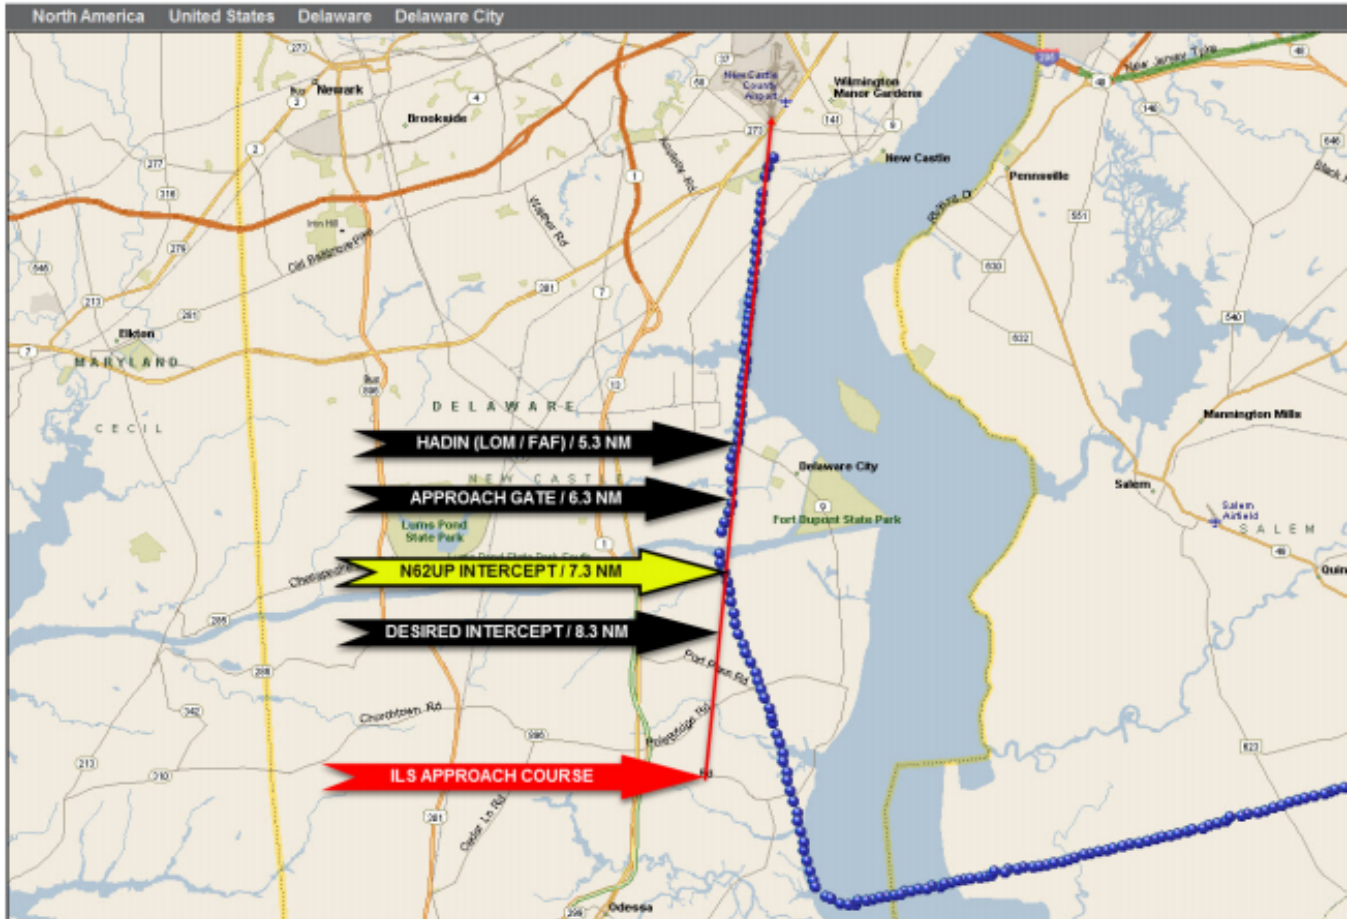
Although the radar vectors provided by the controller during the approach were contrary to the FAA's guidance to air traffic controllers, which required aircraft to be vectored to intercept an ILS localizer course 2 nm outside the approach gate given the weather conditions that prevailed at that time, radar data confirmed that the helicopter successfully tracked inbound toward the airport on the localizer course. Although the radar vectors did not directly contribute to the accident, they likely increased the pilot's task load during the accident sequence.

Figure 2. Radar flight track of the final segment of the accident flight. Key points along the route of flight have been depicted in order to illustrate the final approach intercept with relation to the final approach fix and approach gate.

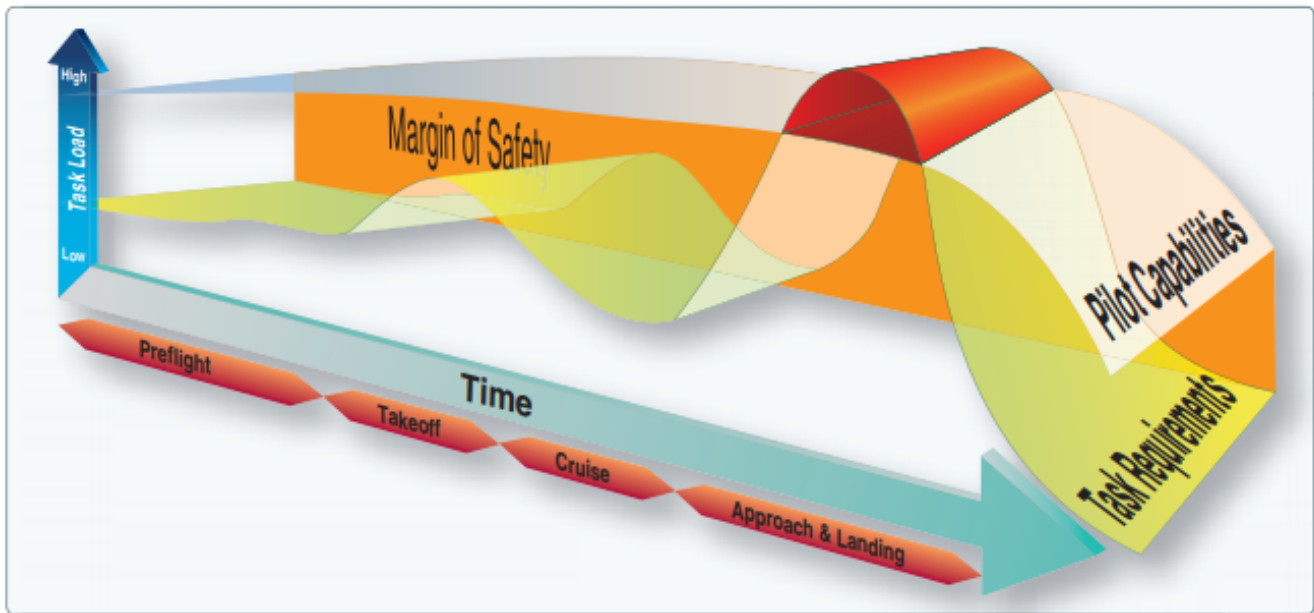
**Figure 14-1.** The pilot has a limited capacity of doing work and handling tasks, meaning there is a point at which the tasking exceeds the pilot's capability. When this happens, either tasks are not done properly or some are not done at all.

Figure 3. A depiction of task requirements and pilot capabilities in reference to a margin of safety.
