# Aviation Investigation Final Report

<b>Location:</b>	Haines, Alaska	<b>Accident Number:</b>	WPR17FA108
<b>Date &amp; Time:</b>	May 27, 2017, 11:01 Local	<b>Registration:</b>	N7376Y
<b>Aircraft:</b>	Piper PA 30	<b>Aircraft Damage:</b>	Substantial
<b>Defining Event:</b>	Loss of control in flight	<b>Injuries:</b>	2 Fatal, 1 Serious
<b>Flight Conducted Under:</b>	Part 91: General aviation - Personal

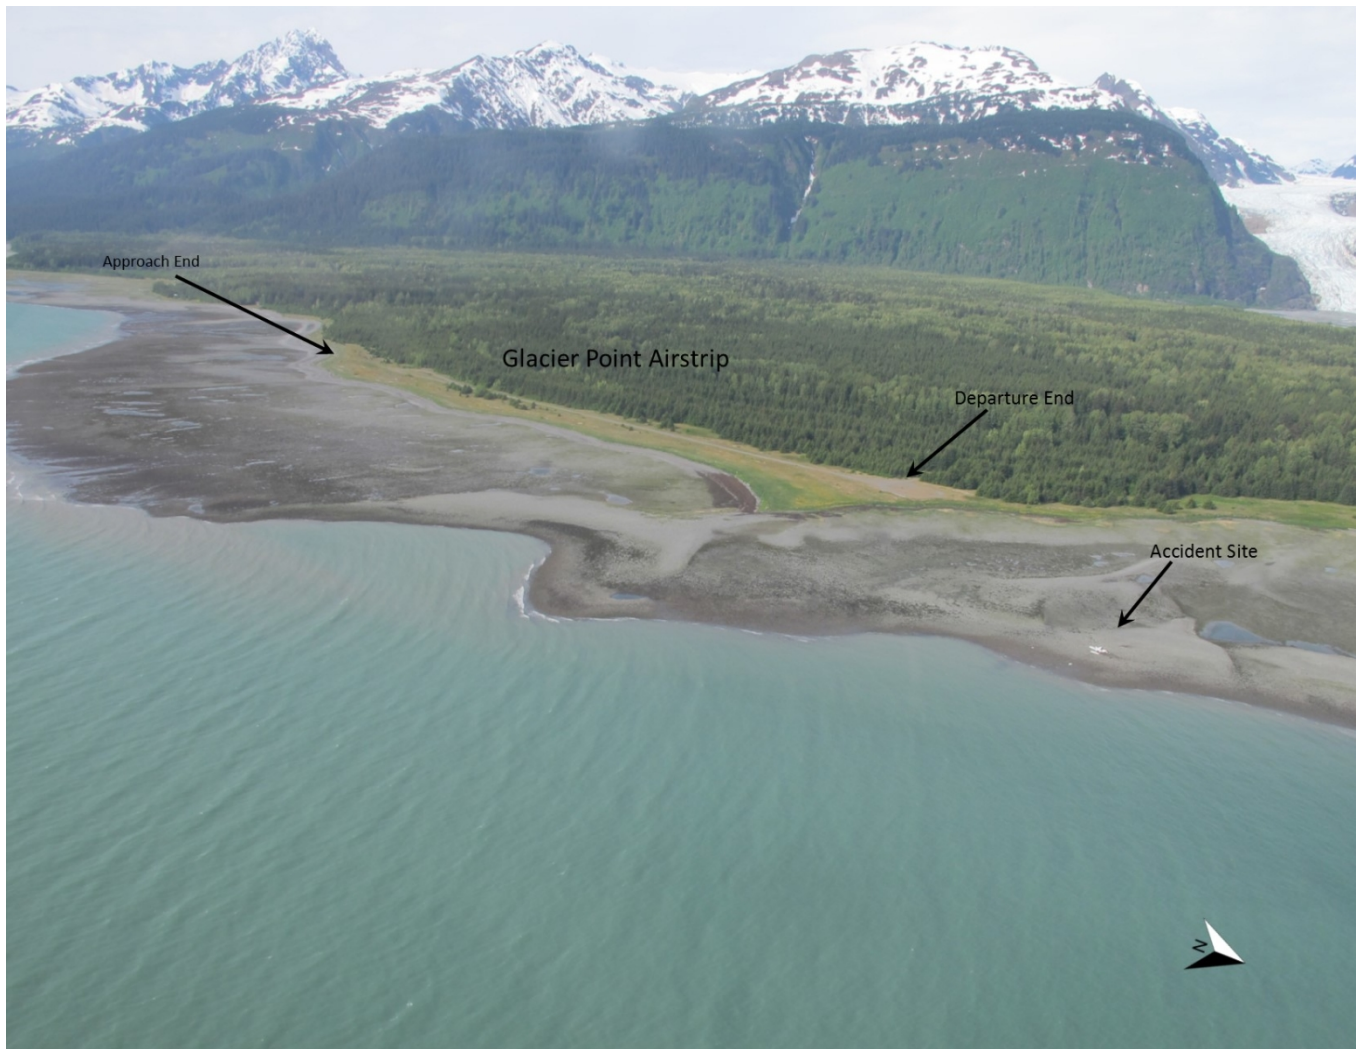
Figure 1-Aerial Image of the Accident Site

The impact site was located on the western tidal flats of the Chilkat Inlet, about 1/4-mile northeast of the north end of the airstrip at Glacier Point.

The initial on-scene examination of the airplane by the NTSB-IIC and a Federal Aviation Administration inspector revealed impact damage consistent with a right-wing-down, nose-down attitude during ground impact. The airplane remained intact, all flight control surfaces were accounted for, and cable control continuity was confirmed. The landing gear was in the down position, and the landing gear position switch was in the down position. The landing gear extension motor release arm was found in the disengaged position. The emergency landing gear extension handle was removed from its stowed position and installed in a socket on the emergency disengage control. The flaps were in the up position and the flap lever was in the down position.

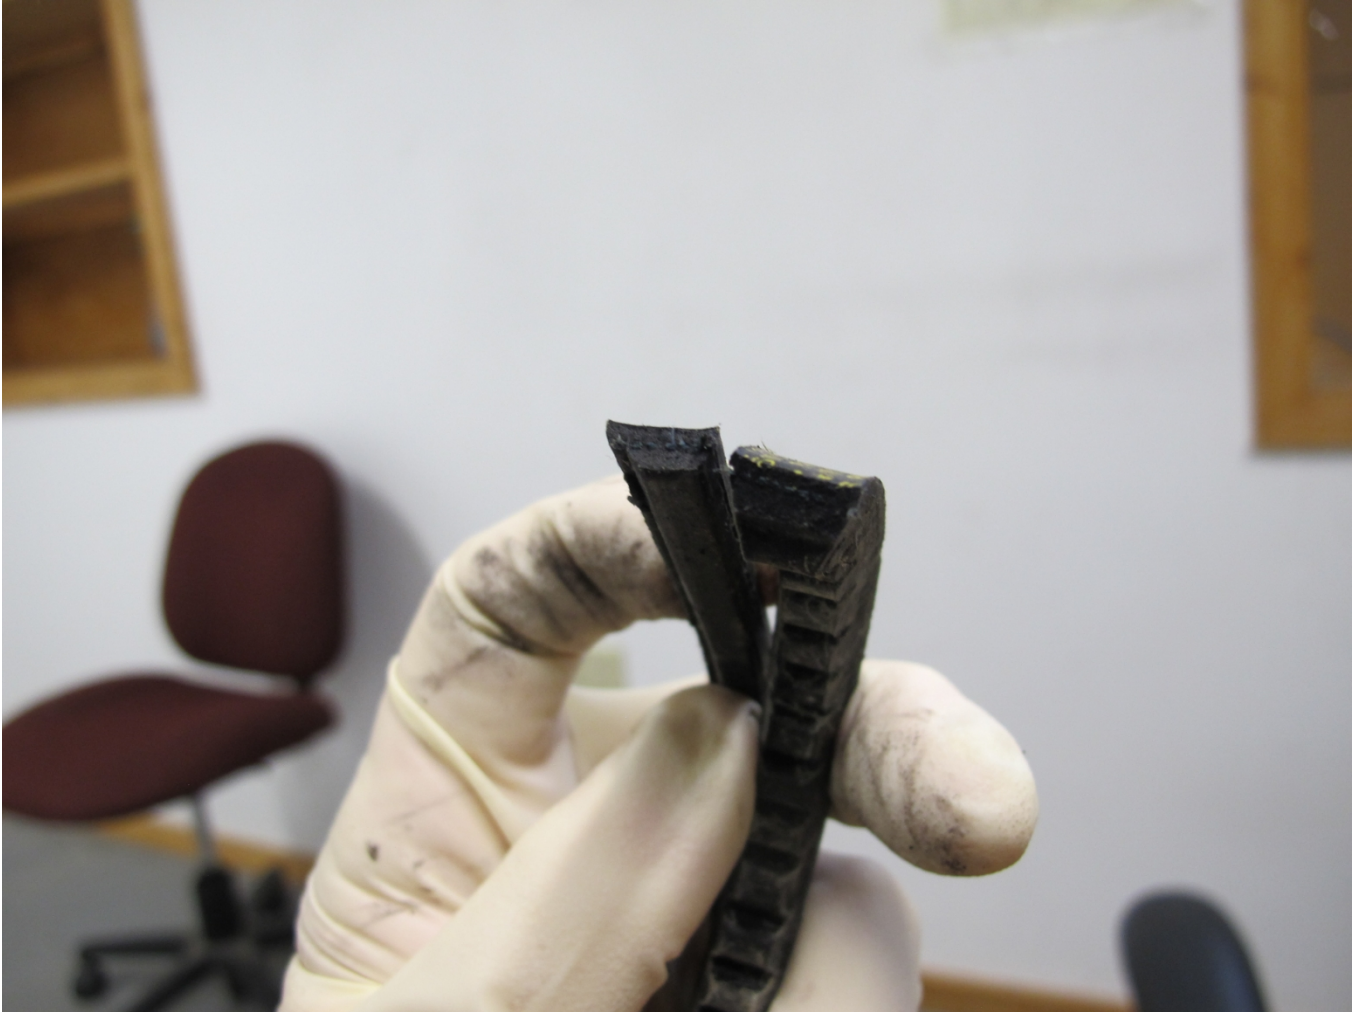
Figure 2-Right Engine Alternator Belt

The right engine alternator drive shaft rotated freely by hand, but the drive belt remained stationary with the crankshaft. The alternator drive belt was loose and excessively worn on the pulley contact area. The right engine inlet cowling section had rubber filings in the forward right interior surface. Rubber filings were also found on the back side of the starter ring gear and surrounding areas. The rubber filings were likely due to the loose fit of the belt on the pulley during engine operation. Given this evidence, the right engine alternator was probably intermittent with a loose belt.

The wreckage was relocated to a hangar at PAGS, and examination of the wreckage showed that the right engine crankshaft propeller flange was bent to one side and that the rocker covers had impact damage. The right engine's exterior surfaces had a dark oily residue. Oil residue was observed in the area of the alternator pulley and belt. The right engine alternator was undamaged and secure, and no signatures suggested that the alternator was repositioned during the accident sequence. The alternator electrical wiring remained secure at the terminals. The alternator drive pulley rotated freely by hand, and the drive belt remained stationary with the crankshaft. The right engine alternator drive belt was loose when examined and was subsequently removed from the engine. The belt was excessively worn on the pulley contact area as shown in Figure 2. A spare alternator drive belt was found stowed to the engine; the stowed belt shared the same part numbers as the worn belt (Napa Premium XL 25-7365). According to the alternator STC installation instructions, a Franklin (P/N 14883) or a Goodyear 5L380 belts should be used.

The right engine inlet cowling section had rubber filings in the forward right interior surface. Rubber filings were also found on the back side of the starter ring gear and surrounding areas.
