# Aviation Investigation Final Report

<b>Location:</b>	Puyallup, Washington	<b>Accident Number:</b>	WPR17LA114
<b>Date &amp; Time:</b>	May 30, 2017, 16:00 Local	<b>Registration:</b>	N399DG
<b>Aircraft:</b>	TAPPEN CHRIS VELOCITY SUV	<b>Aircraft Damage:</b>	Substantial
<b>Defining Event:</b>	Sys/Comp malf/fail (non-power)	<b>Injuries:</b>	1 None
<b>Flight Conducted Under:</b>	Part 91: General aviation - Personal

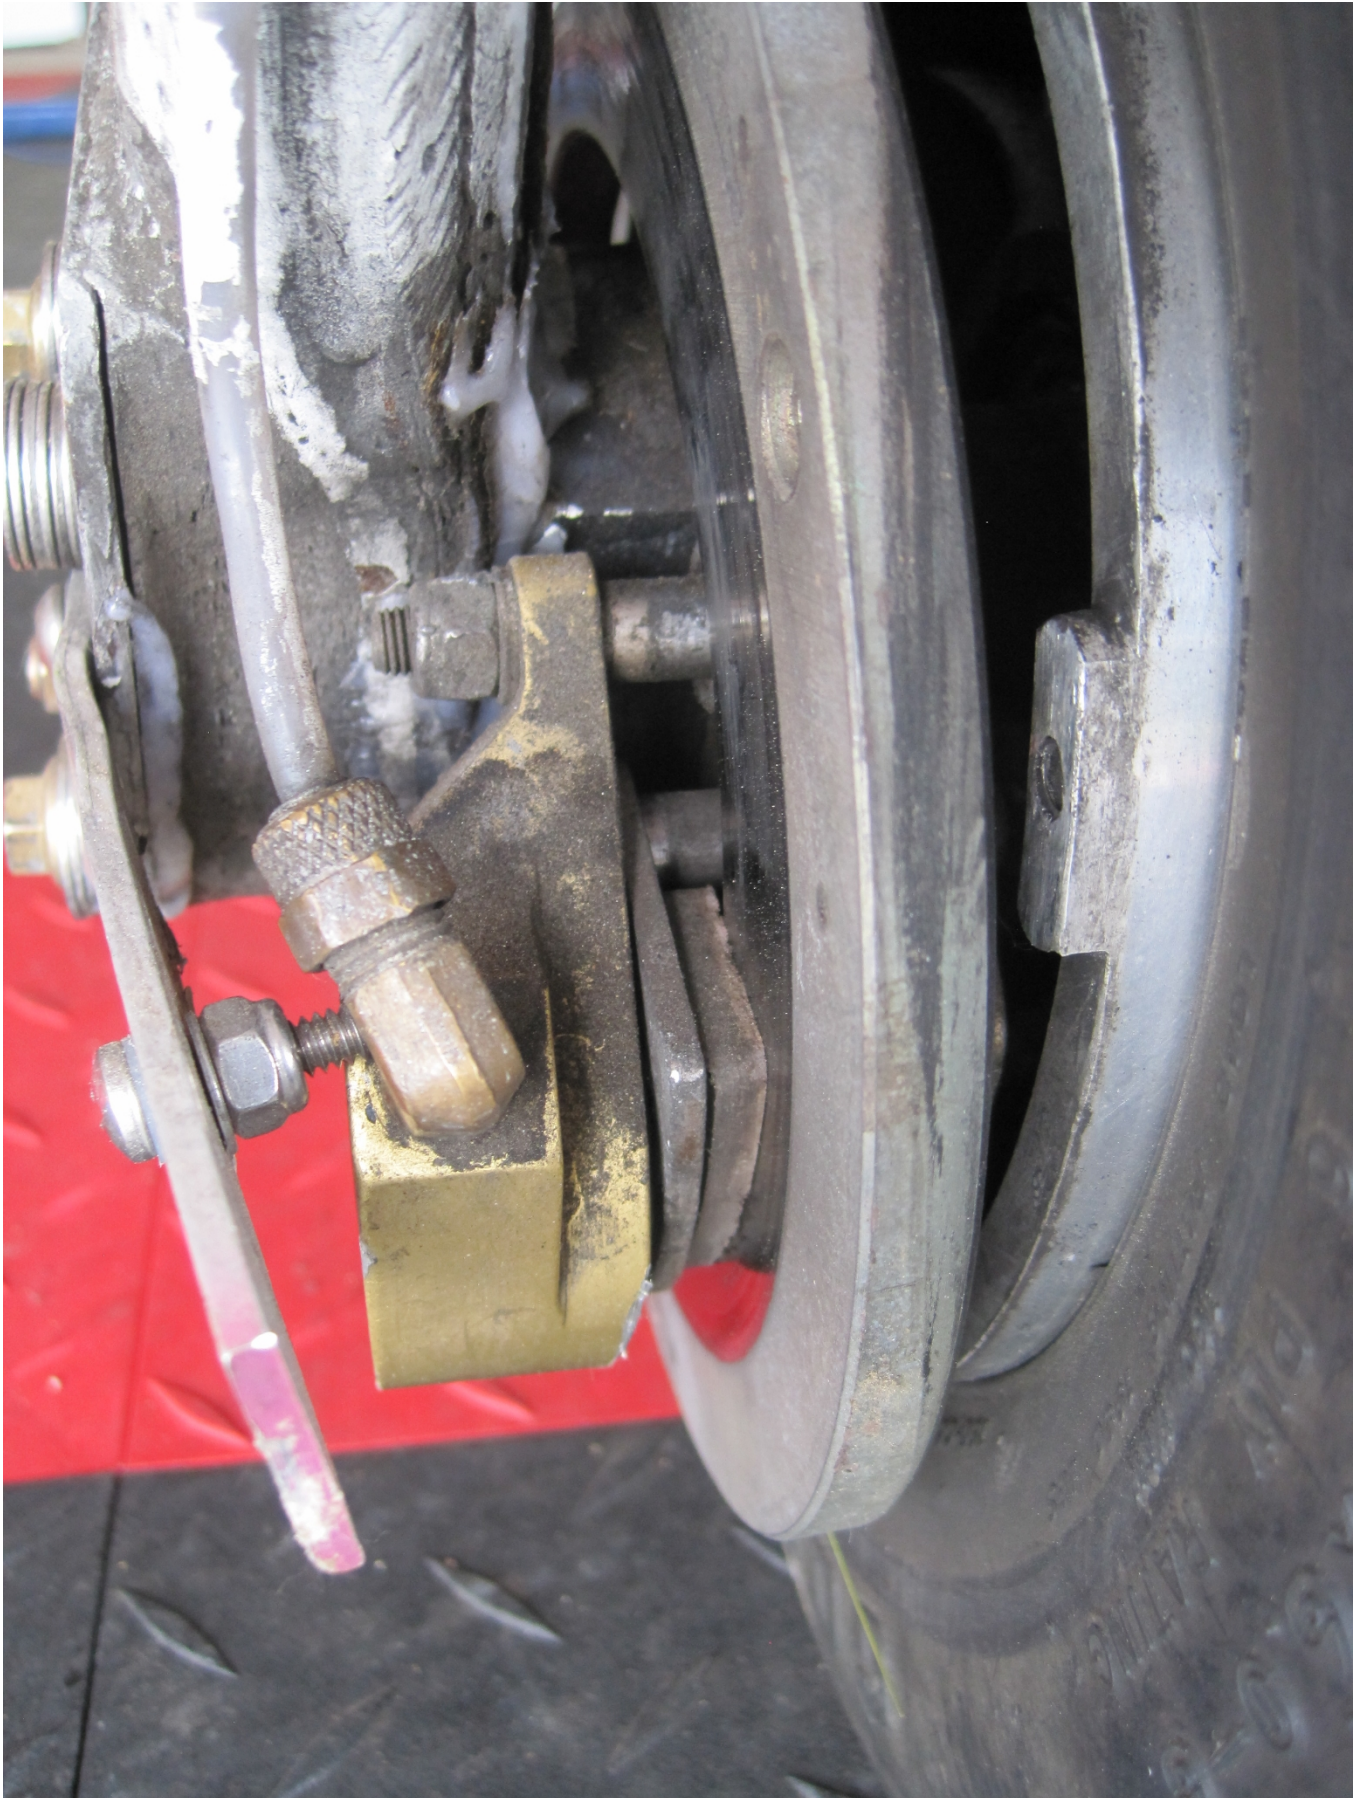
## Right Brake Disk Detached from Wheel Hub

The airplane builder's failure to install safety wires on the brake disc attachment bolts, and the mechanic's failure to identify the omission during the condition inspection. The subsequent brake disc separation resulted in a loss of directional control during the landing roll.

Post-accident examination revealed that all three hex bolts for the right brake disk were missing, and the disk had become detached from the wheel hub. The disk on the left side was still in place, but was loose, and the three bolts were finger-tight. The bolts and disks had holes to accommodate safety wire, but no safety wire was found on either assembly.
