Aviation Investigation Final Report

Location:	Mesa, Arizona	Accident Number:	WPR17FA155
Date & Time:	July 17, 2017, 16:52 Local	Registration:	N571JM
Aircraft:	Evolution 19 Lancair Evolution	Aircraft Damage:	Substantial
Defining Event:	Loss of control in flight	Injuries:	2 Fatal
Flight Conducted Under:	Part 91: General aviation

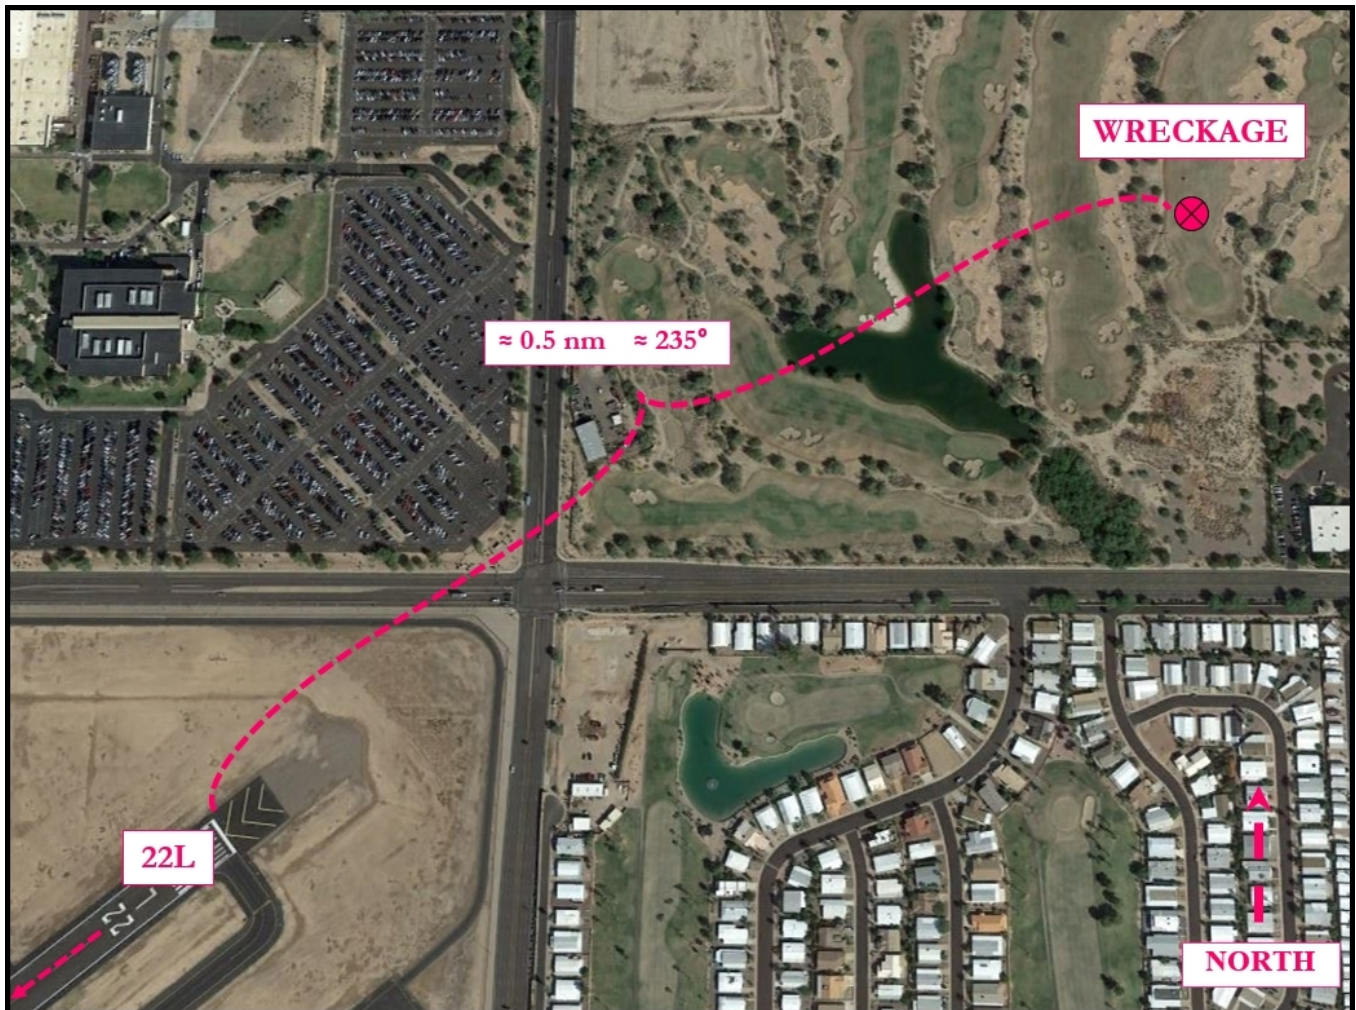
Figure 3: Wreckage in Relation to Runway

The wreckage was located about 0.5 nm northeast of the end of runway 22L, in a green area of a golf course (see figure 3).

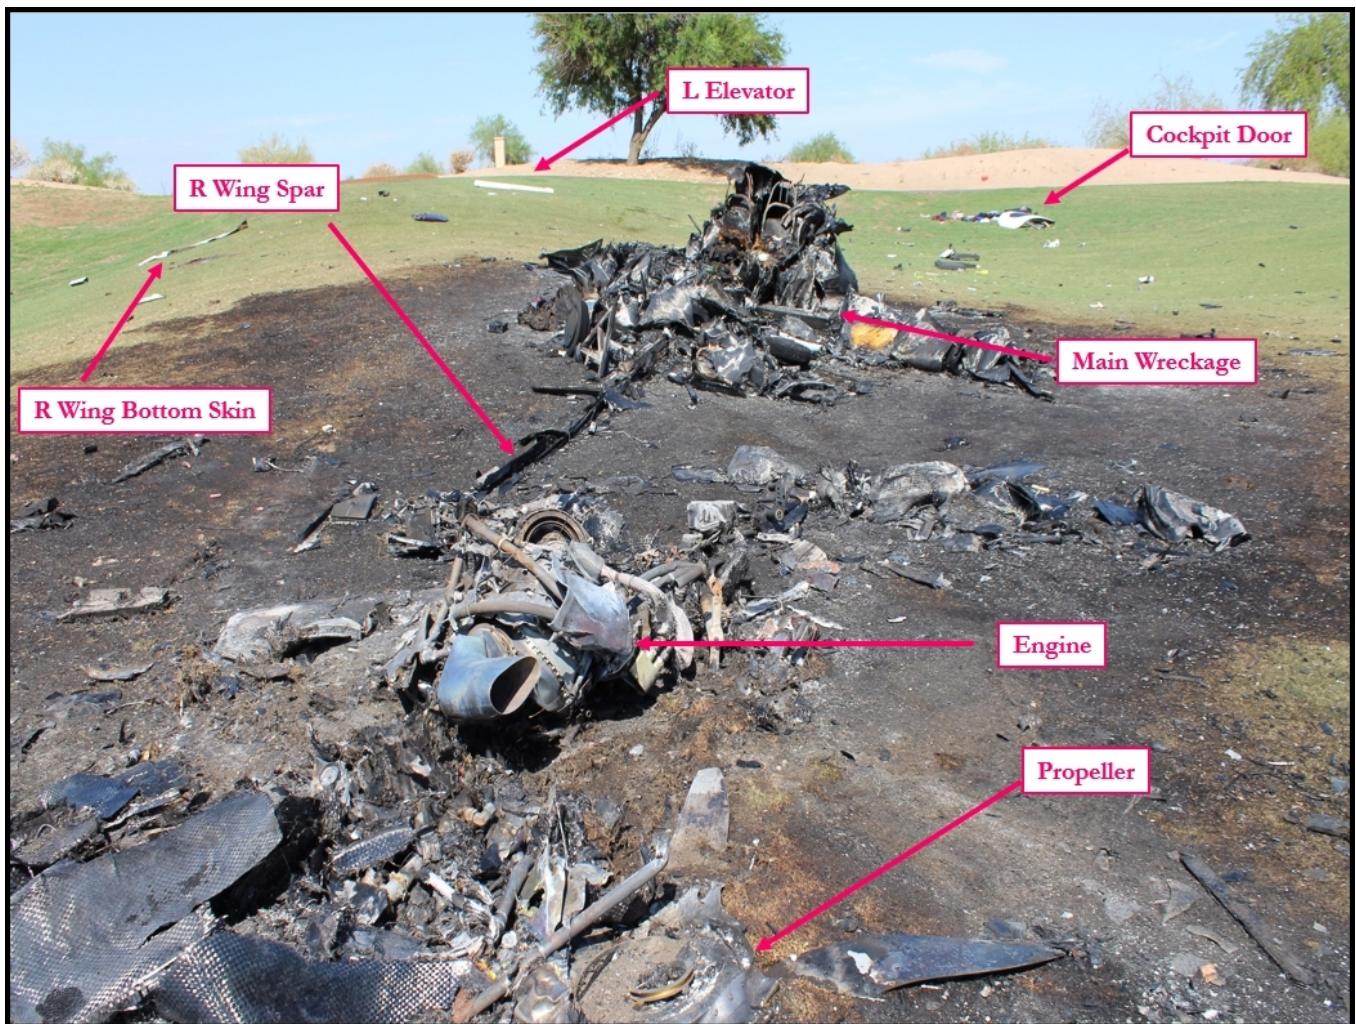
Figure 4: Main Wreckage

The first identified point of impact was a crater in the soft terrain in which the propeller blades were embedded. The engine and numerous portions of the airframe were located in the debris field leading from the initial impact point to the main wreckage. The main wreckage was located in an upright position about 25 ft from the initial impact point on a magnetic heading of 115°. The main wreckage sustained thermal damage and consisted of a majority of the airframe's ashen remains (see picture 4).

The cockpit area sustained severe thermal damage. The avionics were charred with wire bundles exposed and partially melted. The wings were consumed by fire. The wing flaps were consistent with a retracted position at the time of impact. The physical landing gear position and landing gear selector position was consistent with the gear being retracted at the time of impact.
