Aviation Investigation Final Report

Location:	Mesa, Arizona	Accident Number:	WPR17FA155
Date & Time:	July 17, 2017, 16:52 Local	Registration:	N571JM
Aircraft:	Evolution 19 Lancair Evolution	Aircraft Damage:	Substantial
Defining Event:	Loss of control in flight	Injuries:	2 Fatal
Flight Conducted Under:	Part 91: General aviation

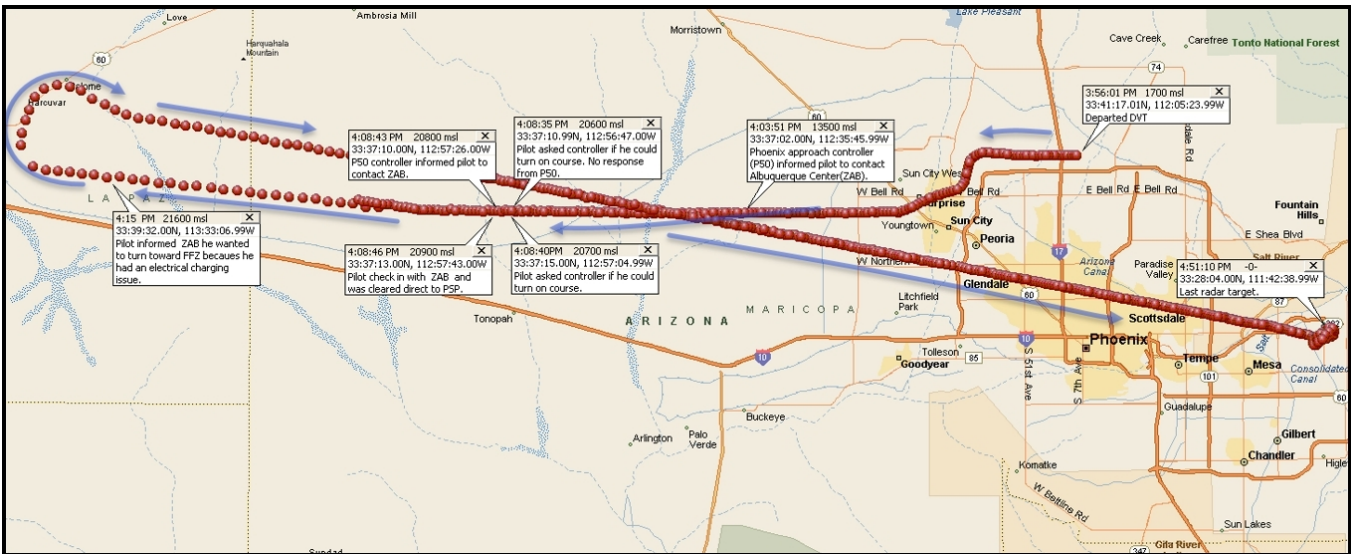
Figure 1: Flight Path

The Federal Aviation Administration (FAA) provided radar data and audio transcripts of the pilot's communications with air traffic control. After departing Deer Valley, the pilot was cleared to climb to 21,000 ft mean sea level (msl). About 1615, the pilot advised an Albuquerque Center controller that he was having "an electrical charging issue" and requested to go to Falcon Field, explaining that was where the airplane's maintenance facility was located. The airplane subsequently made a right turn and began an east-southeasterly track directly toward Falcon Field as the airplane climbed to 22,000 ft msl (see figure 1). At 1617:20, no altitude was associated with the radar return, consistent with a temporary lack of power to the airplane's transponder. The pilot overflew numerous airports on the way to Falcon Field and did not declare an emergency.

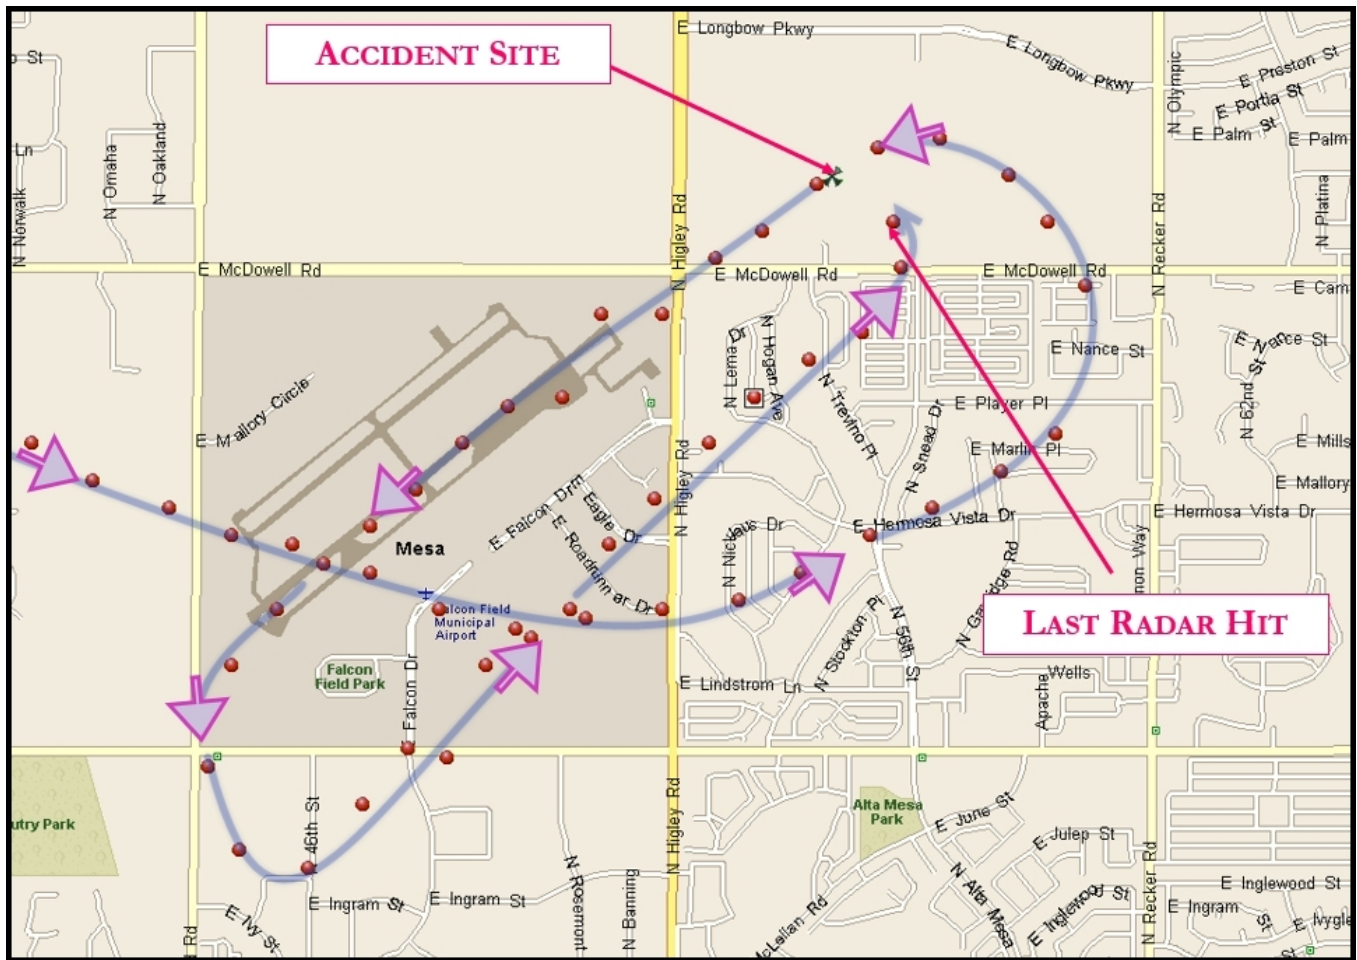
Figure 2: Last Portion of Flight

The Phoenix Approach and Falcon Field Air Traffic Controller (ATC) were in contact with the pilot. At 1633, the pilot stated to the controller, "just in case, my system is not charging," explaining that he had an incident "the other day" where the airplane's primary and multifunction flight displays (PFD and MFD, respectively) "just died on me and I don't think its going to happen before we get to Falcon, but if you could keep me on a direct heading to Falcon that would be great." At 1644, the pilot was cleared to land on runway 22L at Falcon Field and requested to cross midfield to enter the downwind leg of the traffic pattern. He then explained that he was "still having an electrical issue," and that his electrical system was "about to go dead." From 1645:56 through the remainder of the accident flight, the airplane's radar returns showed no associated altitude. The radar track indicated that the airplane crossed over the runway around 1647:27 and joined the left downwind leg of the traffic pattern for runway 22L. At 1649, the controller transmitted, "if you can hear me [your] gear appears down." Radar data indicated that the airplane flew the base and final legs of the traffic pattern and then continued over the runway, consistent with a low-level pass. The airplane then continued in a left turn and began a close downwind leg at 1650, about 1,500 ft from the runway centerline. The airplane proceeded from the downwind to the base leg; the final radar target was about 1,400 ft south of the accident site (see figure 2).

Numerous witnesses in the vicinity of the accident site reported seeing the airplane maneuvering very low and making a steep left turn. They stated that the airplane then entered a nose-low, near-vertical descent. Video footage of the accident captured by a camera mounted in a moving car showed the airplane at an altitude about 325 ft above ground level (agl) before it momentarily climbed 100 ft while making a left turn onto the base leg of the traffic pattern. The airplane remained in a left-wing low attitude at an estimated ground speed of about 83 kts and descended below the tree line. A complete video study is contained in the public docket for this accident.

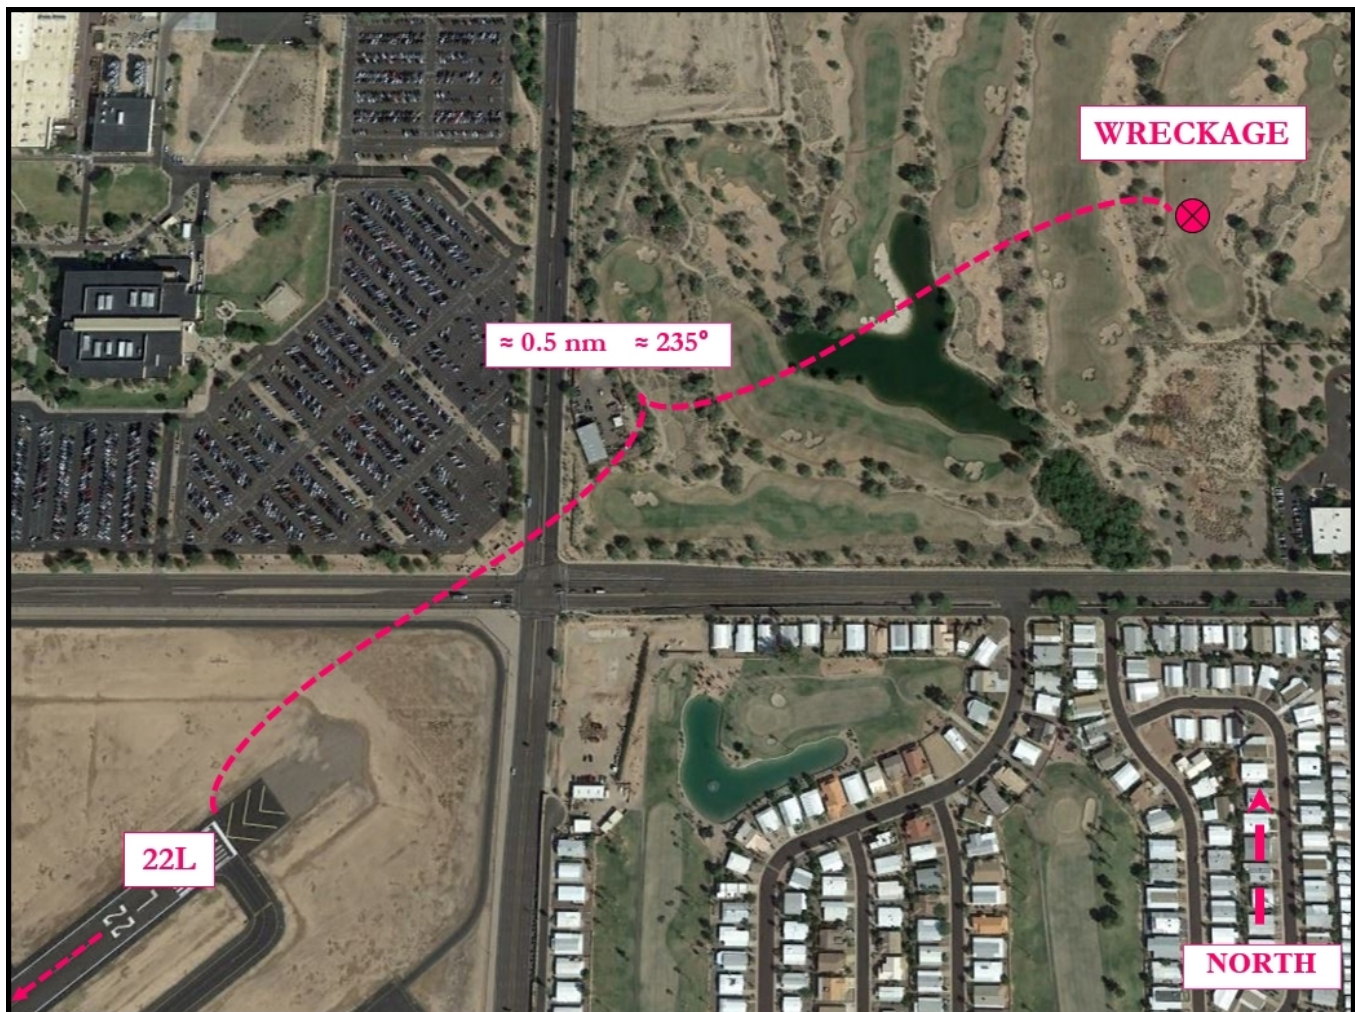
Figure 3: Wreckage in Relation to Runway

The wreckage was located about 0.5 nm northeast of the end of runway 22L, in a green area of a golf course (see figure 3).

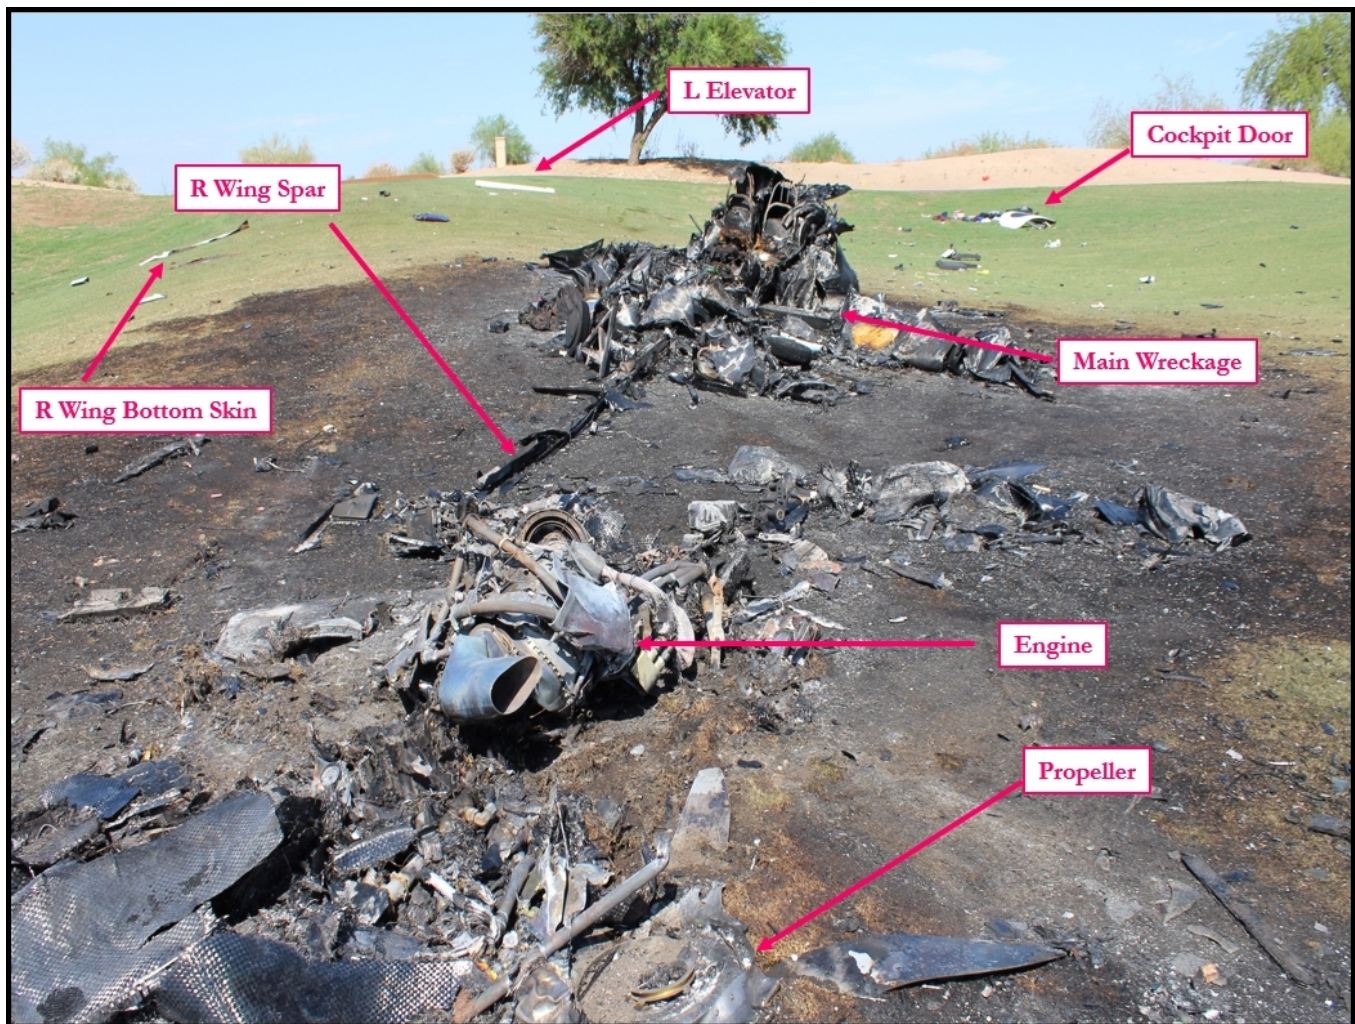
Figure 4: Main Wreckage

The first identified point of impact was a crater in the soft terrain in which the propeller blades were embedded. The engine and numerous portions of the airframe were located in the debris field leading from the initial impact point to the main wreckage. The main wreckage was located in an upright position about 25 ft from the initial impact point on a magnetic heading of 115°. The main wreckage sustained thermal damage and consisted of a majority of the airframe's ashen remains (see picture 4).

The cockpit area sustained severe thermal damage. The avionics were charred with wire bundles exposed and partially melted. The wings were consumed by fire. The wing flaps were consistent with a retracted position at the time of impact. The physical landing gear position and landing gear selector position was consistent with the gear being retracted at the time of impact.
