Aviation Investigation Final Report

Location:	Mesa, Arizona	Accident Number:	WPR17FA155
Date & Time:	July 17, 2017, 16:52 Local	Registration:	N571JM
Aircraft:	Evolution 19 Lancair Evolution	Aircraft Damage:	Substantial
Defining Event:	Loss of control in flight	Injuries:	2 Fatal
Flight Conducted Under:	Part 91: General aviation

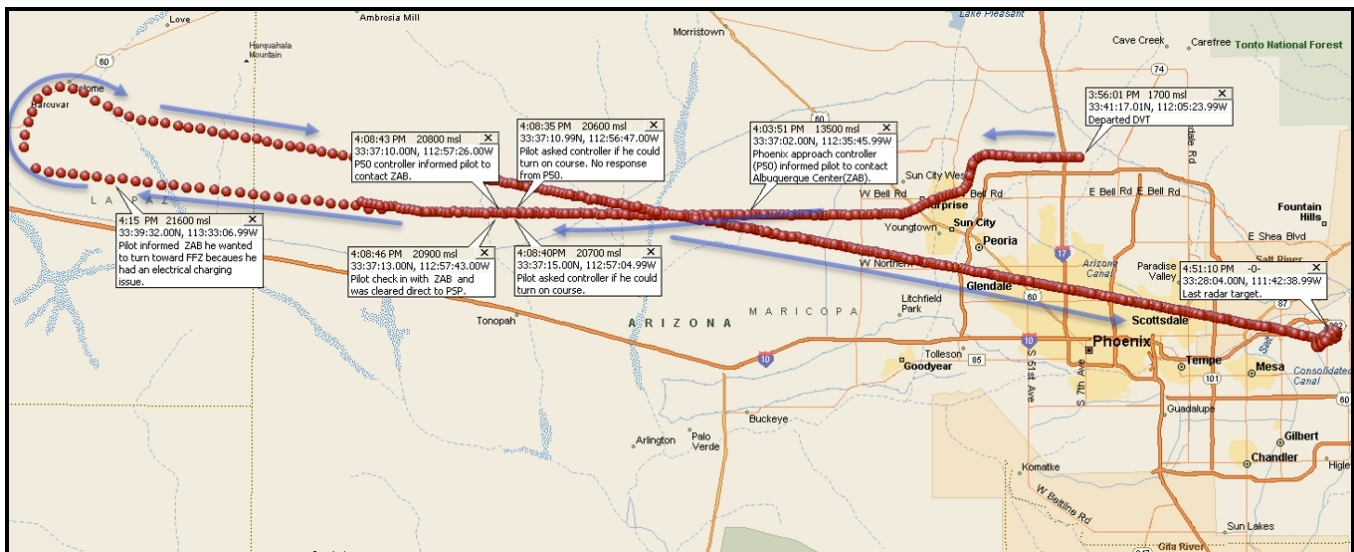
Figure 1: Flight Path

The Federal Aviation Administration (FAA) provided radar data and audio transcripts of the pilot's communications with air traffic control. After departing Deer Valley, the pilot was cleared to climb to 21,000 ft mean sea level (msl). About 1615, the pilot advised an Albuquerque Center controller that he was having "an electrical charging issue" and requested to go to Falcon Field, explaining that was where the airplane's maintenance facility was located. The airplane subsequently made a right turn and began an east-southeasterly track directly toward Falcon Field as the airplane climbed to 22,000 ft msl (see figure 1). At 1617:20, no altitude was associated with the radar return, consistent with a temporary lack of power to the airplane's transponder. The pilot overflew numerous airports on the way to Falcon Field and did not declare an emergency.

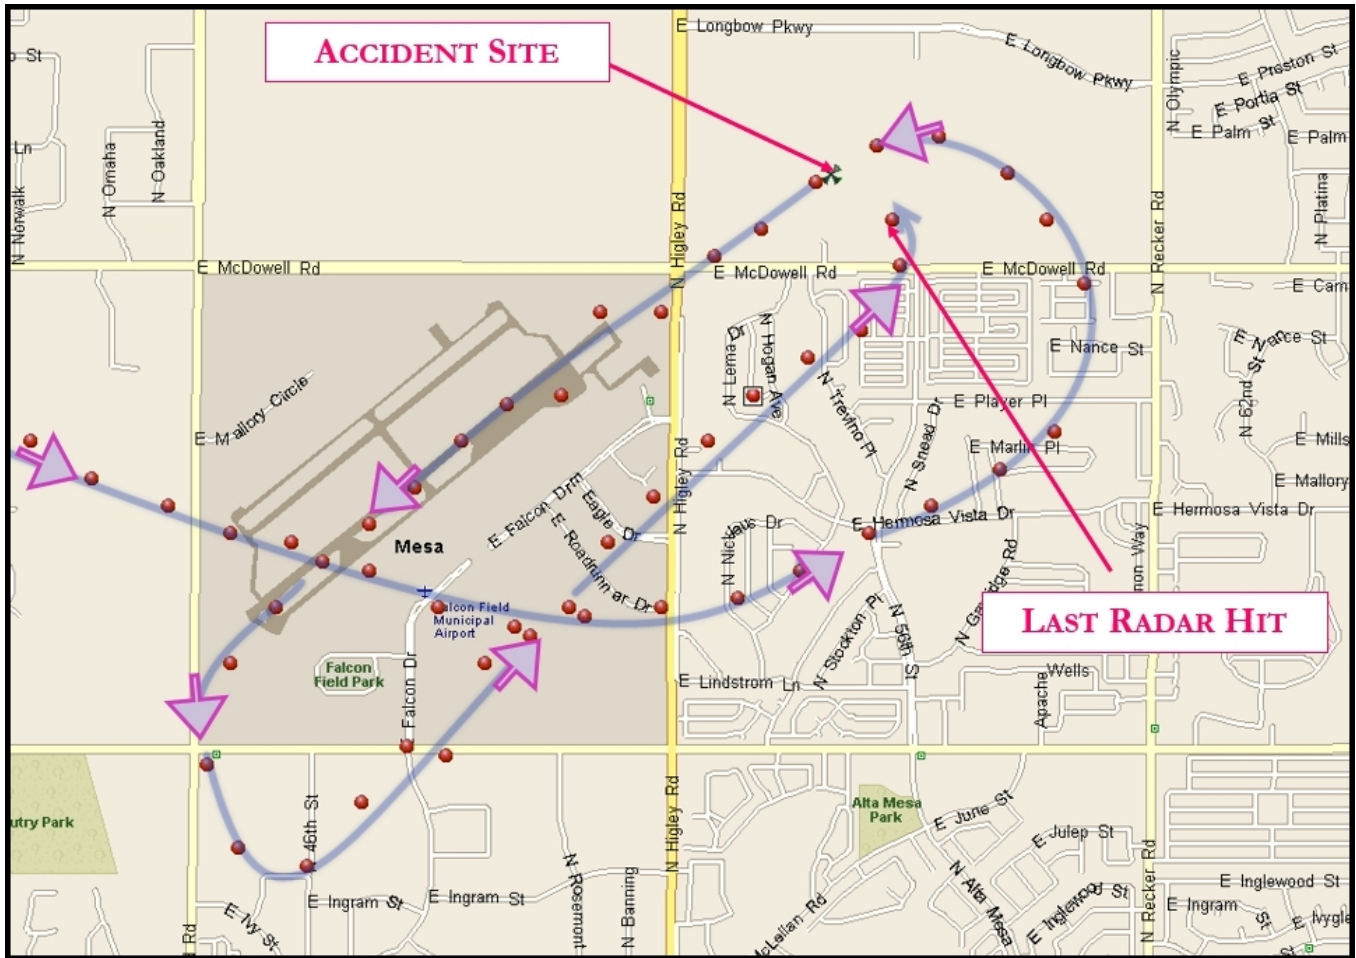
Figure 2: Last Portion of Flight

The Phoenix Approach and Falcon Field Air Traffic Controller (ATC) were in contact with the pilot. At 1633, the pilot stated to the controller, "just in case, my system is not charging," explaining that he had an incident "the other day" where the airplane's primary and multifunction flight displays (PFD and MFD, respectively) "just died on me and I don't think its going to happen before we get to Falcon, but if you could keep me on a direct heading to Falcon that would be great." At 1644, the pilot was cleared to land on runway 22L at Falcon Field and requested to cross midfield to enter the downwind leg of the traffic pattern. He then explained that he was "still having an electrical issue," and that his electrical system was "about to go dead." From 1645:56 through the remainder of the accident flight, the airplane's radar returns showed no associated altitude. The radar track indicated that the airplane crossed over the runway around 1647:27 and joined the left downwind leg of the traffic pattern for runway 22L. At 1649, the controller transmitted, "if you can hear me [your] gear appears down." Radar data indicated that the airplane flew the base and final legs of the traffic pattern and then continued over the runway, consistent with a low-level pass. The airplane then continued in a left turn and began a close downwind leg at 1650, about 1,500 ft from the runway centerline. The airplane proceeded from the downwind to the base leg; the final radar target was about 1,400 ft south of the accident site (see figure 2).

Numerous witnesses in the vicinity of the accident site reported seeing the airplane maneuvering very low and making a steep left turn. They stated that the airplane then entered a nose-low, near-vertical descent. Video footage of the accident captured by a camera mounted in a moving car showed the airplane at an altitude about 325 ft above ground level (agl) before it momentarily climbed 100 ft while making a left turn onto the base leg of the traffic pattern. The airplane remained in a left-wing low attitude at an estimated ground speed of about 83 kts and descended below the tree line. A complete video study is contained in the public docket for this accident.
