Aviation Investigation Final Report

Location:	Breckenridge, Texas	Accident Number:	CEN17LA285
Date & Time:	July 25, 2017, 09:10 Local	Registration:	N254SF
Aircraft:	HILLARD CHARLIE R HAWKER FB60	Aircraft Damage:	Substantial
Defining Event:	Loss of engine power (total)	Injuries:	2 Serious
Flight Conducted Under:	Part 91: General aviation - Other work use

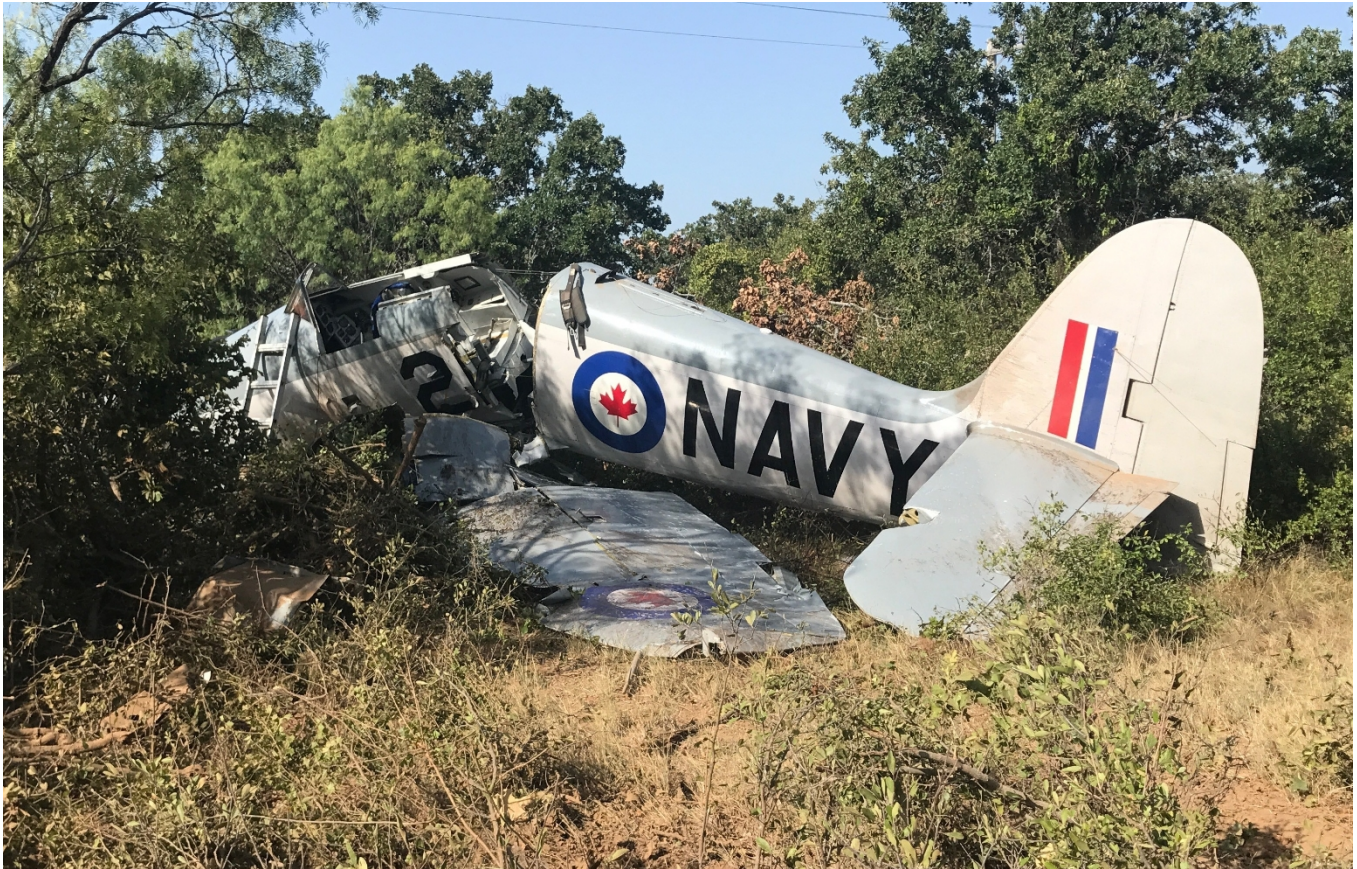
Figure 1 – Damaged Airplane

The airplane collided with a 20 ft tall tree about 1,000 ft north of the approach end of the runway. The airplane impacted the ground and came to rest upright about 150 ft from the initial tree strike. Figure 1 shows the empennage mostly separated from fuselage at the aft bulkhead. The left wing was separated and distorted aft. The right wing was crushed and distorted forward. The forward fuselage, engine cowling, and propeller shaft sustained impact damaged. The four propeller blades remained attached to the hub and did not exhibit leading edge damage or rotational scoring. First responders to the accident

site stated that the fuel lines had been severed and fuel was covering the ground under the airplane.
